Emergency repair of an RC bridge column with fractured bars using externally bonded prefabricated thin CFRP laminates and CFRP strips

An emergency repair technique for a reinforced concrete (RC) bridge column that had buckled and fractured longitudinal bars was developed and assessed through an experimental study. The repair technique involved removing loose concrete, casting grout, cutting a trench around the base of the column in the footing, embedding carbon fiber reinforced polymer (CFRP) strips for flexural reinforcement, building a jacket from a prefabricated thin CFRP laminate, lowering the jacket into the trench bonding the CFRP composites to the column and the footing with pressurized epoxy, and restoring the strength of footing with externally bonded CFRP sheets. The repaired column was tested to failure under constant axial load and cyclic lateral load resulting in combined flexure, shear, and torsional moment loading. Test results showed that the repair method was successful in restoring the seismic performance of the column in terms of lateral strength and deformation capacity.

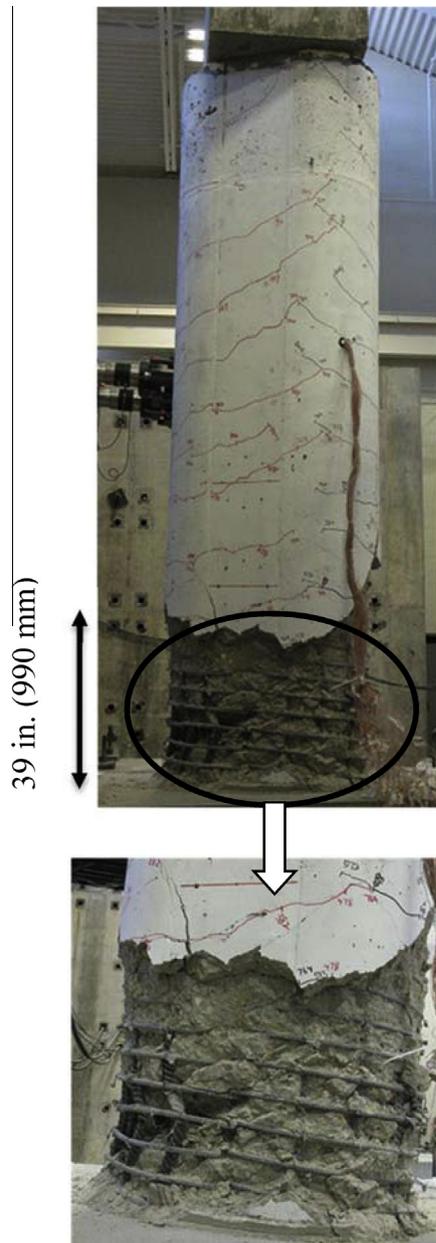
After the original test, the damage to the column was inspected visually and determined by analysis of measured data. As shown in Fig. 4, the concrete damage extended from the column base to a height of 39 in. (990 mm) above the top of footing. Four of the longitudinal bars buckled, and six of the longitudinal bars fractured. Buckled and fractured bars were located around the perimeter of the column on the extreme tension and compression sides. Measured strain data indicated that all of the longitudinal bars yielded. Yielding of the longitudinal bars was indicated by strain gages located in the region 4.0 in. (100 mm) to 61.75 in. (1570 mm) above the top of footing. Yielding may also have occurred within the footing but could not be verified since no strain gages were installed on the portion of the longitudinal bars inside the footing. Strain gages were also installed on the spirals, however most gages within the plastic hinge region stopped functioning prior to termination of testing. The strain values collected from those gages before they malfunctioned and from other sound strain gages did not exceed the yield strain of the spirals. However, yielding of spirals may have occurred near the base of the column for the reason that crushing of core concrete was observed and is usually considered to be a result of loss of confinement, which suggests that the spirals yielded.

Fig. 4. Visible damage to concrete and reinforcement of Calt-3 after original test.

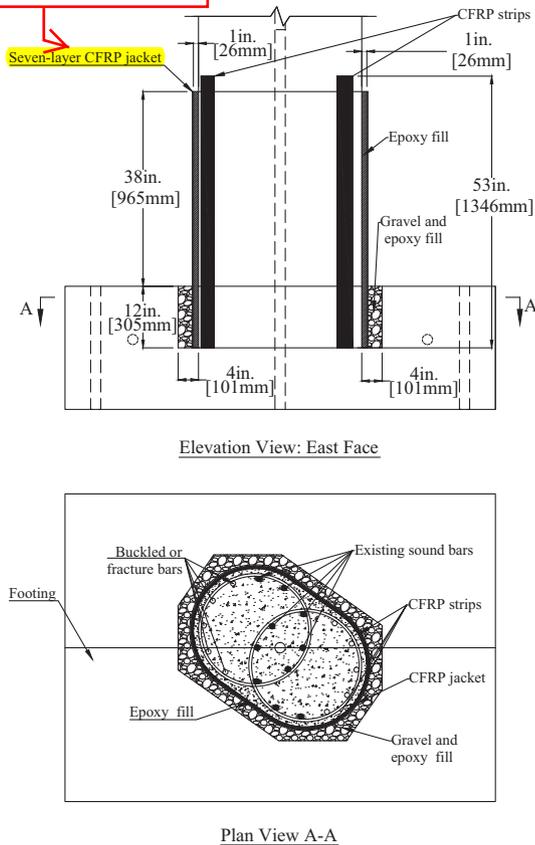
Fig. 5. Details of CFRP plates, CFRP jacket, and epoxy fill for R-Calt-3.

since additional layers of footing reinforcement might be damaged in the process. Thus, the CFRP embedment length was designed as 12 in. (305 mm) in this study, which was less than that estimated by the methods described above. Based on the repair design, the details of CFRP plates, CFRP jacket, and epoxy fill for the repaired column are illustrated in Fig. 5.

Several reinforcing bars in the footing needed to be cut to facilitate the embedment of the CFRP jacket and strips (shown in Fig. 5). Thus, CFRP fabric was externally bonded to the top surface of the footing to compensate for the loss of strength. Unidirectional CFRP fabric was cut into 12 in. (305 mm) wide straps to provide the required materials. The number of CFRP fabric layers was determined by the method proposed by Saini and Saiidi [34]. 10 layers of 12 in. (305 mm) wide CFRP straps were designed on four sides of the column, and the CFRP straps were extended to the side faces of the footing to secure the full development of the straps. The layout and orientation of the CFRP straps are shown in Fig. 6.

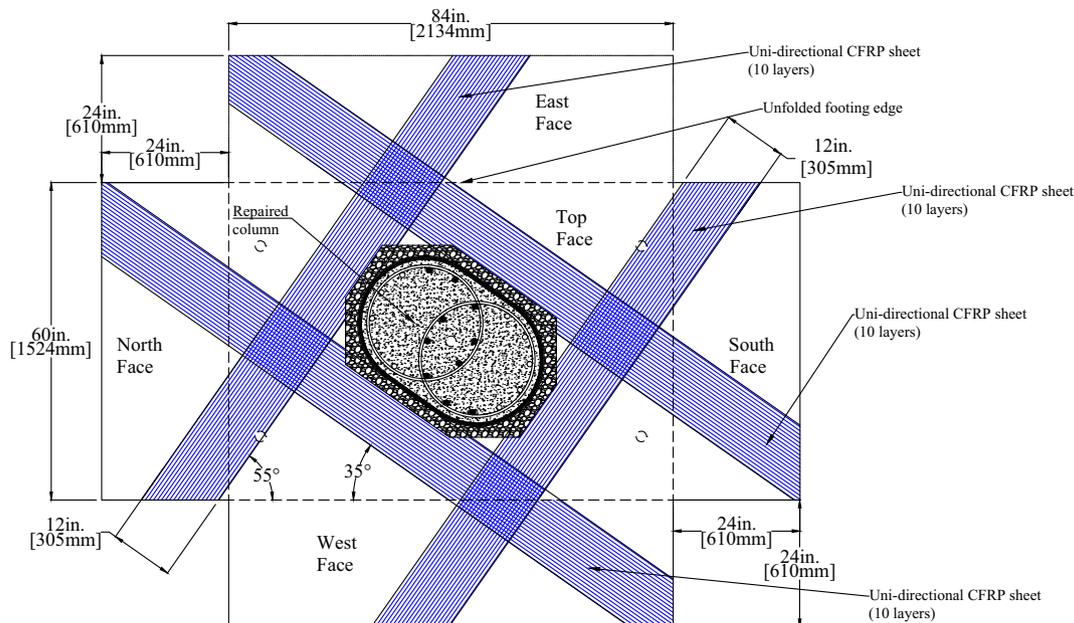
Fig. 6. CFRP strap layout on footing faces for R-Calt-3.

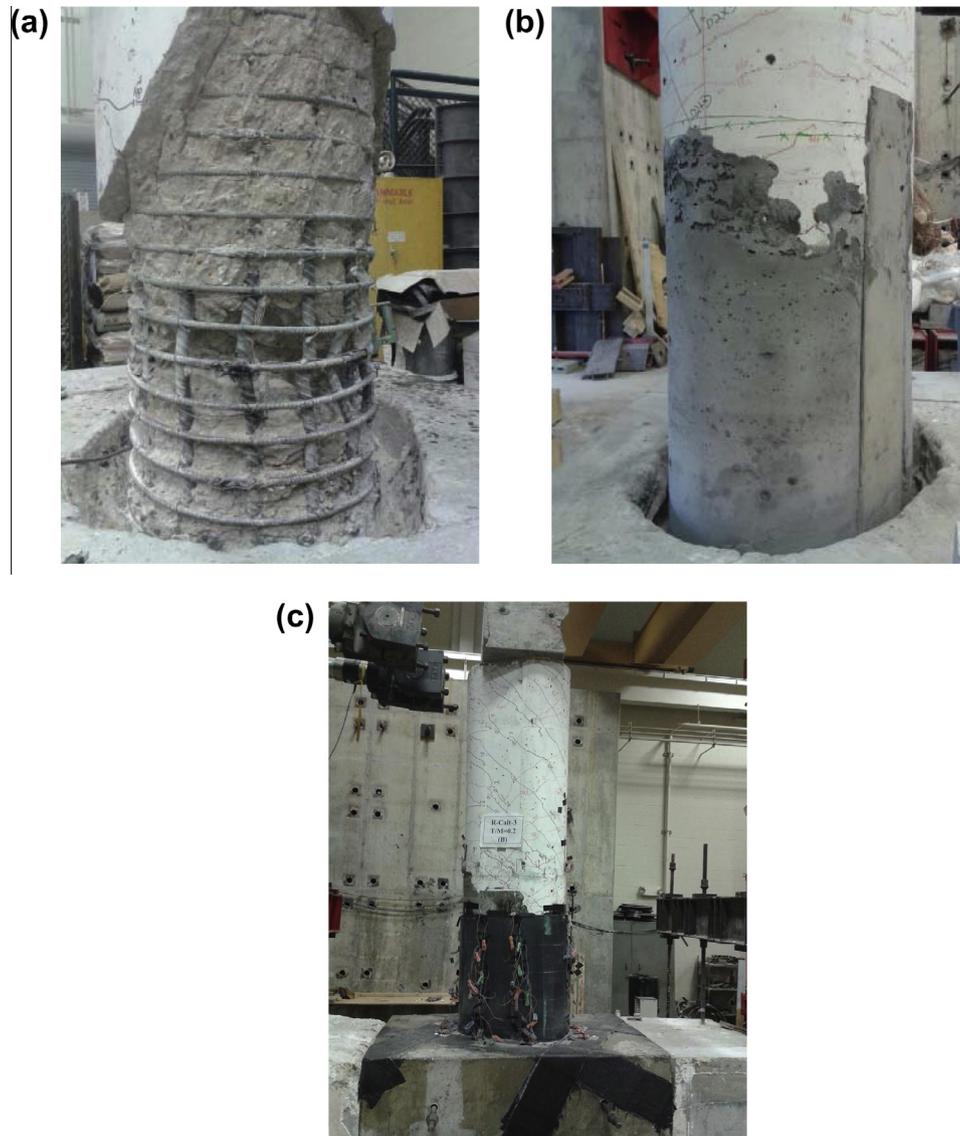
Fig. 7. Repair procedure for R-Calt-3. (a) Removal of loose concrete. (b) Grout placement. (c) R-Calt-3 prior to testing.

The damaged column was relatively straight vertically and could support its own weight; thus, shoring and straightening was not conducted during the repair procedure. The repair procedure involved the following steps: (1) cutting a 4 in. (100 mm) wide and 12 in. (300 mm) deep trench around the base of the

column in the footing; (2) removing loose concrete from the column; (3) placing formwork and then a high-fluidity grout to restore the column cross-section; (4) installing CFRP strips on the column surface; (5) wrapping a 4 ft wide \times 60 ft long (1.2 m \times 18.3 m) epoxy-coated prefabricated laminate around the column to create a 7-ply jacket; (6) lowering the jacket into the trench until it touched the base of the trench; (7) filling the trench with an epoxy aggregate; (8) injecting a low-viscosity resin between the jacket and the column; and (9) installing CFRP fabric on the footing surface. Fig. 7 shows photos of the column during the repair procedure.

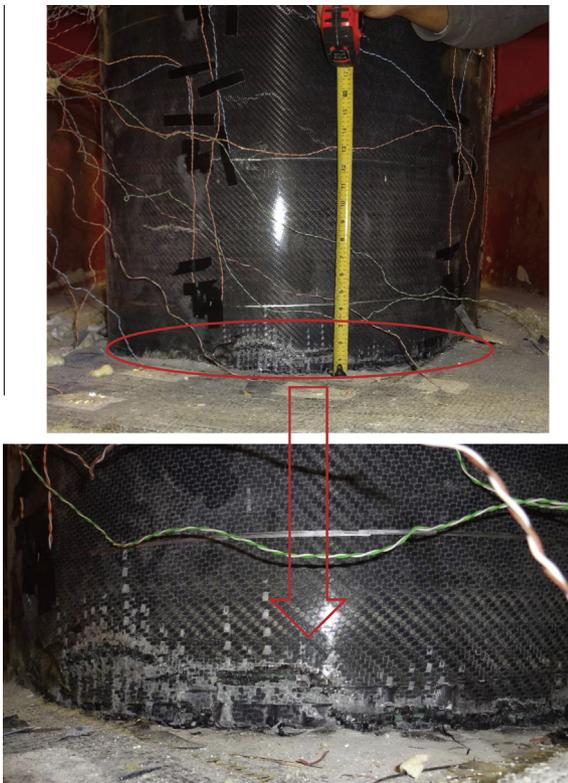
noise was heard that was later proved to be fracture of one of the existing longitudinal bars. The CFRP jacket started to rupture at a height of about 1 in. (25 mm) from the top of the footing on the compression side at a drift ratio of 3%, which explains the drop in lateral load at this level. Slip of the CFRP jacket from the footing was also noticed at this level. At higher levels (drift ratio > 3%), rupture of the CFRP jacket progressed and was observed on both sides of the column (see Fig. 11). Forensic inspection was conducted by removing the CFRP jacket after termination of test. Two bars that had buckled during the original test were observed as fractured. The CFRP strips were also found to have ruptured at a height of about 1 in. (25 mm) from the top of the footing during testing.

Fig. 11. CFRP rupture on column tension side at drift ratio of 3% (R-Calt-3).
