# Repair of Wood Piles Using Prefabricated Fiber-Reinforced Polymer Composite Shells

Roberto Lopez-Anido, M.ASCE<sup>1</sup>; Antonis P. Michael, S.M.ASCE<sup>2</sup>; Thomas C. Sandford, M.ASCE<sup>3</sup>; and Barry Goodell<sup>4</sup>

**DOI:** 10.1061/(ASCE)0887-3828(2005)19:1(78)

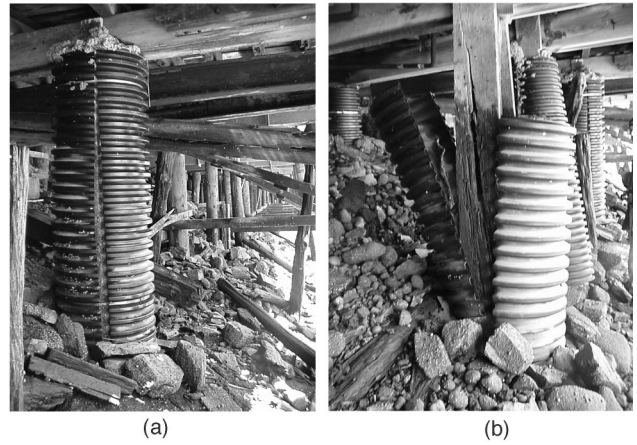
The wood pile repair method used in this pier consisted of a corrugated (profile wall) high-density polyethylene (HDPE) pipe encasing [Fig. 2(a)]. The corrugated HDPE pipe was split into two halves that were placed around the wood pile and held together with circumferential metal straps. The metal straps were spaced approximately 910 to 1,220 mm apart, and the space between the wood pile and the corrugated HDPE pipe was grouted with unreinforced concrete. Typical dimensions of the corrugated HDPE pipe used were 686 mm for the external diameter and 584 mm for the internal diameter. The thickness of the corrugated profile wall was 51 mm. Several problems with this repair method were observed in individual piles: (1) The steel straps were damaged and severed, and the corrugated HDPE pipe halves were

**Fig. 2.** Repair method using corrugated HDPE pipe encasing: (a) repaired wood pile; and (b) failure of HDPE pipe encasing

opened as shown in Fig. 2(b); (2) wood damage was observed at pile sections above the repaired area; (3) the concrete fill was deteriorated and disintegrated with relatively little effort; and (4) at the opened joint of the corrugated HDPE pipe, the concrete was spalling and exposing the interior wood pile.

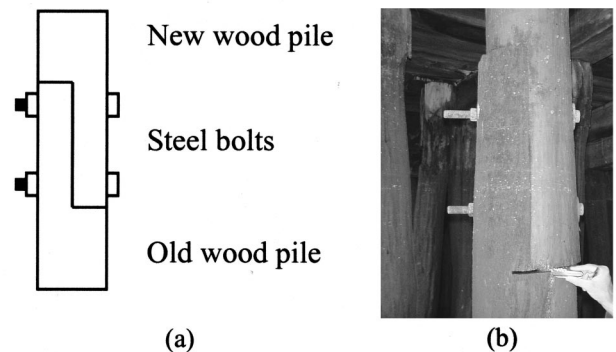
Another type of wood pile repair method observed was splicing. In this method the top portion of the old damaged pile was removed and a new wood pile portion was spliced using steel bolts, as shown in Fig. 3. For a wood pile with an approximate diameter of 254 mm, the steel bolts were spaced 203 mm apart. A

**Fig. 3.** Splicing of wood piles with steel bolts

problem observed in the splices was a gap between the horizontal surfaces of the two wood pile portions, which does not allow for proper vertical load transfer by bearing. The splice also exposes the untreated center of the wood pile as pressure preservative treatments rarely extend all the way to the center of the impermeable heartwood region of a pile. In areas where gaps occurred in the splice, shipworm larvae could enter and attack the untreated wood.

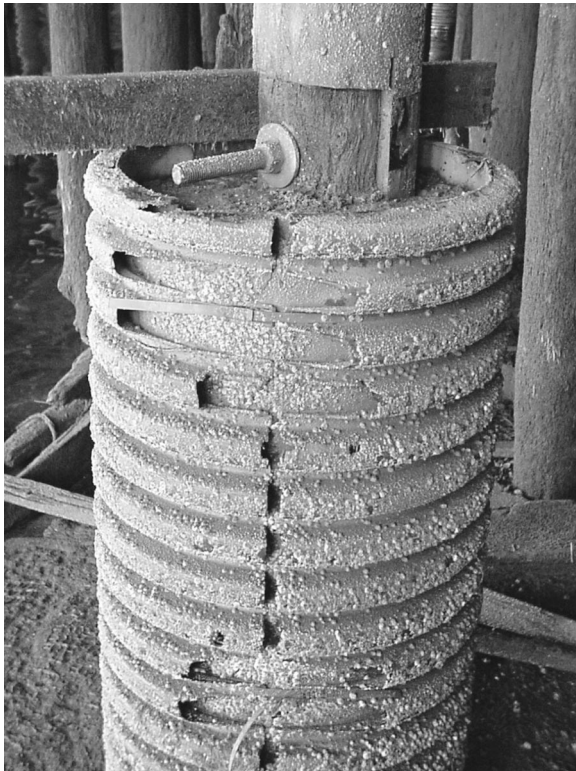
**Fig. 4.** Repair method using HDPE pipe encasing and splicing with steel bolts

At the Maine Wharf, repair methods were also applied to several damaged wood piles. Several piles were repaired using splicing, as shown in Fig. 3(b). Corrugated HDPE pipes were also used at this facility. The pipes were placed around the pile in two halves and metal straps were used to hold them together. At the vertical joints metal plates were used to close the gap and contain the concrete. The concrete was in good condition. A combination of corrugated HDPE pipes and the splicing method with steel bolts was observed. Part of the splice length was buried in concrete and part was exposed, as shown in Fig. 4.

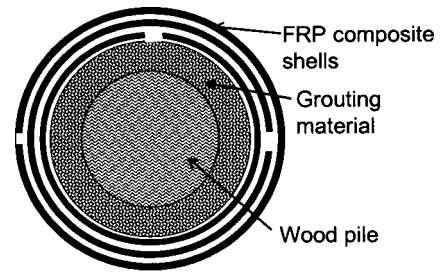
**Fig. 5.** Cross section of wood pile repaired with fiber-reinforced polymer composite shells

The wood pile repair method proposed in this paper utilizes an FRP composite encasement or shield that encapsulates and splices the deteriorated portion of the pile. The encasement was developed based on experience with appropriate technologies in the structural FRP composites field (Kshirsagar et al. 2000; Lopez-Anido and Karbhari 2000; Lopez-Anido et al. 2000; Lopez-Anido and Xu 2002) combined with the needs for wood pile protection and strengthening observed in the field inspection, survey, and literature review. The shield is made of bonded thin and flexible FRP composite prefabricated cylindrical shells that deliver the required strength to repair damaged wood piles. The shells are fabricated in a quality-controlled composites manufacturing facility. The cylindrical shells have a slit or opening along their length, which enables them to be opened and placed around the deteriorated wood pile. Since it is advantageous to encase the pile with a series of overlapping shells, the minimum number of FRP composite shells required is two; however, additional shells can be added, depending on the structural restoration needs. The slit in each cylindrical shell is staggered to avoid lines of weakness through the entire shield (Fig. 5).

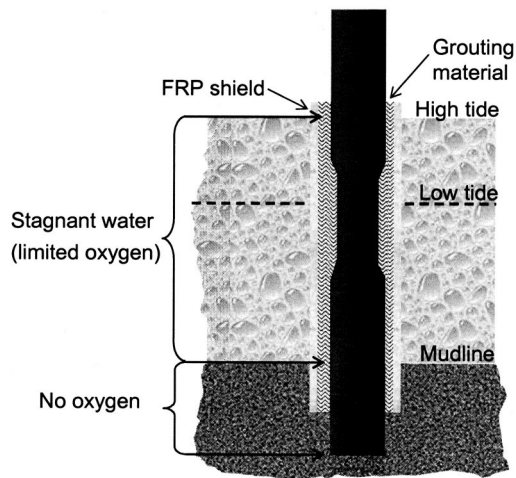
**Fig. 6.** Schematic of wood pile repair with fiber-reinforced polymer composite shells

In the proposed repair method, the space between the FRP composite shield and the wood pile is filled with a grouting material that does not provide a structural bond with the wood pile, but rather provides interlocking (friction) between the wood pile and the FRP composite shells. Since the grout is not expected to completely seal the wood core, seawater saturates the pile, creating a layer of stagnant water, potentially limiting the oxygen supply. Assuming a lack of oxygen, marine borers already inside the wood pile would be expected to die and new borers would be prevented from attacking the wood pile. A schematic of the proposed repair system is depicted in Fig. 6.

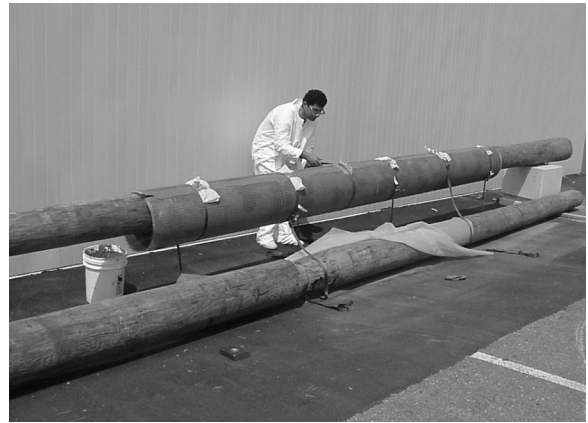
**Fig. 11.** Application of fiber-reinforced polymer composite shells to predamaged wood pile

The feasibility of the repair method was demonstrated in the laboratory by fabricating FRP composite shells and restoring “damaged” wood pile prototypes (Fig. 11). Marine borer damage was simulated by reducing the cross-sectional area of the pile. The space between the wood core and the FRP composite shells was filled with a grouting system. Two different grouting materials were used: (1) portland cement-based (inorganic) structural grout (Fig. 12), and (2) polyurethane-based (organic) nonstructural grout with shear connectors that transfer loads from the wood pile to the FRP composite shells (Fig. 13). Laboratory prototypes were fabricated for two types of experiments: (1) pushout tests by compression loading to characterize the interface response (wood/grout/shear connector/FRP composite) (Lopez-Anido et al. 2004a); and (2) full-size bending tests to characterize the overall structural response (Lopez-Anido et al. 2003).
