Repair of Wood Piles Using Prefabricated Fiber-Reinforced Polymer Composite Shells

Roberto Lopez-Anido, M.ASCE¹; Antonis P. Michael, S.M.ASCE²; Thomas C. Sandford, M.ASCE³; and Barry Goodell⁴

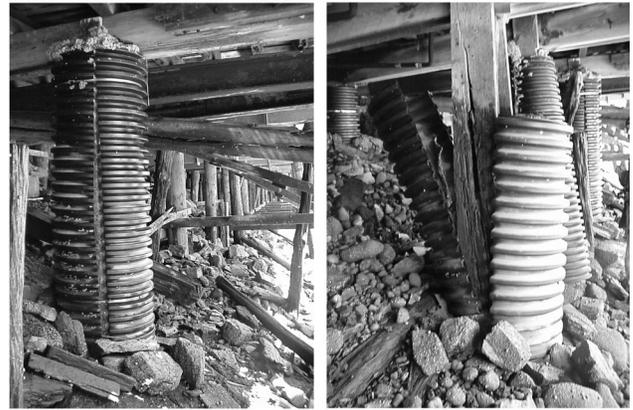
The wood pile repair method used in this pier consisted of a corrugated (profile wall) high-density polyethylene (HDPE) pipe encasing [Fig. 2(a)]. The corrugated HDPE pipe was split into two halves that were placed around the wood pile and held together with circumferential metal straps. The metal straps were spaced approximately 910 to 1,220 mm apart, and the space between the wood pile and the corrugated HDPE pipe was grouted with unreinforced concrete. Typical dimensions of the corrugated HDPE pipe used were 686 mm for the external diameter and 584 mm for the internal diameter. The thickness of the corrugated profile wall was 51 mm. Several problems with this repair method were observed in individual piles: (1) The steel straps were damaged and severed, and the corrugated HDPE pipe halves were

Fig. 2. Repair method using corrugated HDPE pipe encasing: (a) repaired wood pile; and (b) failure of HDPE pipe encasing

opened as shown in Fig. 2(b); (2) wood damage was observed at pile sections above the repaired area; (3) the concrete fill was deteriorated and disintegrated with relatively little effort; and (4) at the opened joint of the corrugated HDPE pipe, the concrete was spalling and exposing the interior wood pile.

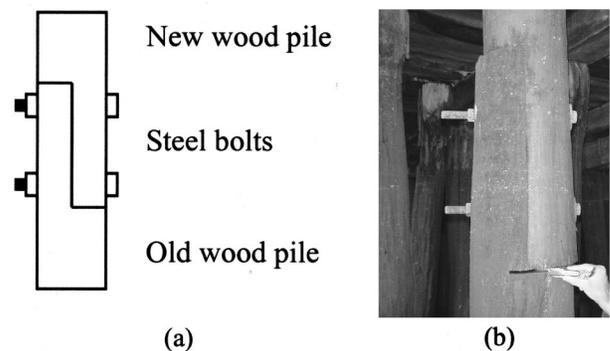
Another type of wood pile repair method observed was splicing. In this method the top portion of the old damaged pile was removed and a new wood pile portion was spliced using steel bolts, as shown in Fig. 3. For a wood pile with an approximate diameter of 254 mm, the steel bolts were spaced 203 mm apart. A

Fig. 3. Splicing of wood piles with steel bolts

problem observed in the splices was a gap between the horizontal surfaces of the two wood pile portions, which does not allow for proper vertical load transfer by bearing. The splice also exposes the untreated center of the wood pile as pressure preservative treatments rarely extend all the way to the center of the impermeable heartwood region of a pile. In areas where gaps occurred in the splice, shipworm larvae could enter and attack the untreated wood.

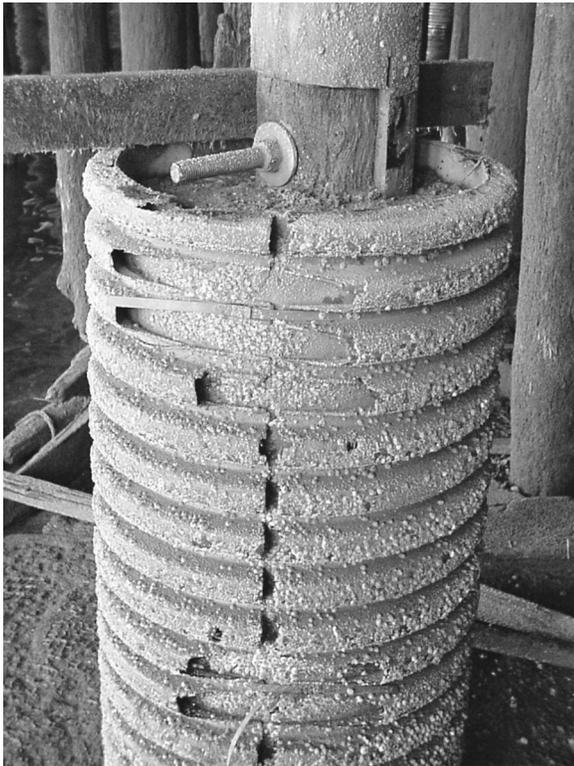
Fig. 4. Repair method using HDPE pipe encasing and splicing with steel bolts

At the Maine Wharf, repair methods were also applied to several damaged wood piles. Several piles were repaired using splicing, as shown in Fig. 3(b). Corrugated HDPE pipes were also used at this facility. The pipes were placed around the pile in two halves and metal straps were used to hold them together. At the vertical joints metal plates were used to close the gap and contain the concrete. The concrete was in good condition. A combination of corrugated HDPE pipes and the splicing method with steel bolts was observed. Part of the splice length was buried in concrete and part was exposed, as shown in Fig. 4.
