Assessment and Evaluation of Timber Piles Used in Nebraska for Retrofit and Rating

Sponsored By
Nebraska Department of Roads

April, 2014

1. Report No.	2. Government Accession No.	3. Recipient's Catalog No.	
4. Title and Subtitle Assessment and Evaluation of Timber Piles Used in Nebraska for Retrofit and Rating		5. Report Date April. 2014

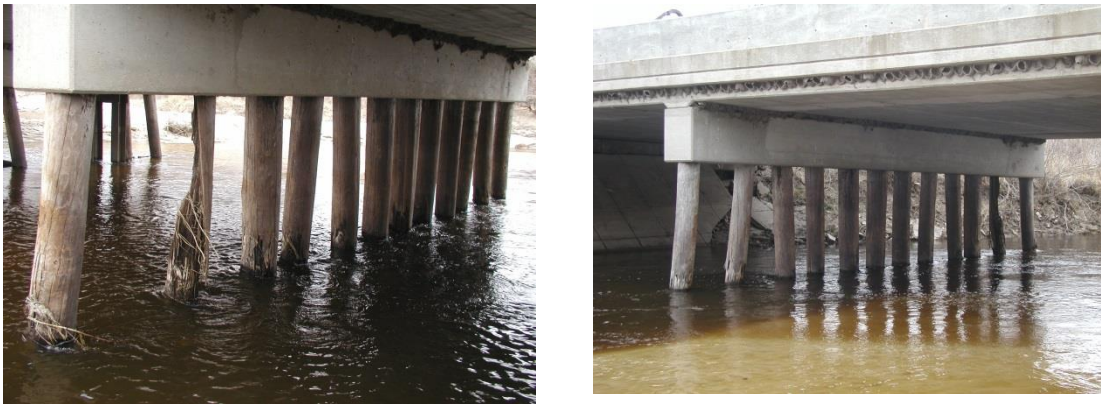
Figure 1.1: Examples of observed damages in Timber Piles in Nebraska

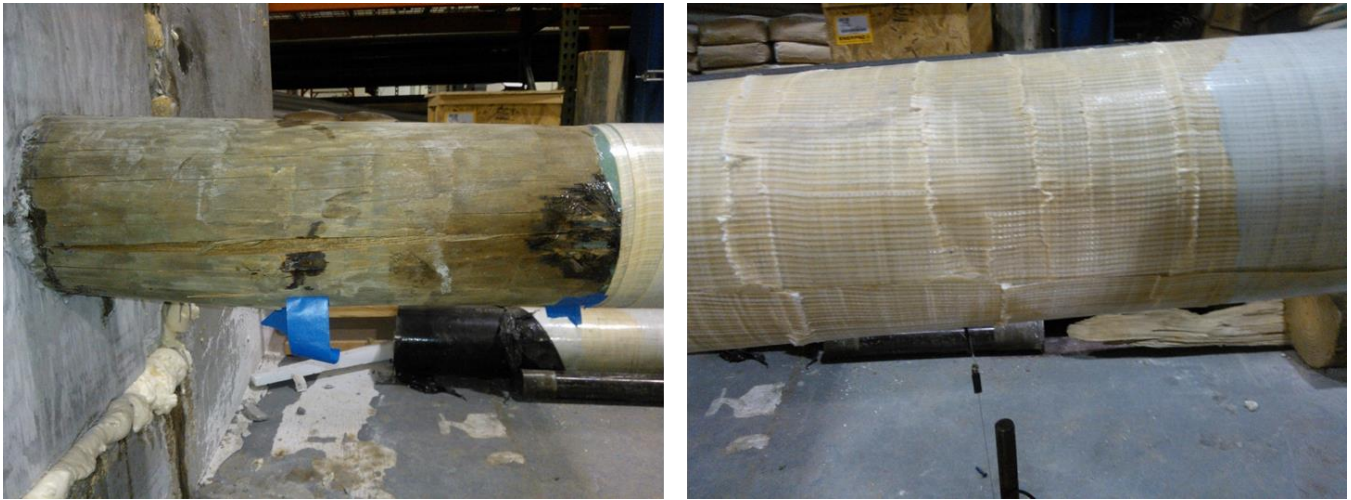
Specimen 1, with one inch deep damage filled by resin, showed the highest ultimate load capacity among the five specimens tested as part of this study. The specimen failed at approximately 177 kips axial load with rapid cracking. Major damage was observed at two locations after the failure of the specimen. Damage was observed near the fixed end where the pile had a big longitudinal crack splitting the pile into two halves. Damage was also observed at the repair location resulting in ripping and delamination of FRP jacket. Note these damages occurred at failure and were not progressive in nature.

Figure 5.7: Failure of specimen 1 (1 inch deep damage filled with resin)

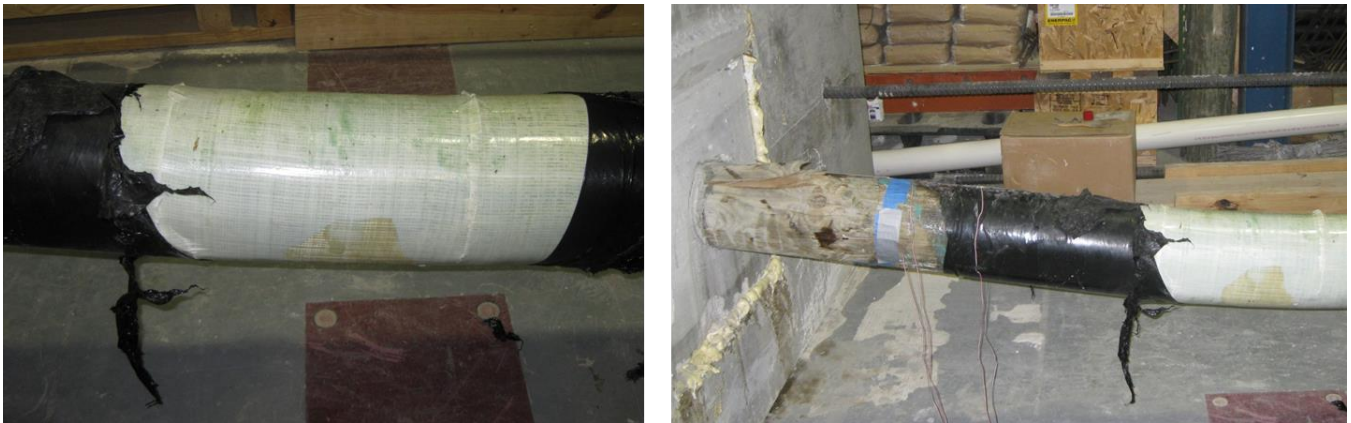
Specimen 2, with 1.5 inch deep damage filled with resin, showed the lowest ultimate load capacity (95 kips) among the five specimens tested as part of this study. This specimen failed mainly due to large gradual deflection at the repair location. FRP jacket was damaged at the two ends of the 14 inch long damaged region. The test was continued even after the large downward deflection of the repaired region that resulted in cracking of the fixed end of the pile.

Figure 5.8: Failure of specimen 2 (1.5 inch deep damage filled with resin)

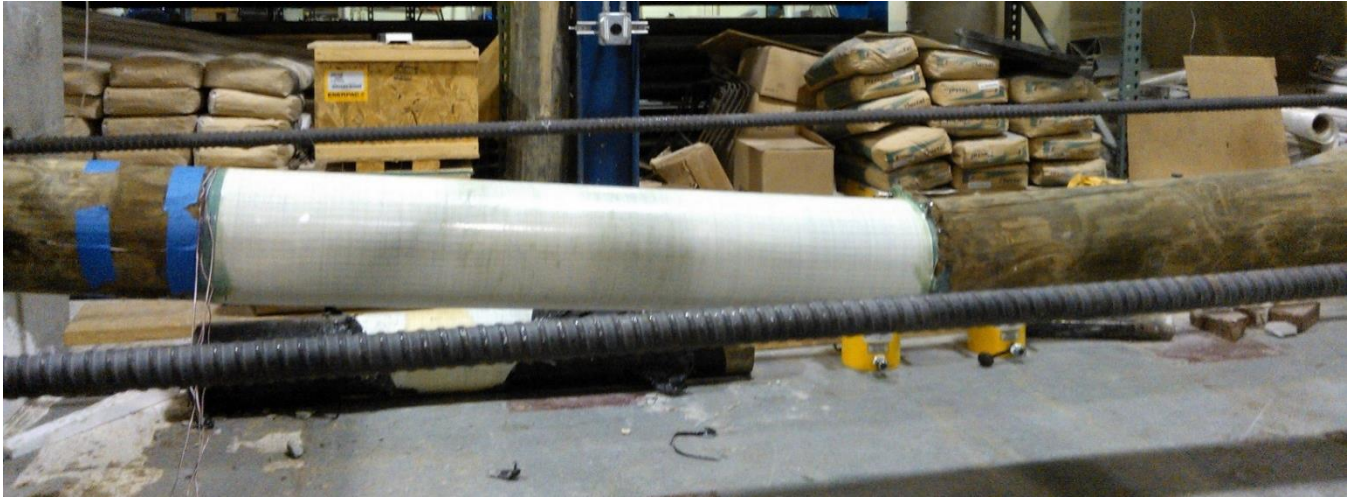
failed specimen indicated bending type failure resulting in crumpling top fibers and splintering bottom fibers. No damage of FRP wrap was observed during this test.

Figure 5.9: Failure of specimen 3 (2 inch deep damage filled with grout)

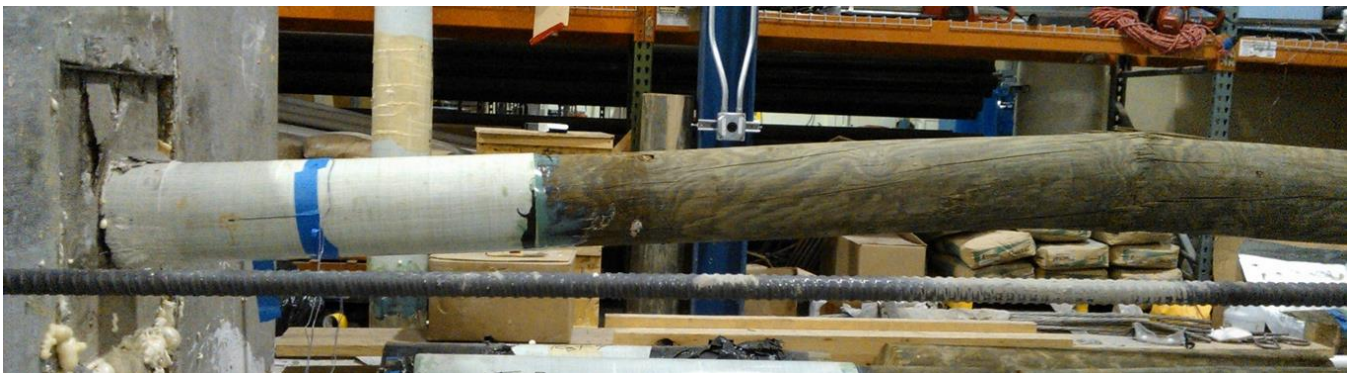
Specimen 4 also had 2 inch deep damage filled with grout similar to specimen 3 however; the location of damaged region was different from specimen 3. In specimen 4, the damaged region was placed at the most critical location (fixed end) in an attempt to fail the specimen in damaged region. The failure of this specimen however appeared away from the damaged region during the test. The specimen took approximately 170 kip maximum axial load before failure.

Figure 5.10: Failure of specimen 4 (2 inch deep damage filled with grout)

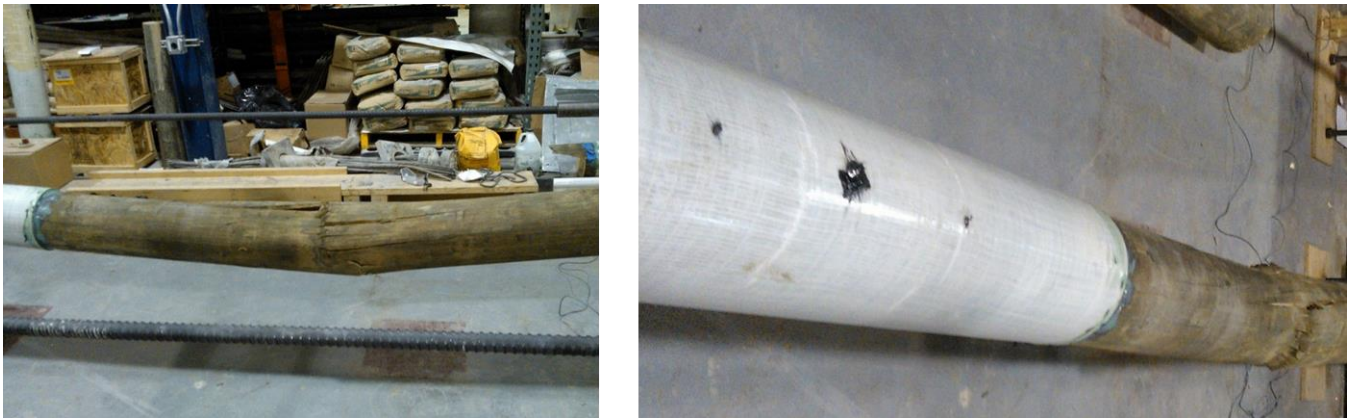
Specimen 5, with two inch deep damage filled with resin gravel, failed at approximately 115 kips axial load. The failure took place away from the repaired section. Insignificant damage was observed in the FRP jacket on the repaired section.

Figure 5.11: Failure of specimen 5 (2 inch deep damage filled with resin + gravel)

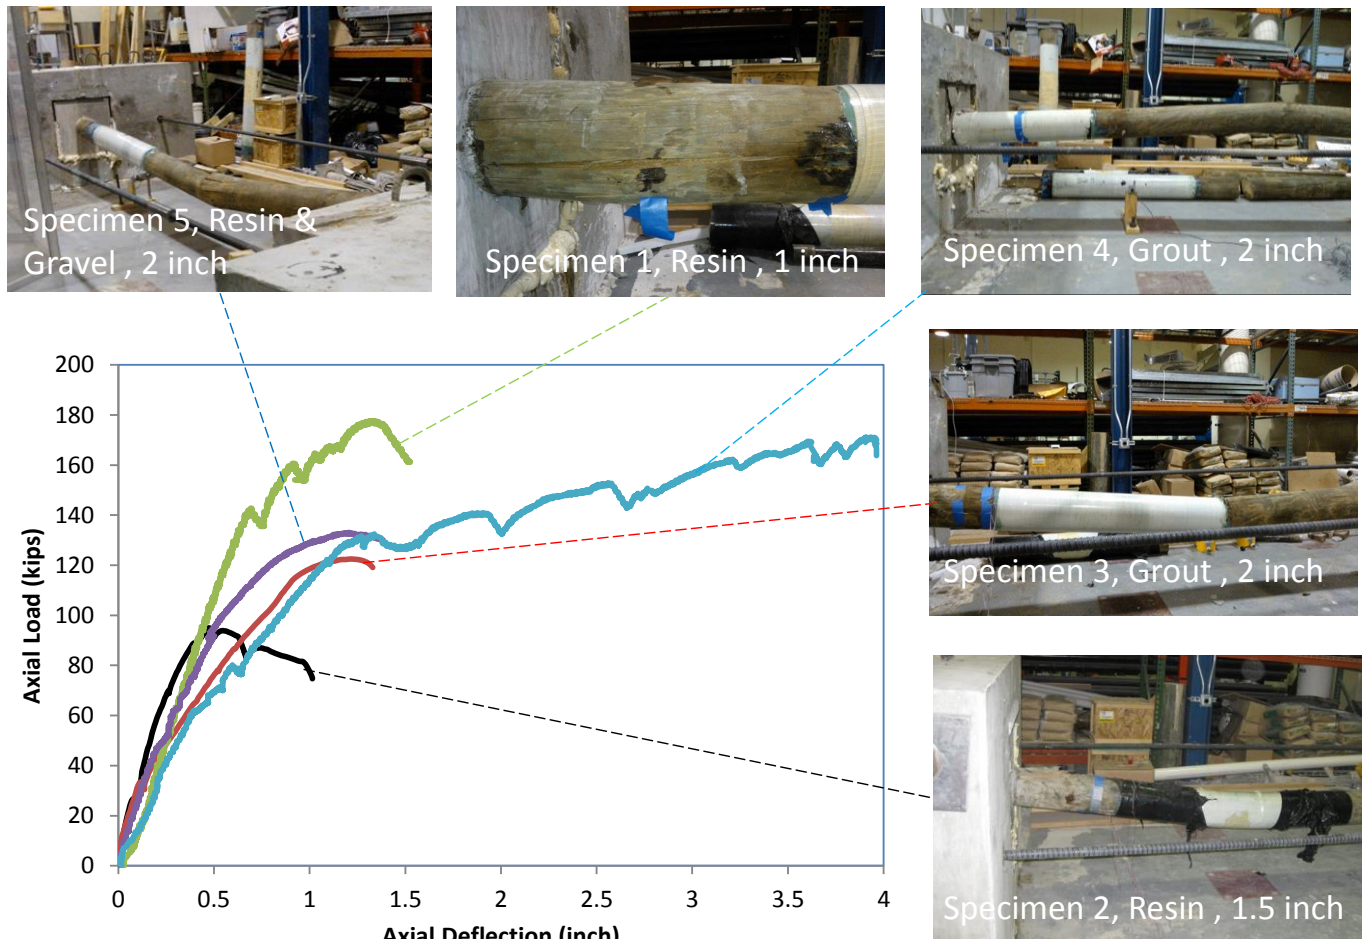
load drops can be observed in load deflection curve of specimen 1 at approximately 140 kips and 160 kips load. These load drops correspond to cracking of the wood during the test. Whenever wood cracking sound was heard, the load was put to hold to allow the failure to take place by progressive wood cracking. However, if the cracking sound stops and failure did not take place, the load was increased again until the next cracking sound or complete failure of the test specimen.

Figure 5.12: Load deflection curve and failure mode of specimens
