Repair of Corrosion-Damaged Substation Structures

*Mo Ehsani, PhD, PE, F.ASCE, Prof. Emeritus of Civil Eng., U. of AZ and President,
QuakeWrap, Inc. Mo@QuakeWrap.com, and
Gannon McGhee, PE, Civil Engineer IV, Tucson Electric Power Company
gmcghee@tep.com*

Presented at the 2015 ASCE Electrical Transmission and Substation Structures Conference

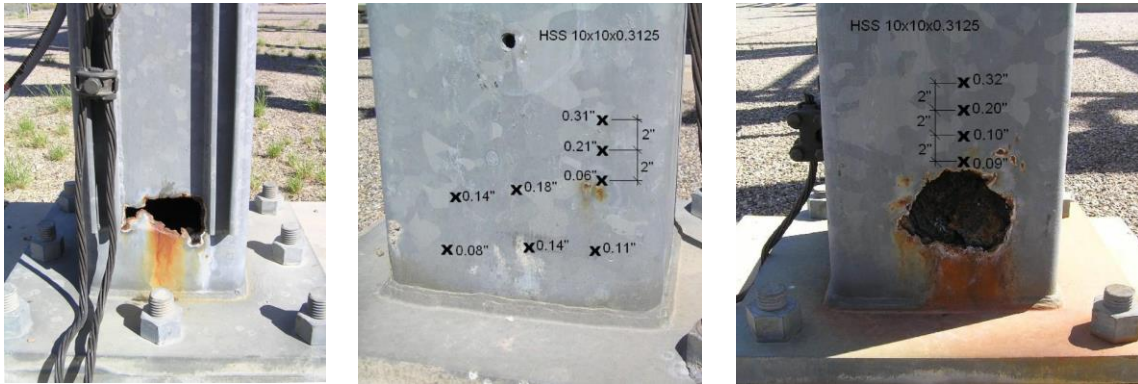
During an inspection at one of Tucson Electric Power's substations, extensive corrosion was discovered on many of the substation support columns. Based on a visual inspection, it seemed that the corrosion had begun on the inside of the column wall meaning that the damage was potentially much worse than it appeared. An ultrasonic thickness gauge was used to determine the steel thickness adjacent to the visible damage. Measurements along the height of the columns indicated that the loss of wall thickness was more severe closer to the base of the column (Fig. 1). These investigations also revealed that in many cases

the majority of the structural damage was on the inside of the square columns with little or no visible damage from the outside.

Fig. 1. Typical steel columns damaged by corrosion and measured wall thickness

Since the majority of the structural damage was found to be on the inside of the square columns, it was concluded that the damage is most likely the result of deficiencies during the galvanizing process. It is likely that the acid bath was not properly drained from the columns during the prepping stage causing the inside of the square columns near the base not to be galvanized properly. In addition, during the installation of these columns, grout had been placed between the base plate and the foundation. This caused rainwater to be trapped inside the structure, which accelerated the corrosion process.

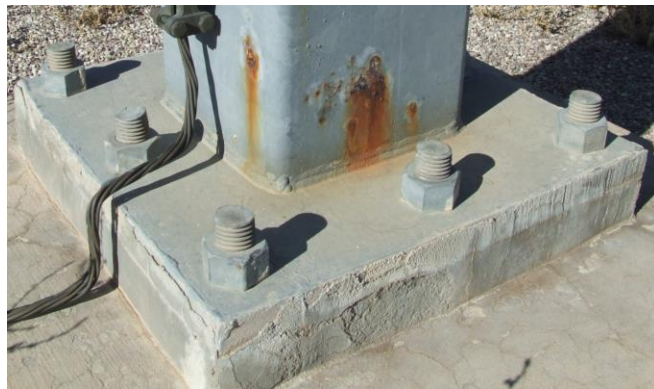
Fig. 2. Concrete grout at the base of the columns

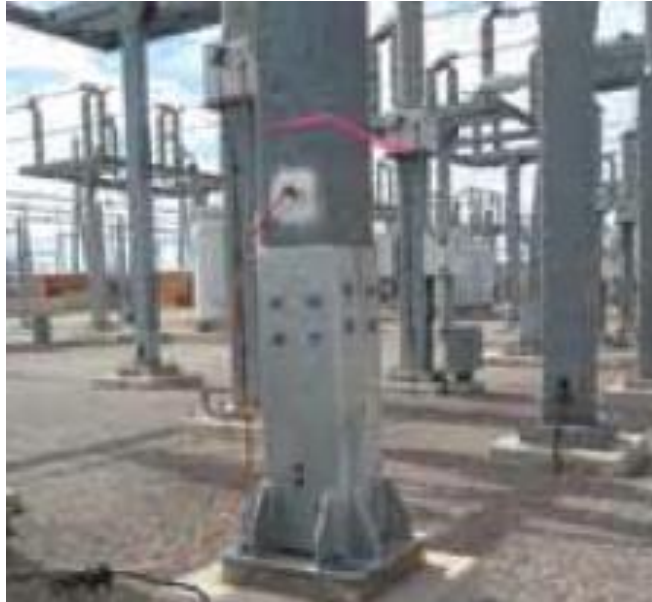
Earlier attempts to repair these columns included the use of steel collars as shown in Fig. 3. These collars had to be manufactured to fit the various size-damaged columns. The steel collars were bolted to the columns. An examination of these repaired columns showed that the corrosion process still continued inside the columns and the steel collars would hide the damage. In essence this would offer a false sense of security. These collars were also very heavy and difficult to install. They had to be custom designed to ensure that they could be installed considering the base configuration at each column and the supporting equipment that may be present.

Fig. 3 Original repair using steel collars

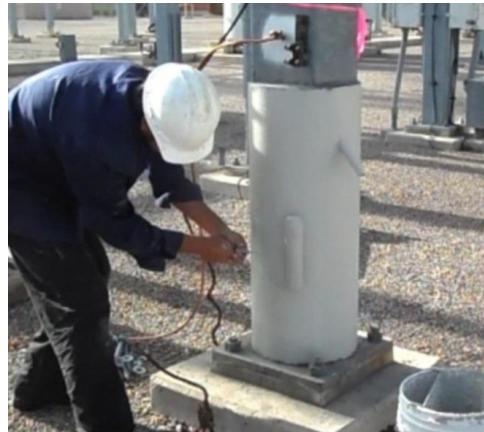
Fig. 7 Completed repaired column

After several hours, the ratchet straps were removed and the exterior of the shell was painted with a UV-protecting coating (Fig. 7). All of these repairs were performed while the substation remained fully operational.
