# Assessment and Evaluation of Timber Piles Used in Nebraska for Retrofit and Rating

Sponsored By  
**Nebraska Department of Roads**

April, 2014

1. Report No.	2. Government Accession No.	3. Recipient's Catalog No.	
4. Title and Subtitle Assessment and Evaluation of Timber Piles Used in Nebraska for Retrofit and Rating		5. Report Date April. 2014

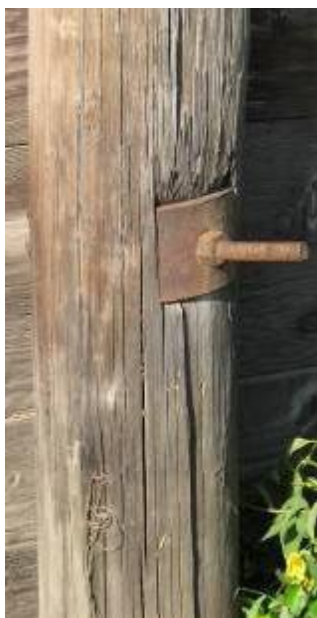
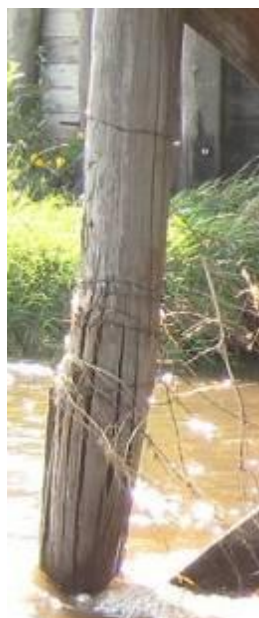
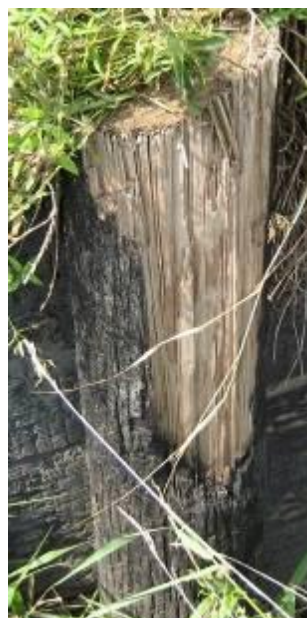
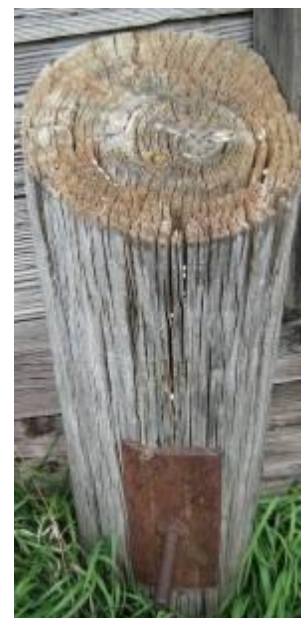
Physical damages are caused by different factors and cause the deterioration of exterior treated wood cover. Damage of exterior protective cover provides biological mechanism access to interior untreated wood resulting in decay of the interior wood. Different types of physical damages are shown in Figure 2.1. The most common type of physical damage is caused by impact of objects floating in water. Physical damage is also caused by overloading due to heavy loads, failure of adjacent piles, and over-tightening of the fasteners. Fire can destroy and cause failure of timber pile bridges in a matter of hours. Partially burned timber pile can carry load depending on the remaining unburned cross section of the pile.

**Figure 2.1 Breaks in preservative barriers by exterior damage leads to premature decay [2]**

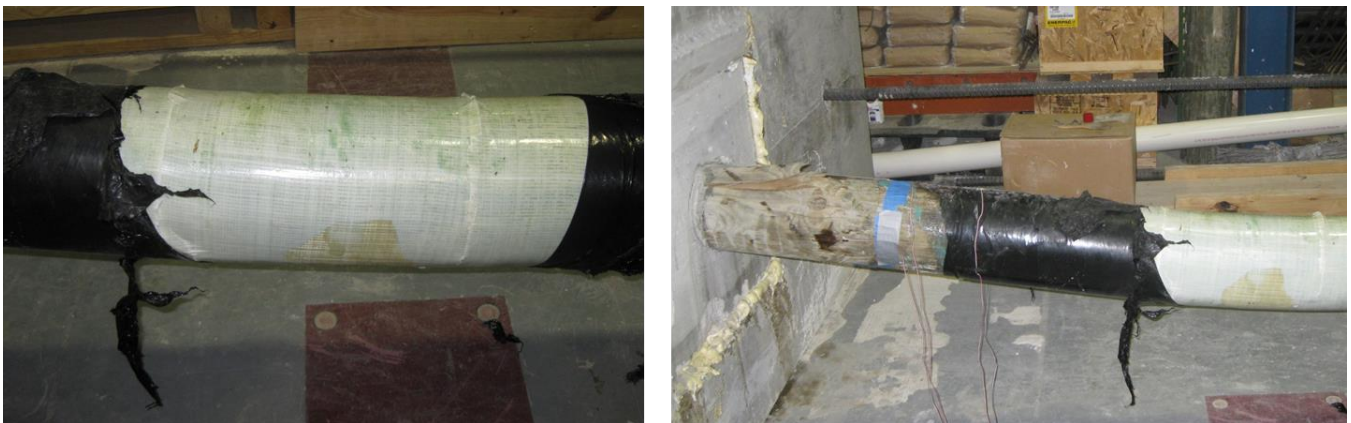
Specimen 2, with 1.5 inch deep damage filled with resin, showed the lowest ultimate load capacity (95 kips) among the five specimens tested as part of this study. This specimen failed mainly due to large gradual deflection at the repair location. FRP jacket was damaged at the two ends of the 14 inch long damaged region. The test was continued even after the large downward deflection of the repaired region that resulted in cracking of the fixed end of the pile.

**Figure 5.8: Failure of specimen 2 (1.5 inch deep damage filled with resin)**

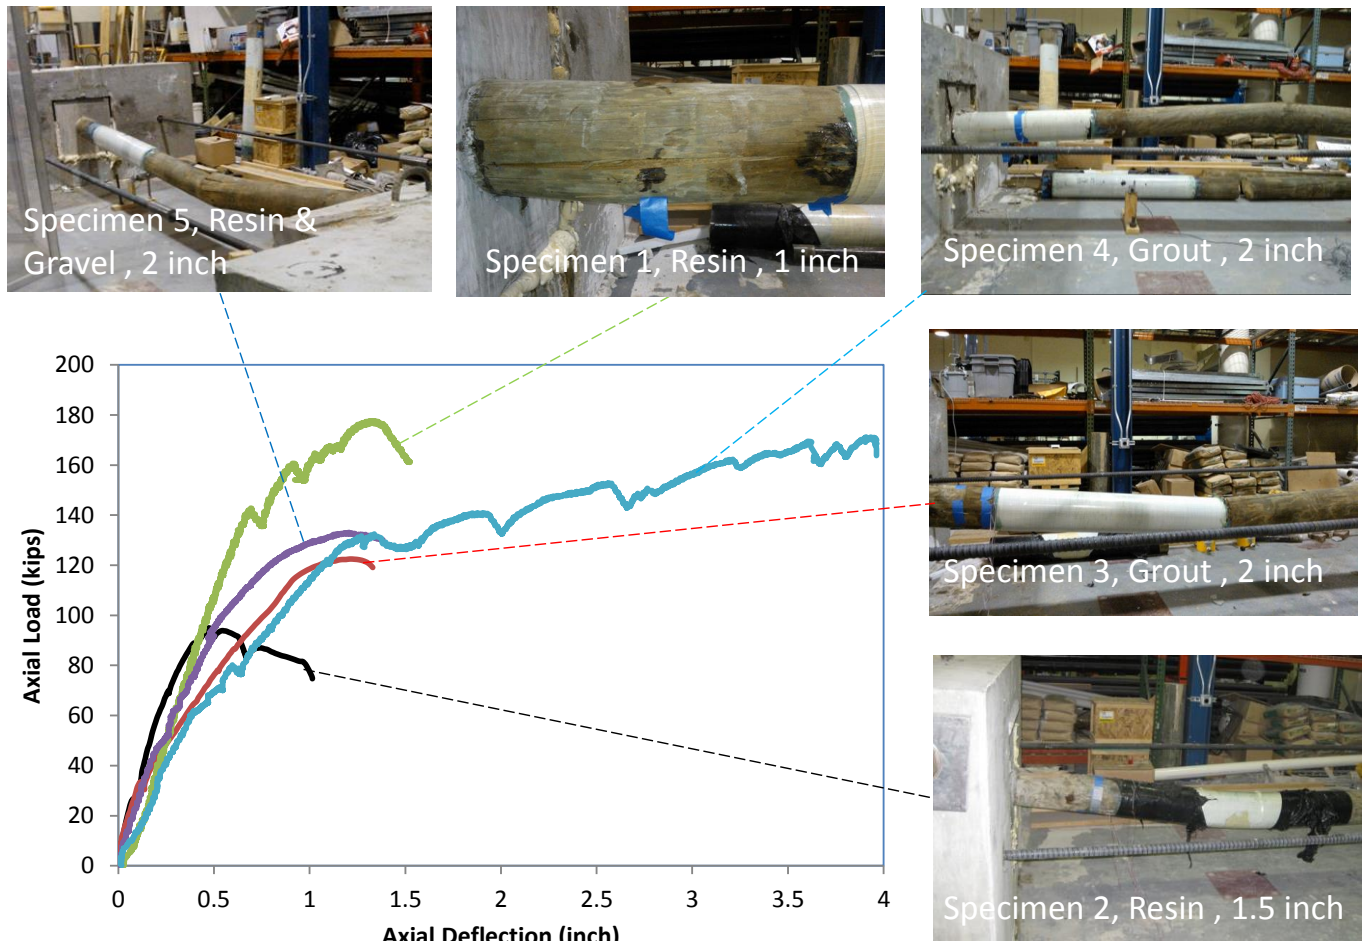
load drops can be observed in load deflection curve of specimen 1 at approximately 140 kips and 160 kips load. These load drops correspond to cracking of the wood during the test. Whenever wood cracking sound was heard, the load was put to hold to allow the failure to take place by progressive wood cracking. However, if the cracking sound stops and failure did not take place, the load was increased again until the next cracking sound or complete failure of the test specimen.

**Figure 5.12: Load deflection curve and failure mode of specimens**
