Midwest AASHTO Bridge Preservation Conference

TIMBER PILE REPAIR

By: Roe Enchayan, PE

Nebraska Department of Roads

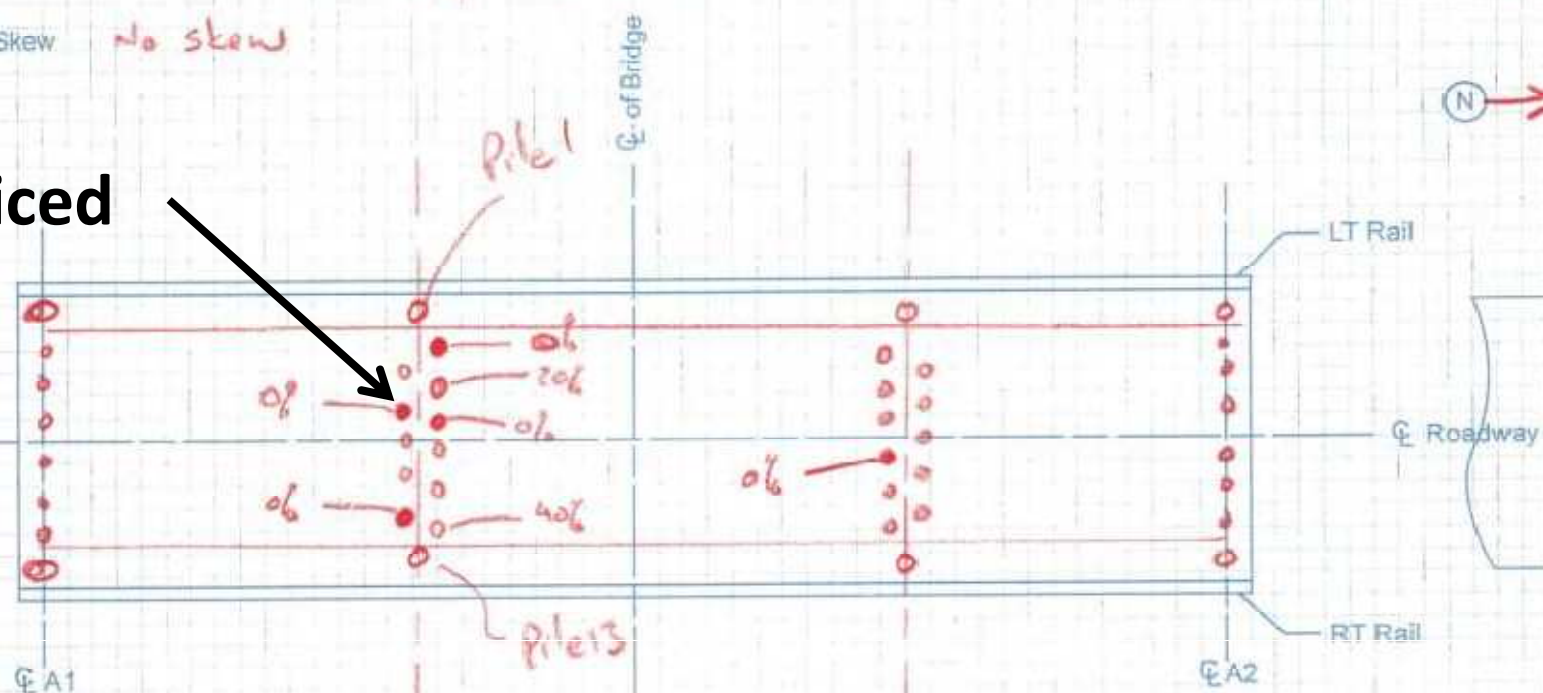
S1P1

All others are @ 90% section remaining
Bent 1 **Bent 2**

Pile rating computed @ 4 (poor condition)
