Investigation of Steel-Stringer Bridges: Superstructures and Substructures, Volume II

Final Report
October 2007

Sponsored by
the Iowa Highway Research Board (Project TR-522)
and the Iowa Department of Transportation (CTRE Project 04-184).

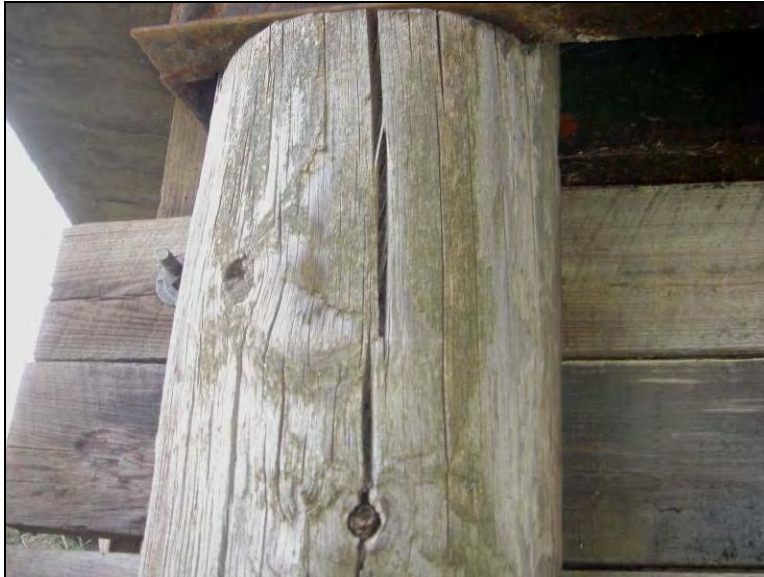
Figure 4.2. Pile cracking near the pile top (Bridge No. 1045 Black Hawk County – April 2 2005)

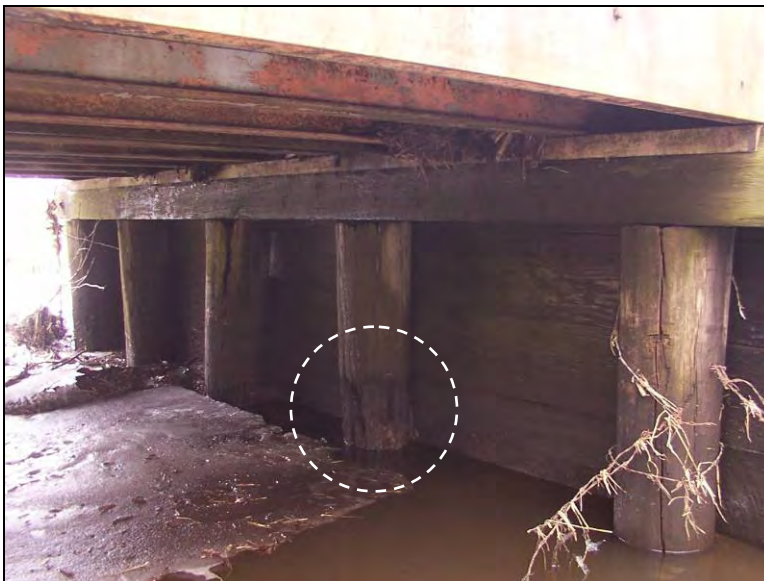
Figure 4.3. Reduction of pile cross section by abrasion from flowing debris and ice (Bridge No. 27-74-23 – February 15 2007)

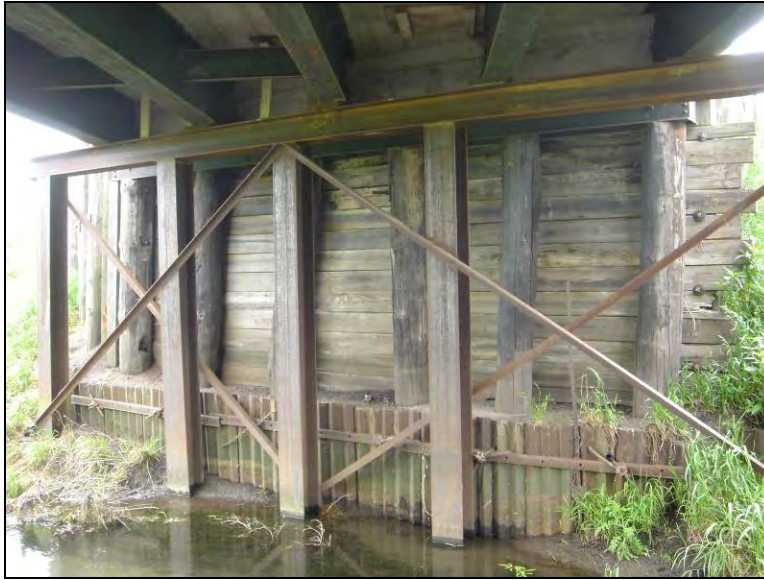
Figure 4.14. Steel piles used to replace deteriorated timber abutment (Bridge in Boone County – June 1 2005)

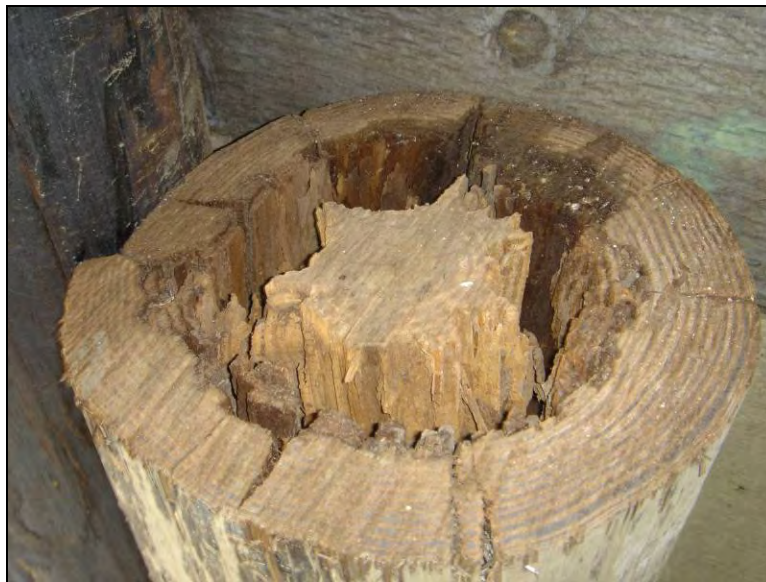
An example of a deteriorated pile is shown in Figure 5.1. The rapid attenuation of the wave in the hollow region hindered the detection of the intact area near the pile core and prevented the wave from reaching the receiving transducer.

Figure 5.1. Significant internal pile deterioration that is difficult to detected using the stress wave technique (Bridge No. 31-72-50 Tama County – June 10 2005)

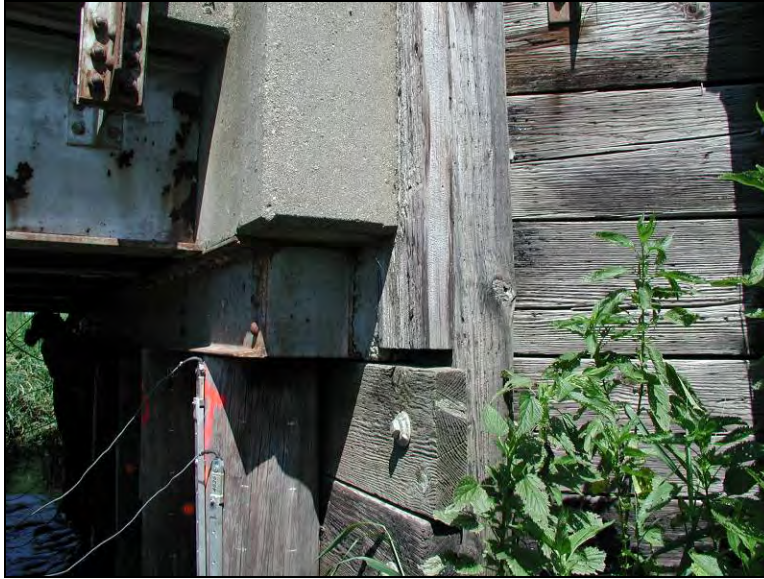
Figure 7.13. Possible eccentric loading caused by misalignment of pile cap (Bridge No. 7710 – Boone County)

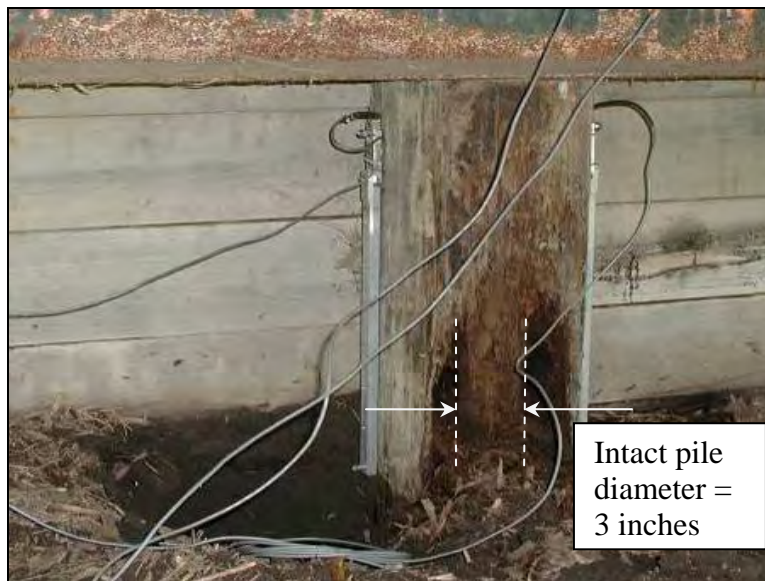
Figure 8.7. Pile no. 4 at the north abutment undergoing biological deterioration (Bridge No. 243470 Marshall County – July 27 2005)

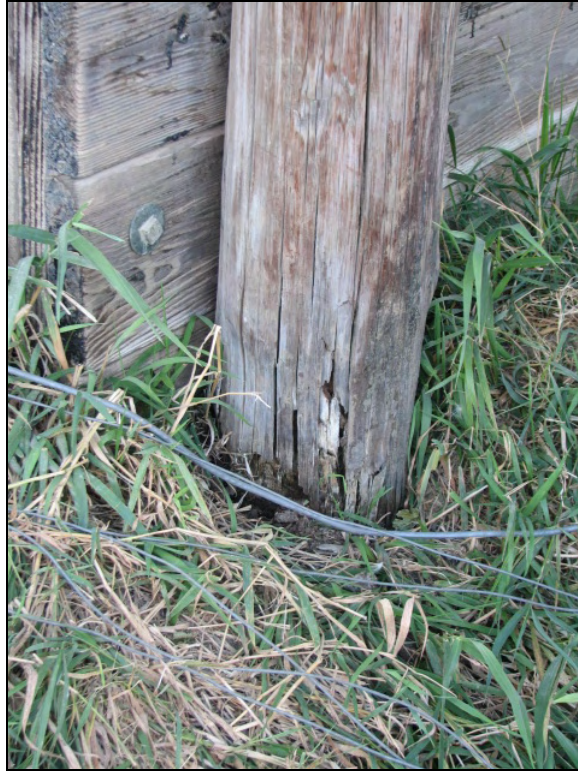
Figure 9.4. Biological deterioration of pile No. 1 at the ground level (Bridge No. 237350 Mahaska County – October 25 2005)

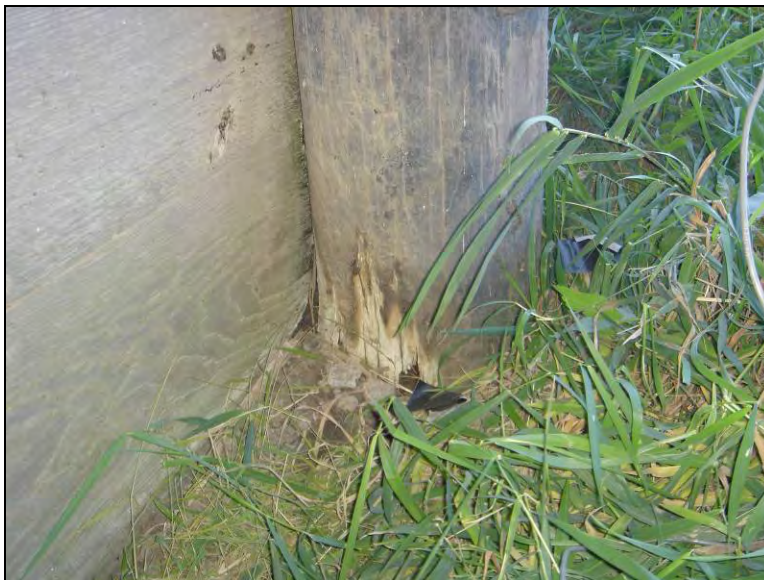
The south abutment, shown in Figure 9.6, has an average exposed pile length of about 94 inches and an average pile spacing of 49 inches. The tie back rods are about 6.5 ft from the pile heads. Figure 9.7 is a schematic diagram of the south abutment illustrating the exposed pile lengths and spacing. Visual observation revealed brooming in pile no. 2 near the ground level as shown in Figure 9.8. For pile no. 5, rotting near the ground level was observed (See Figure 9.9).

Figure 9.9. Rotting observed at pile No. 5 (Bridge No. 237350 Mahaska County – October 25 2005)

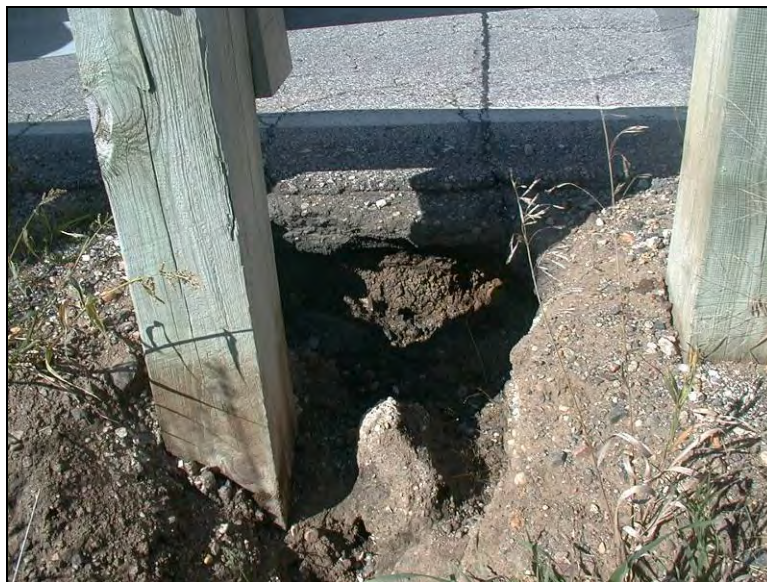
Figure 10.3. Soil erosion near the north abutment (Bridge No. 094680 Carroll County – April 15 2006)

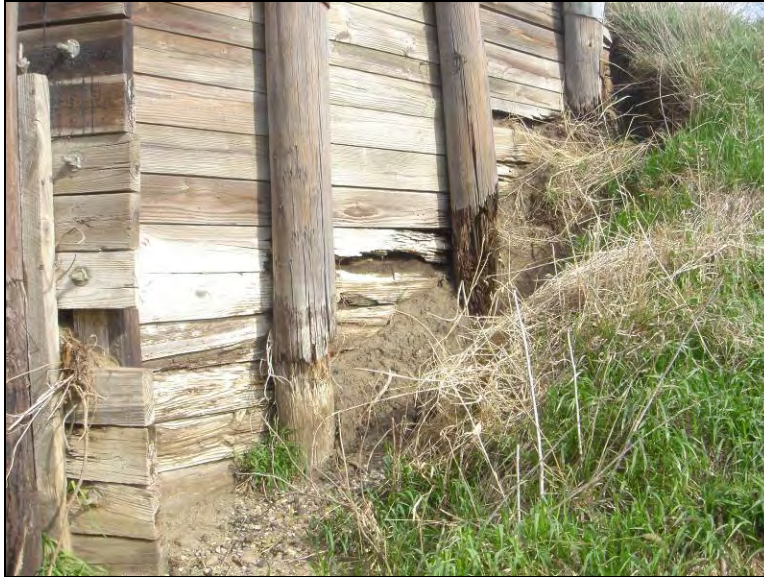
Figure 10.4. Severe deterioration observed at the northeast wingwall piles (Bridge No. 094680 Carroll County – April 15 2006)

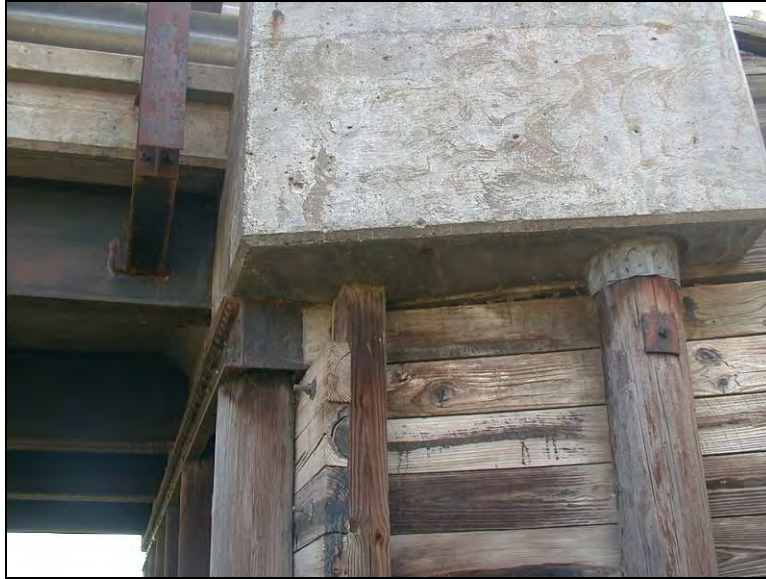
Figure 10.14. Pile cap partially resting on the backwall (Bridge No. 094680 Carroll County – May 16 2006)

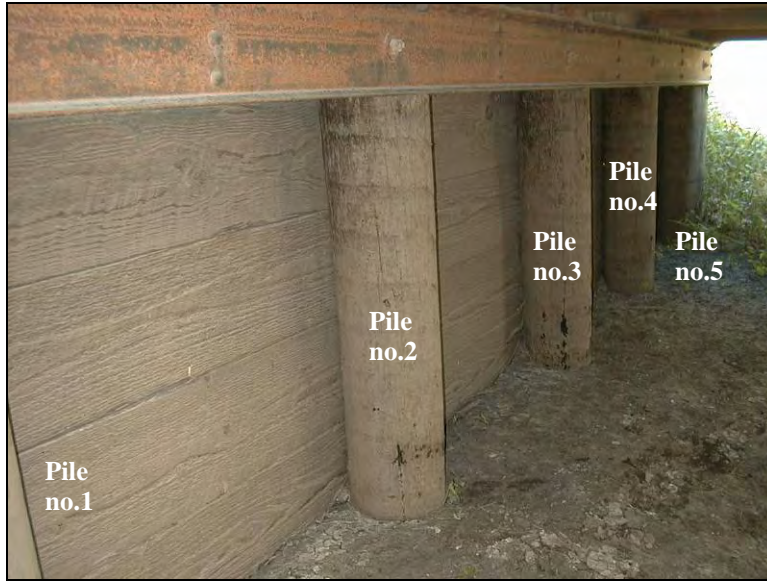
Figure 11.6. Southeast abutment at a higher elevation than the water level (Bridge No. 237380 Mahaska County – April 16 2006)

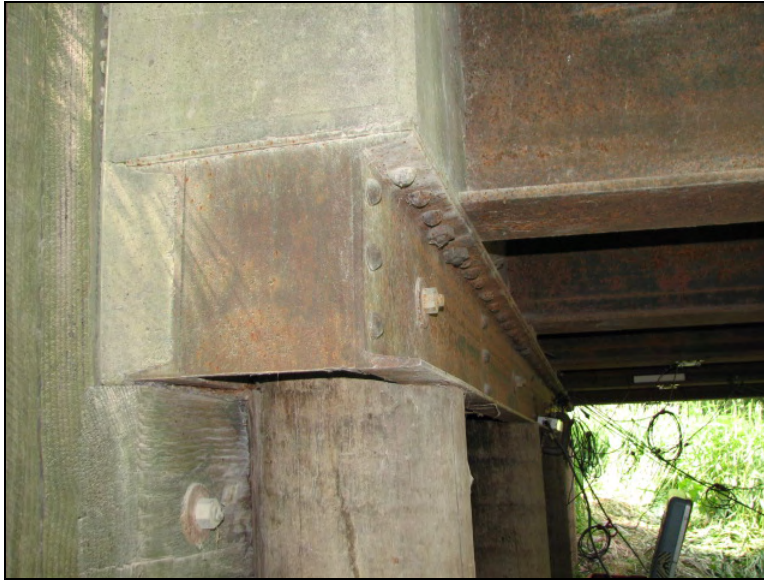
Figure 11.15. Partial bearing of the pile cap on the southeast abutment backwall (Bridge No. 237380 Mahaska County – May 27 2006)
