Arizona DOT performs first CFRP bridge repair saving critical resources

MO EHSANI, AND TADD JOHNSON, QuakeWrap Inc., Tucson, AZ WILLIAM DOWNES, Arizona DOT, Phoenix, AZ

IBC 18-10

ABSTRACT: In its first application of Carbon FRP, ADOT successfully completed the repair of 12 AASHTO Type II girders that were damaged by truck collision. The loss of flexural strength in the girders varied from 20% to 50%. The positive outcome of this project will allow ADOT to include this repair option in future similar applications.

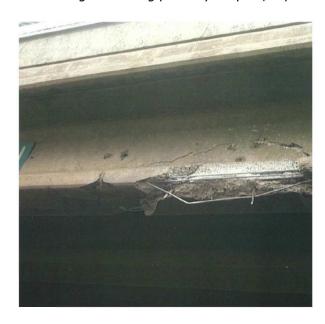
The bridge at Jefferson Street is a two simple span precast prestressed AASHTO Type II concrete girder bridge built in 1959. The bridge is 132'-9" long composed of two 65'-4 ½" spans with an out to out width of 64 feet. The existing northwest girder over I-17 southbound has been repaired multiple times due to vehicle collisions in 2003, 2006, 2008 and 2014 (Fig. 2). Each time the girders were repaired and the girder shape reformed to the original shape. Several of the remaining girders have sustained minor damage consisting primarily of spalls, exposed

Fig. 2. Damage to Jefferson Street underpass from one of the earlier collisions.

rebar and minor cracking. Only the single northwest girder over I-17 that was severely compromised was of concern at this time.

The I-17 underpass at Jefferson Street was determined to have a maximum flexural design capacity of 1988 k-ft. Since the girder at Jefferson Street had sustained multiple major impacts completely severing multiple strands Bridge Group assumed a strength loss of 50% for that girder. Thus, the FRP was supposed to provide an additional flexural capacity of 994 k-ft. It is noted that the girder on Jefferson Street was an edge girder supporting a sidewalk, not live traffic and the bridge was deemed capable of continuing to function even without that girder. At no time would ADOT risk public safety.

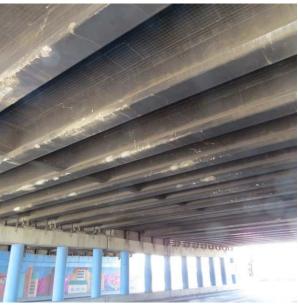
The bridge at 19th Ave was originally two, two simple span precast prestressed AASHTO Type II girder bridges built in 1961. In 1984 the median between the two bridges was closed with four precast prestressed BI-36 box beams to form a single structure. The current bridge is 103′-9″ long composed of two 49′-3″ spans with an out to out width varying from 122′-5″ to 125′-7″. The 19th Ave bridge has endured numerous vehicle collisions. Most of these collisions are minor collisions leading to spalling at the bottom flange of the girders. Several girders have had exposed rebar and few collisions have led to exposed and damaged prestressing strands.

Due to the vast numbers of collisions and the fact that it is very unusual to catch a vehicle that has impacted the bridge, it is impossible to determine exactly how many times this bridge has been hit. Moreover, it is difficult to determine if the damage was sustained from a single collision or multiple bridge collisions. Examples of several damaged girders can be seen in Fig. 3. Although the number of collisions to girders is greater at 19th Ave than at Jefferson Street, the amount of damage to any single girder is far less.

Fig. 3. Damage to 19th Ave. bridge girders from numerous collisions.

The I-17 overpass at 19th Avenue Street was determined to have a maximum flexure moment design capacity of 1799 k-ft. Since the girders at 19th Avenue had only sustained minor impacts without completely severing strands, Bridge Group assumed a strength loss of 20%. Thus, the FRP solution was supposed to provide an additional flexural strength of 360 k-ft.

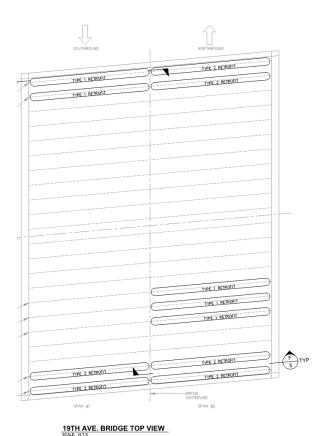
Fig. 7. Location of the 11 girders requiring repair at the 19th Ave. bridge.

7). The design documents provided by QuakeWrap Inc. detailed several types of repairs and which girders receive them. Some girders received both longitudinal fabric with U-wrap strips, while others just received the U-wrap strips.
