TxDOT Project 0-6731

Repair Systems for Deteriorated Bridge Piles

Technical Memorandum #4a

Task 4a: Full-scale laboratory tests of repaired piles

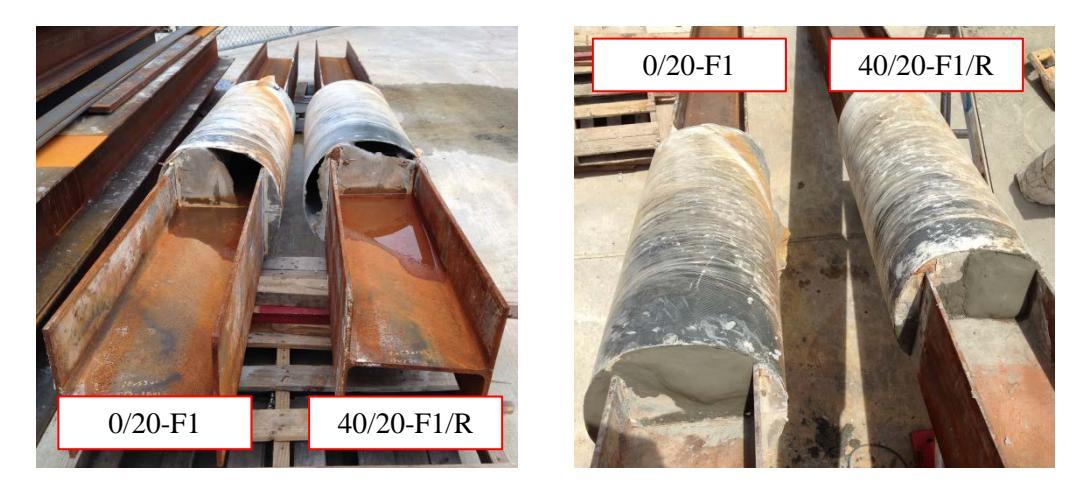
The grout was installed using a tremie approach in which the grout hose was lowered into the bottom of the jacket and gradually extracted as grout was cast. This was done to the extent possible within the constraints of the laboratory environment. When grouting the F1 jackets, the available grouting hoses were too short to achieve a complete tremie installation for all of the piles. Thus, voids were observed after opening the end-caps of piles 0/20-F1 and 40/20-F1/R. The voids were subsequently filled with the same type of grout after removing the piles from the water tanks as shown in Figure 15. Longer pump hoses were used to cast the grout for the piles with the F2 jackets to ensure that the nozzle could be fully inserted into the jackets.

Figure 15: Voids in the Grout of Two Piles Before and After Repairs

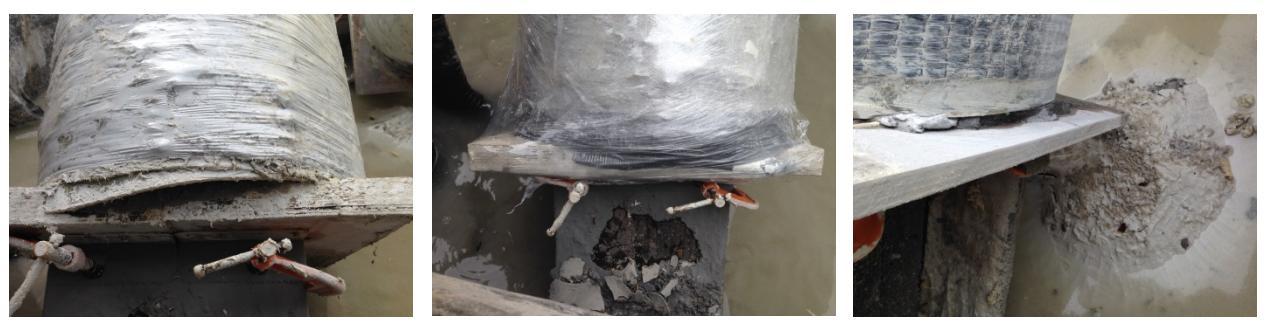
Figure 16: Incomplete Sealing at the Base of the Piles for the F2 Repair System

The grouting operation of the piles that were repaired using the F2 jackets required an excessive amount of grout. The process was halted after filling 5 of the 7 jackets to inspect the seal at the bottom of the jackets. The cause of the excessive use of grout was attributed to an incomplete seal at the bottom of two of the jackets. Figure 16 shows the end cap of two of the piles that were repaired with F2 jackets. The photos were taken after draining the repair tank for the inspection. The inspection indicated that the jacket at the base of the 80/60/3-F2/RA pile was larger than the plywood seal allowing grout to leak out of the base as shown in Figure 16(a). This was due to a taper of the jacket in the as installed condition which resulted in the diameter of the jacket at the base being 1.9 in. larger than the diameter of the jacket at the top. The pile was sealed using tape and shrink wrap before re-filling the tank and casting as shown in Figure 16 (b). Figure 16 (c) shows the bottom of pile 80/60-F2/RA which also exhibited an incomplete seal between the jacket and the end-cap. Careful inspection of the seals at the base of the piles prior to grouting is recommended.

(a) Tapered jacket

(b) Sealing of the jacket with shrink wrap and tape

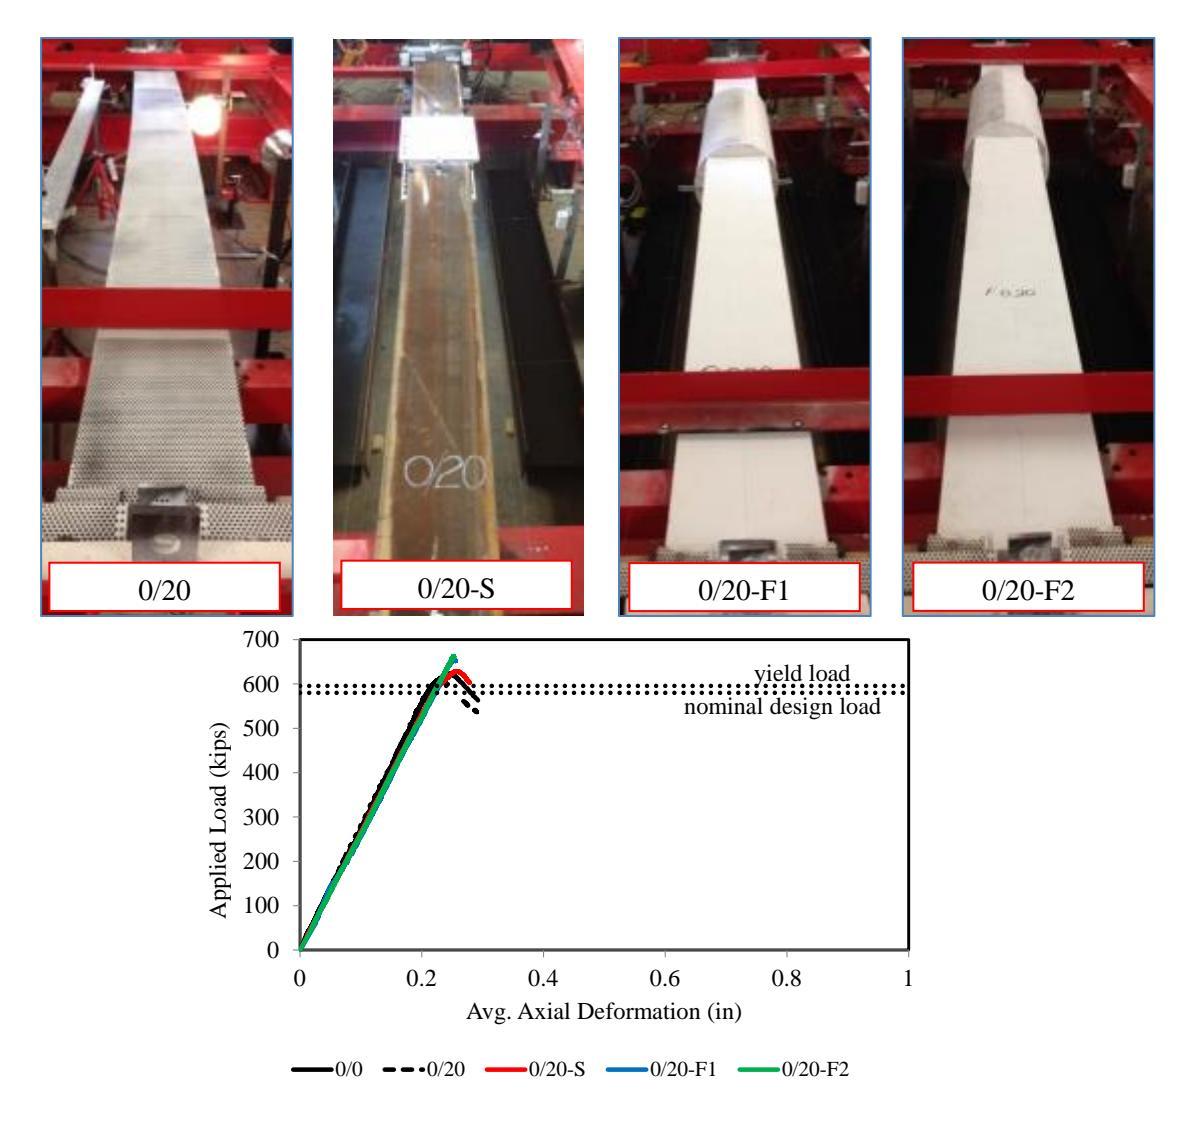
Figure 17: Tested Specimens and Load-deformation Response of the Piles 0/20 Repaired with Three Different Systems

The piles were loaded up to the peak load monotonically. No visible signs of lateral deformation were observed during the test. The load-axial shortening response of the piles, shown in Figure 17, remained linear up to the maximum load levels of 655kips and 663 kips respectively. The tests were terminated when the capacity of the hydraulic loading system was reached before any significant damage of the repaired piles was observed.

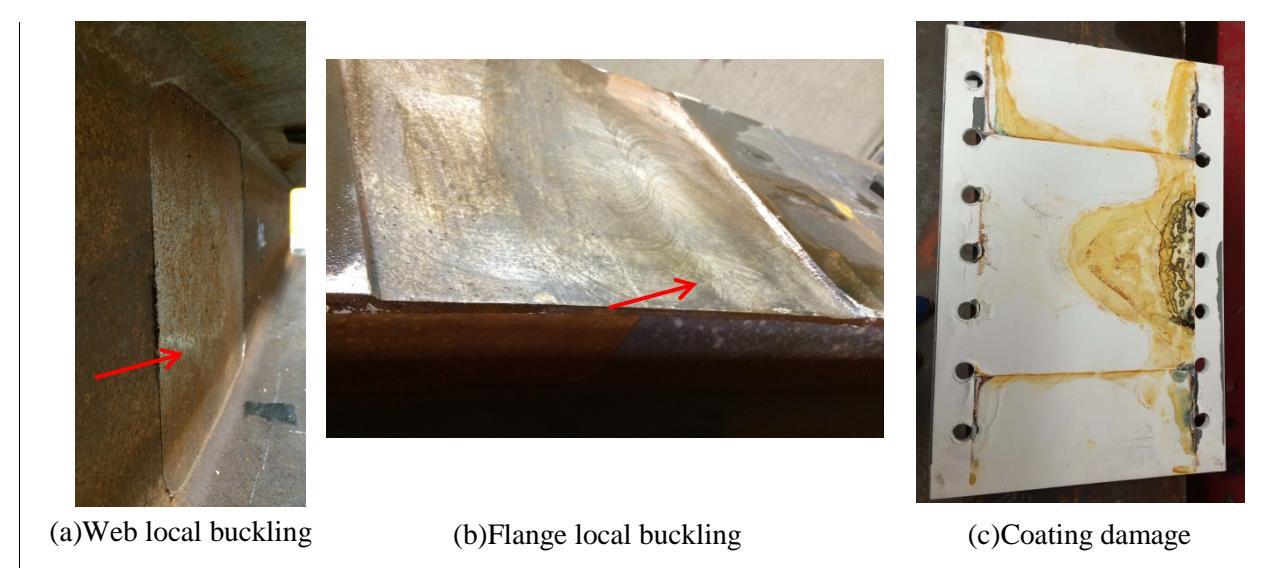
Figure 19: Flange and Web Local Buckling of 40/20-S

The pile was loaded monotonically up to a peak load of 665kips. Failure occurred due to flexural buckling of the pile. Inspection of the pile after failure further indicated the presence of a localized buckle in the web as shown in Figure 19(a). After completion of the test, the strengthening plates were removed to observe the flanges. The inspection indicated a minor local buckle in the flange as shown in Figure 19(b). The inspection also revealed localized damage and flaking of the protective coating on the main steel repair plate as shown in Figure 19(c).

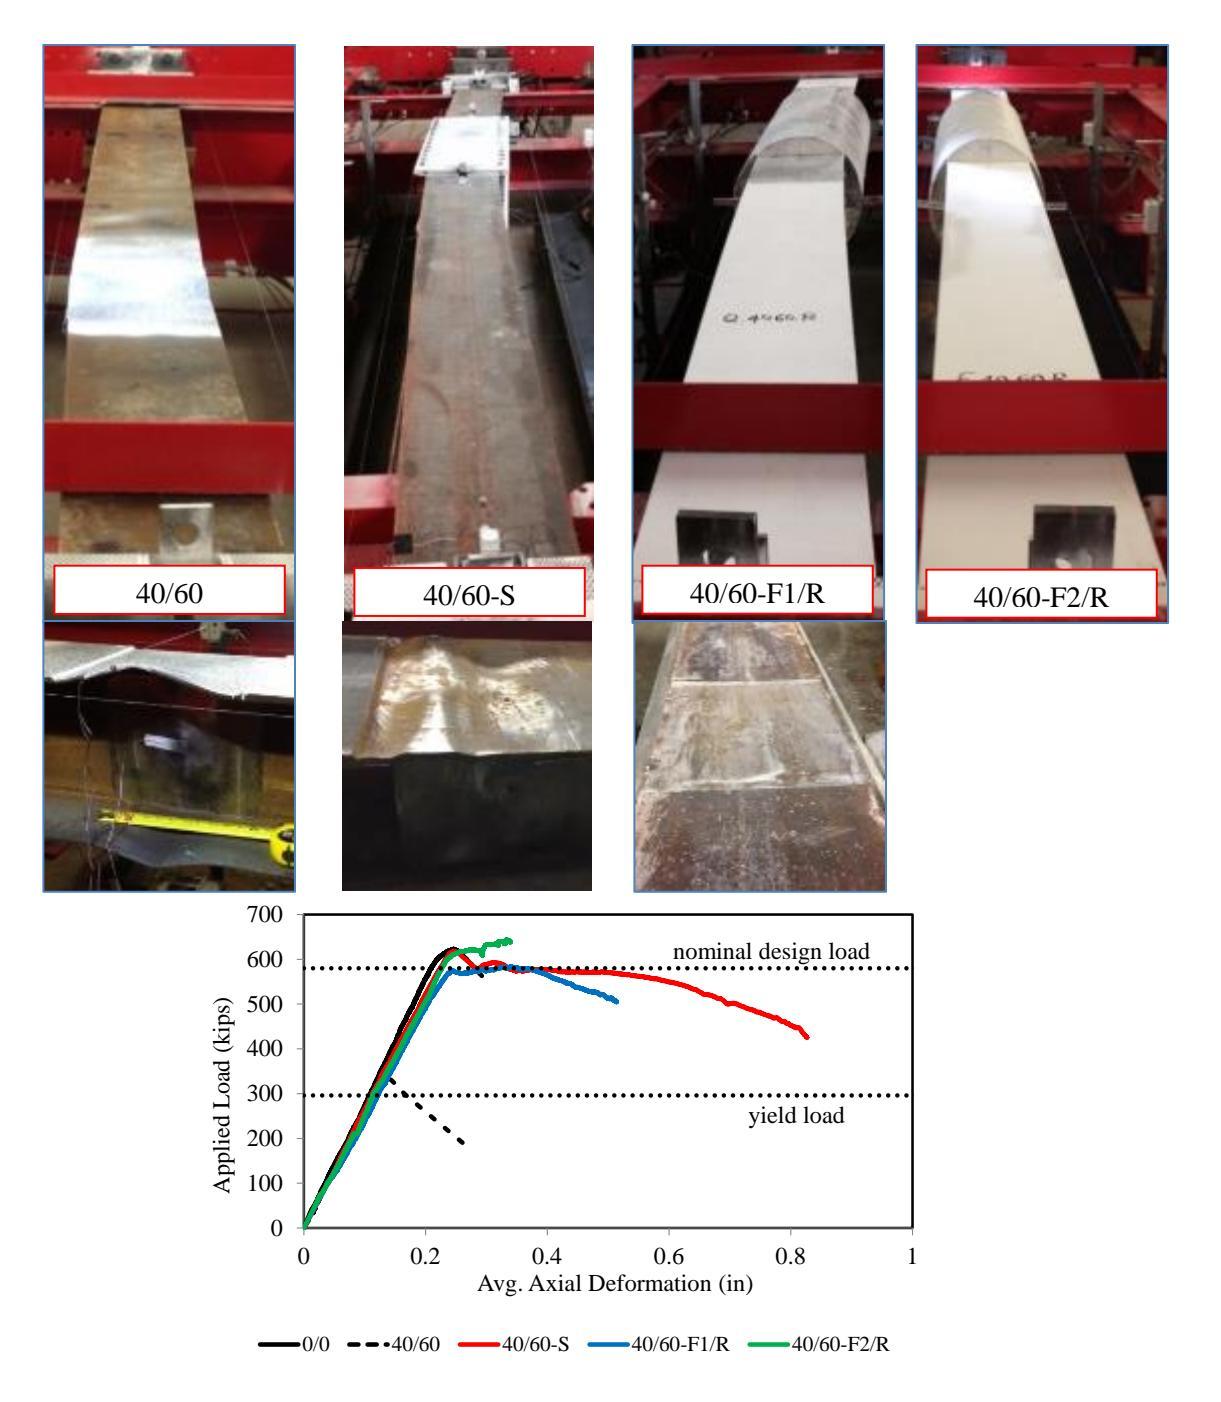
Figure 20: Tested Specimens and Load-deformation Response of the Piles 40/60 Repaired with Three Different Systems

Figure 20 illustrates the failure mode and axial load-deformation relationships of the 40/60 group of piles. The behavior is compared to that of the corroded and uncorroded control piles. Table 7 summarizes the measured axial peak loads, elastic stiffnesses, and failure modes of all of the tested piles.

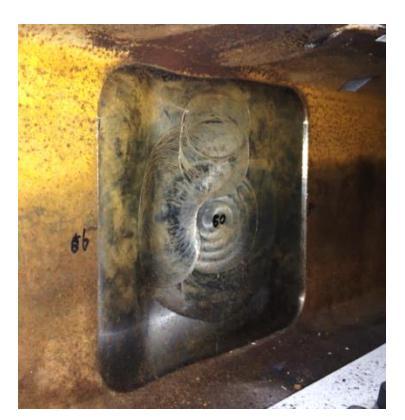
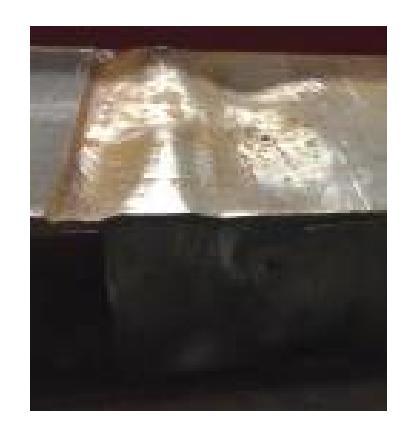
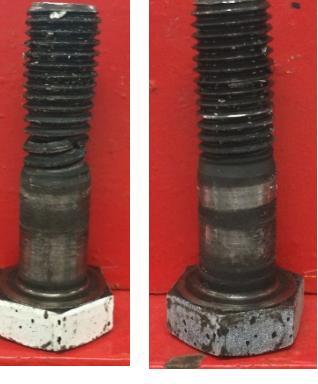
Figure 21: Failure Observed from 40/60-S

The pile was loaded up to 618kips and failed by web local buckling as shown in Figure 21(a). Lateral deformation was observed after the peak load. After the test, the plates were removed for further inspection. Observation indicated a higher order plate buckling on the flange as shown in Figure 21(b). Additionally, all of the bolts bolts were bent and one of them had ruptured as shown in Figure 21(c). This was because bevel washers were not used for this pile. Bevel washers were used in all of the other tests and no bolt bending was observed.

(a)Web local buckling

(c)Ruptured and bent bolts

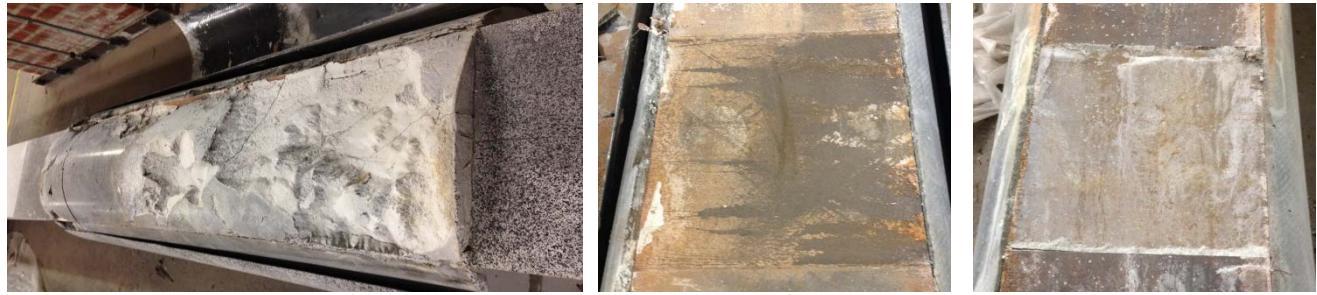
The pile exhibited a linear response up to a load of 584 kips with no visible sign of lateral deformation. As testing continued the applied load remained constant and began to decrease while the pile continued to deform as shown in Figure 20. The test was terminated when the load decreased to 504 kips. After the test, the FRP jacket was removed to inspect the condition of the grout core and the damaged region of the pile as shown in Figure 22(a). Removal of the jacket indicated the presence of significant air voids in the grout on top of one of the flanges. However, no localized deformation was observed in the flanges within the corroded region as shown in Figure 22(b) and (c).

(a)Air voids

(b)Top flange

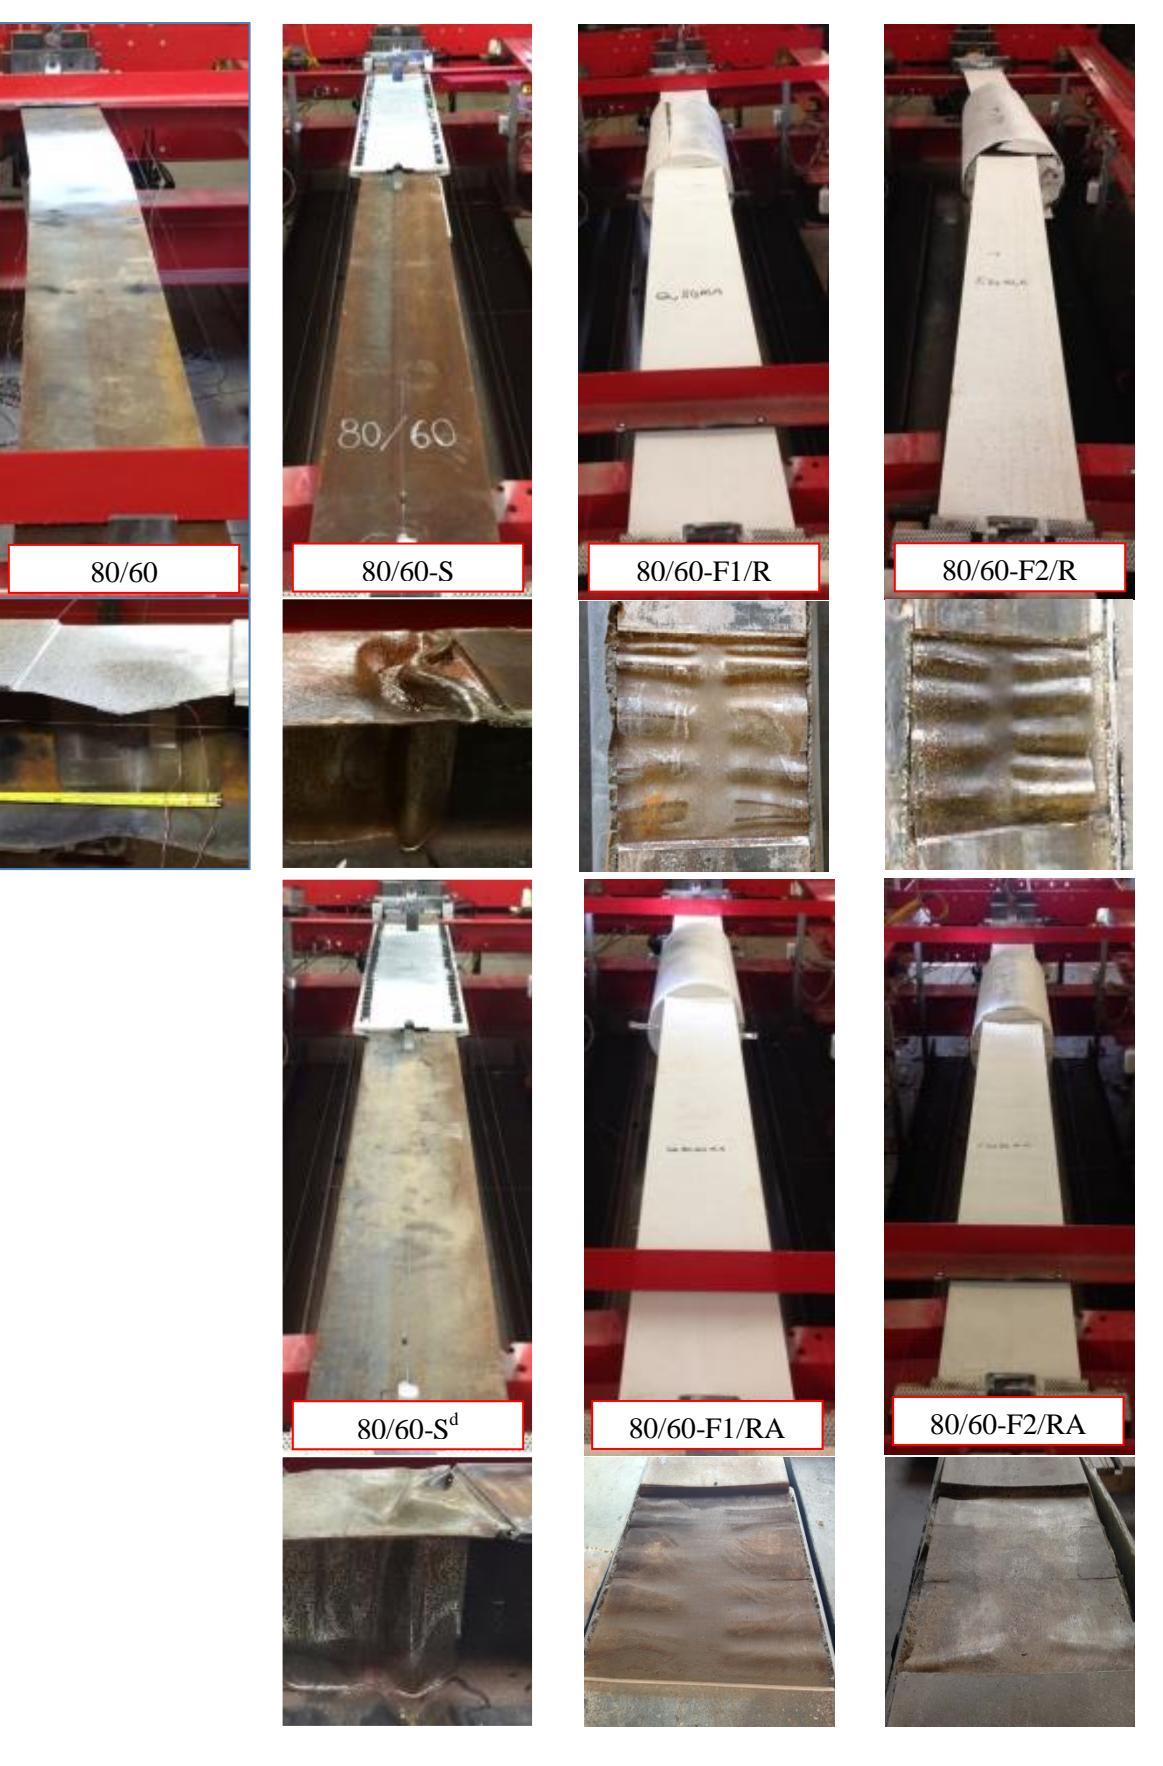
Figure 23: Tested Specimens of the Piles 80/60 Repaired with Three Different Systems

Figure 23 and Figure 24 illustrate the failure mode and axial load-deformation relationships, respectively, of the 80/60 group of piles. The behavior is compared to that of the corroded and uncorroded control piles. Table 8 summarizes the measured axial peak loads, elastic stiffnesses, and failure modes of all of the tested piles.

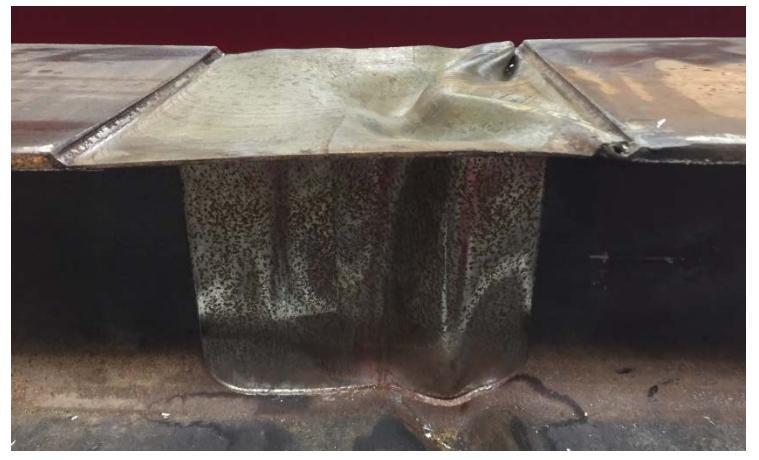
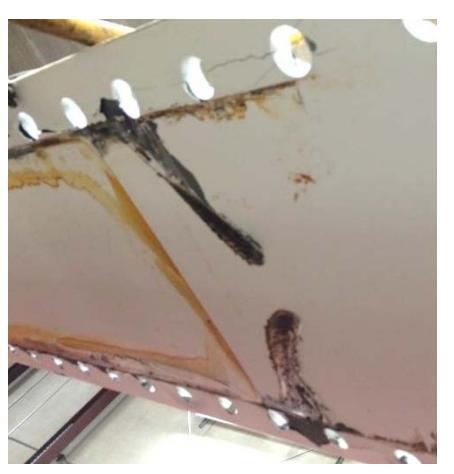
Figure 25: Observed Damage of 80/60-S and 80/60-S^d

Two similar piles were milled and repaired to evaluate the repeatability of the results. The piles were loaded monotonically to failure. The onset of non-linearity was observed at a load level of 600kips and 580kips, respectively. At this stage, web local buckling was observed along with sounds of the coating cracking. Flange local deformation was also observed outside of the repair region. The piles failed due to flange and web local buckling when the applied load reached 632kips and 615kips, for 80/60-S(1) and 80/60-S(2), respectively. After testing the repair systems were removed to investigate the condition of the deteriorated regions. Inspection indicated a crumpling deformation in the repaired region as shown in Figure 25(a). Furthermore, the outer layer of the coatings cracked and peeled near the edges of the flange tips while both layers of coatings exhibited damage at the most deformed region of flanges, as shown in Figure 25(b).

(a)Flange and web local buckling

(b)Coating damage

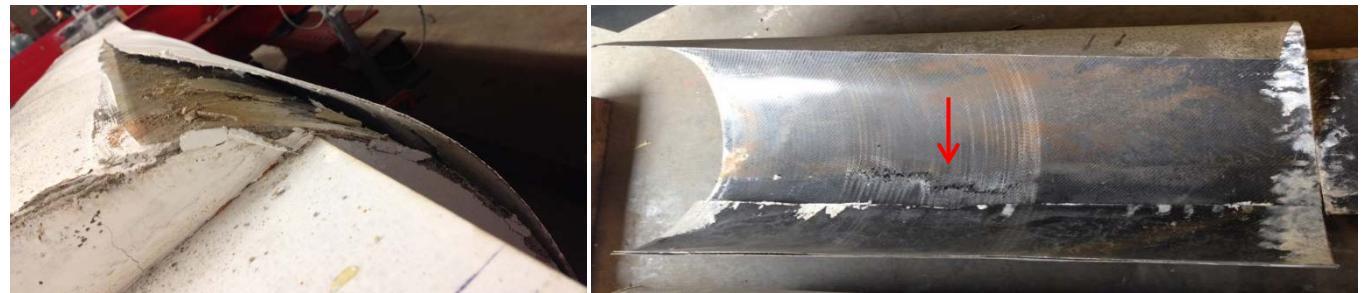
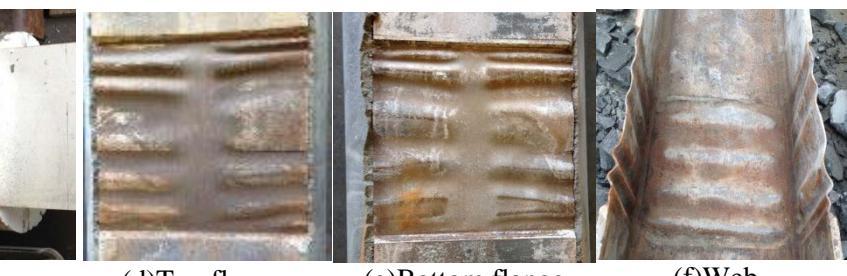
The pile was loaded monotonically to failure. The axial load shortening response became non-linear at a load level of 410 kips. Failure was observed when the applied load reached 556 kips. Subsequently, the load dropped to 396 kips. This sudden drop of load was accompanied by a loud sound and partial delamination of the FRP jacket as shown in Figure 26(a). Although no sign of lateral deformation was observed. The test was terminated at this stage. Removal of the jacket after testing indicated that the rupture initiated where the steel rubbed against the FRP jacket during construction as shown in Figure 26(b). This highlights the importance of proper placement of protective spacers between the FRP jacket and the corroded pile during construction. Removal of the jacket also indicated the presence of air voids in the grout above the top flange as shown in Figure 26(c). The grout was removed using a jack hammer to observe the web and flanges in the corroded regions. Both the flanges and web exhibited localized crumpling in the corroded region as shown in Figure 26(d) – (f).

(a)FRP delamination

(b)Rupture of the internal layerof the FRP jacket

(c)Air voids

(d)Top flange

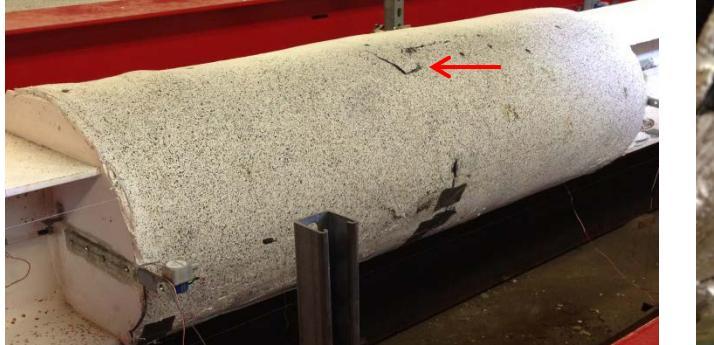
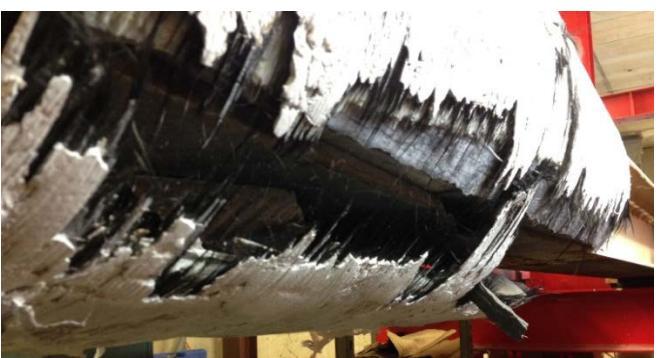
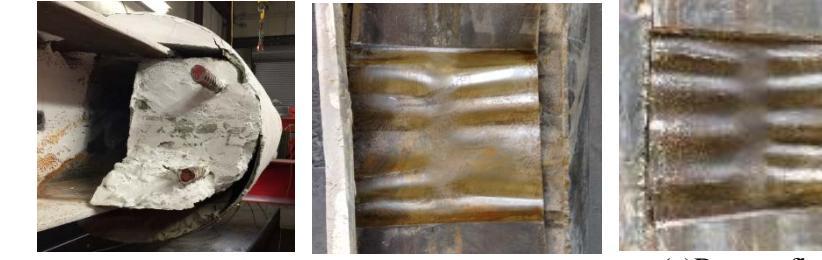
The axial load-shortening response of the pile remained linear up to a load of 455 kips. Subsequently the stiffness of the pile decreased but load continued to increase up to a load of 620 kips. At that stage part of the FRP jacket on the top flange partially ruptured as shown in Figure 27(a), and the load reduced to 575 kips. Afterwards the load increased up to 610 kips at which stage the FRP jacket ruptured at the bottom bottom flange. The load suddenly dropped to 470 kips which was accompanied by a loud sound, complete rupture of the FRP jacket at the bottom flange, as shown in Figure 27(b), and crushing of the confined grout. Loading was stopped when the applied load decreased to 235 kips. This was accompanied by excessive lateral deformation of the pile as can be seen in Figure 23. Figure 27(c) shows separation of the grout from the pile after rupture of the jacket. After testing the repair system was removed from the pile. It was observed that the flanges and web crumpled locally at the corroded region as shown in Figure 27(d) - (f).

(a)FRP rupture over the top flange

(b)FRP rupture along the bottom flange

(c)Grout separation

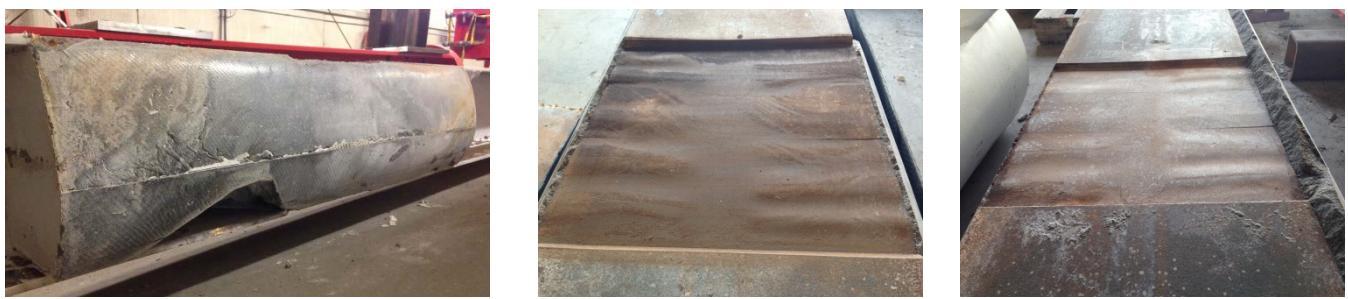
As shown in Figure 28(a), air voids were observed in the grout of the pile repaired with the F1 system, but they were not located within the corroded region. Both flanges demonstrated crumpling flange deformation as shown in Figure 28(b) and (c).

(a)Air voids

(b)Top flange

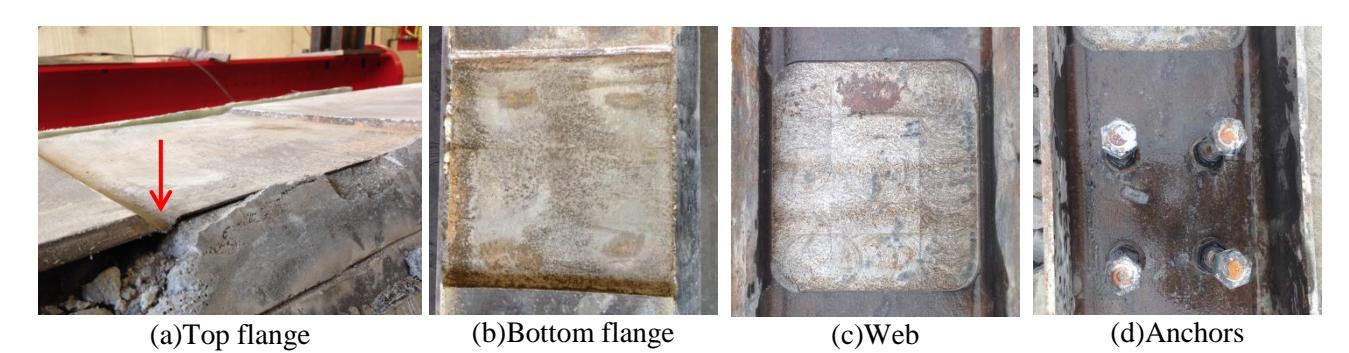
Figure 29: Pile 80/60-F2/RA

As shown in Figure 29(a), air voids were observed in the grout of the pile repaired with F2 system adjacent to the top flange near the corroded region. The top flange demonstrated premature localized deformation at the section adjacent to the void. However, no localized deformation was observed in the bottom flange or the web as shown in Figure 29(b) and (c). Figure 29(d) shows the headed-stud anchors after removing the grout using a jack hammer. No visible sign of damage was observed in the anchors.

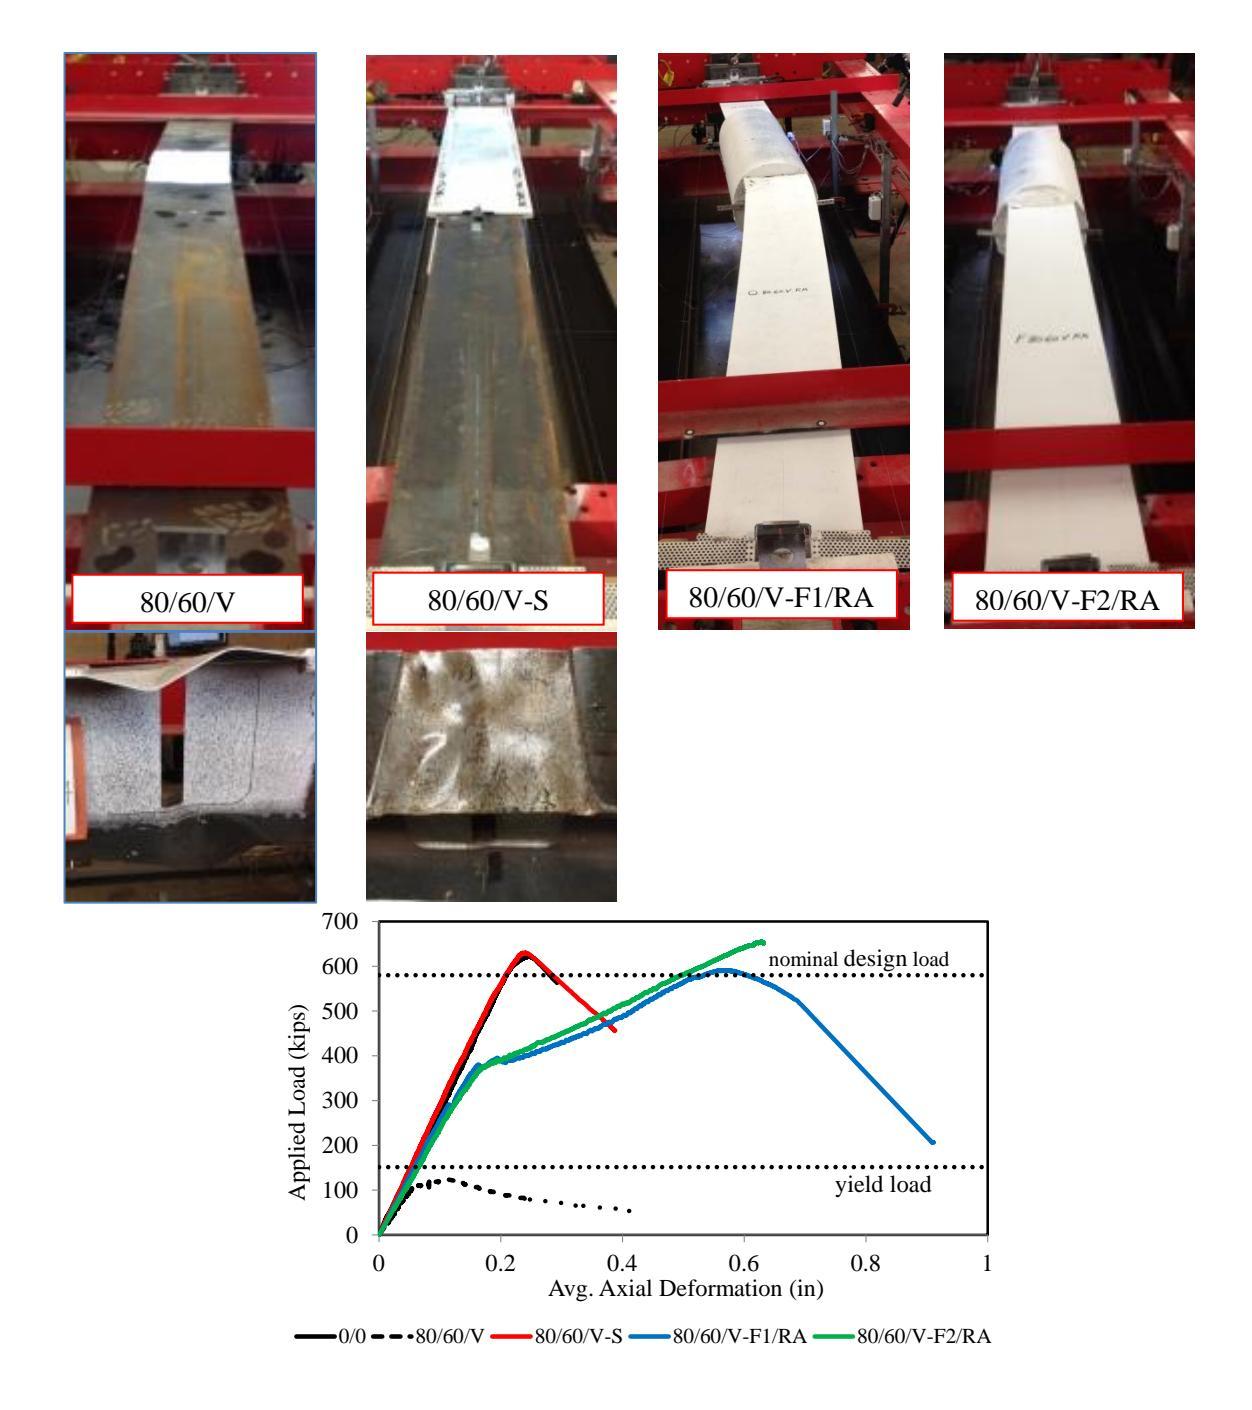
Figure 30: Tested Specimens and Load-deformation Response of the Piles 80/60/V Repaired with Three Different Systems

Figure 30 illustrates the deformed specimens and axial load-deformation relationships of the 80/60/V group of piles. The behavior is compared to that of the corroded and uncorroded control piles. Table 9 summarizes the measured axial peak loads, elastic stiffnesses, and failure modes of all of the tested piles.

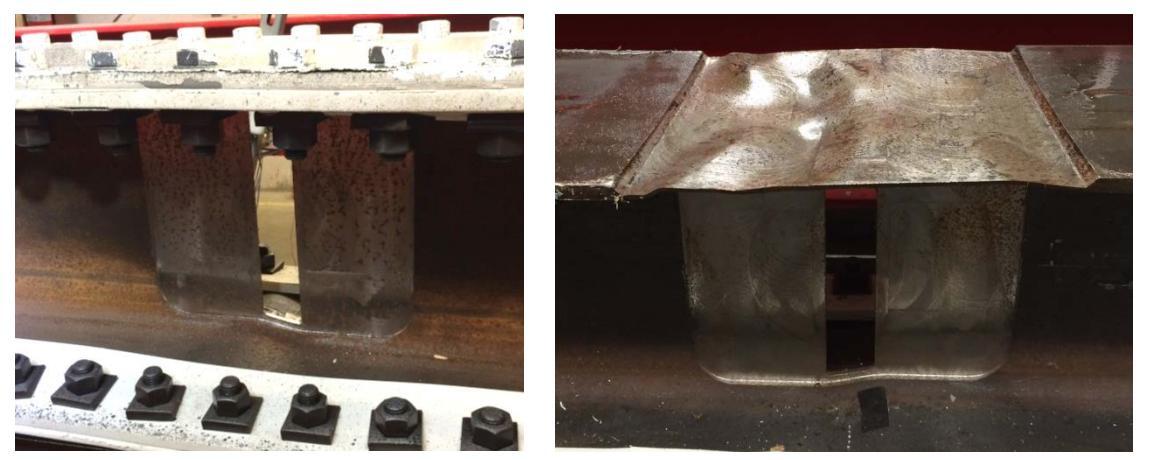
Figure 31: Observed Damage of 80/60/V-S

The pile was loaded up to 630kips and failed in a similar pattern as the damaged control specimen (Figure 31(a)). no web buckling or lateral deformation were observed. The string potentiometer installed on the pile flange indicated slip between top flange of the pile and the main plate of the repair system at a load level of 620kips. After the test, the steel plates were removed. Flange crumpling in the corroded region and next to the void in the web were observed as shown in Figure 31(b) and attributed to lack of support from the severely corroded web.

(a) Pile failure

(b) Flange local buckling

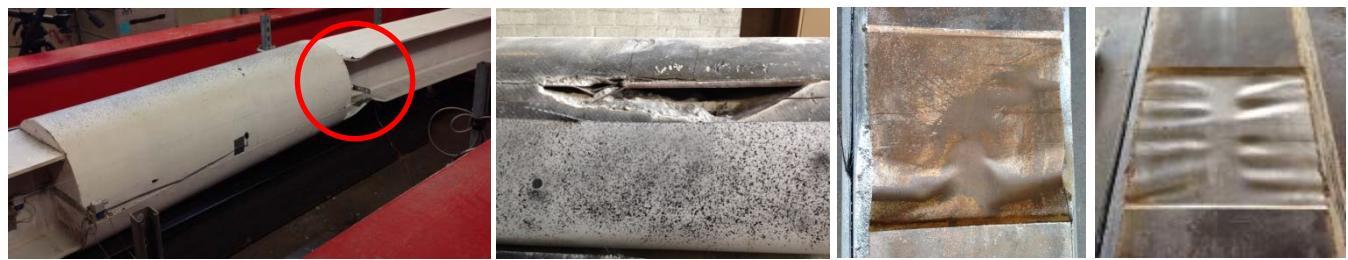
The pile was loaded up to 375 kips monotonically. Afterwards the axial stiffness of the piles decreased, however, the load continued to increase up to a peak load of 591 kips. Subsequently the load gradually decreased to 485 kips with increasing lateral deformation. At this point the flanges suddenly buckled just outside of the repaired region as shown in Figure 32(a), and the load dropped to 207 kips. Figure 32(b) shows air voids adjacent to the top flange that were observed after removing the FRP jacket after testing. These voids caused the top flange to exhibit a different local deformation pattern from the bottom flange as shown in Figure 32(c) and (d).

(a)Flange local buckling

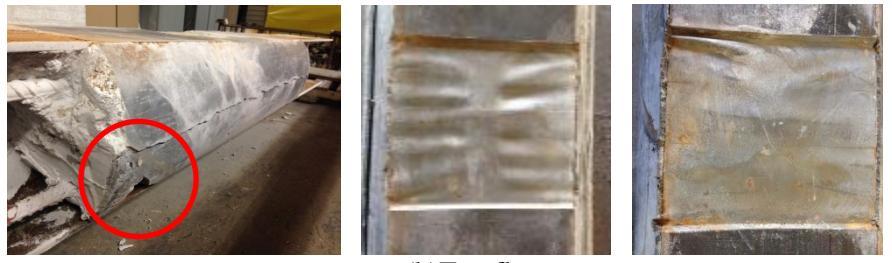
demonstrated crumpling like deformation with slightly higher amplitude than the bottom flange as shown in Figure 33(b) and (c).

(a)Air voids

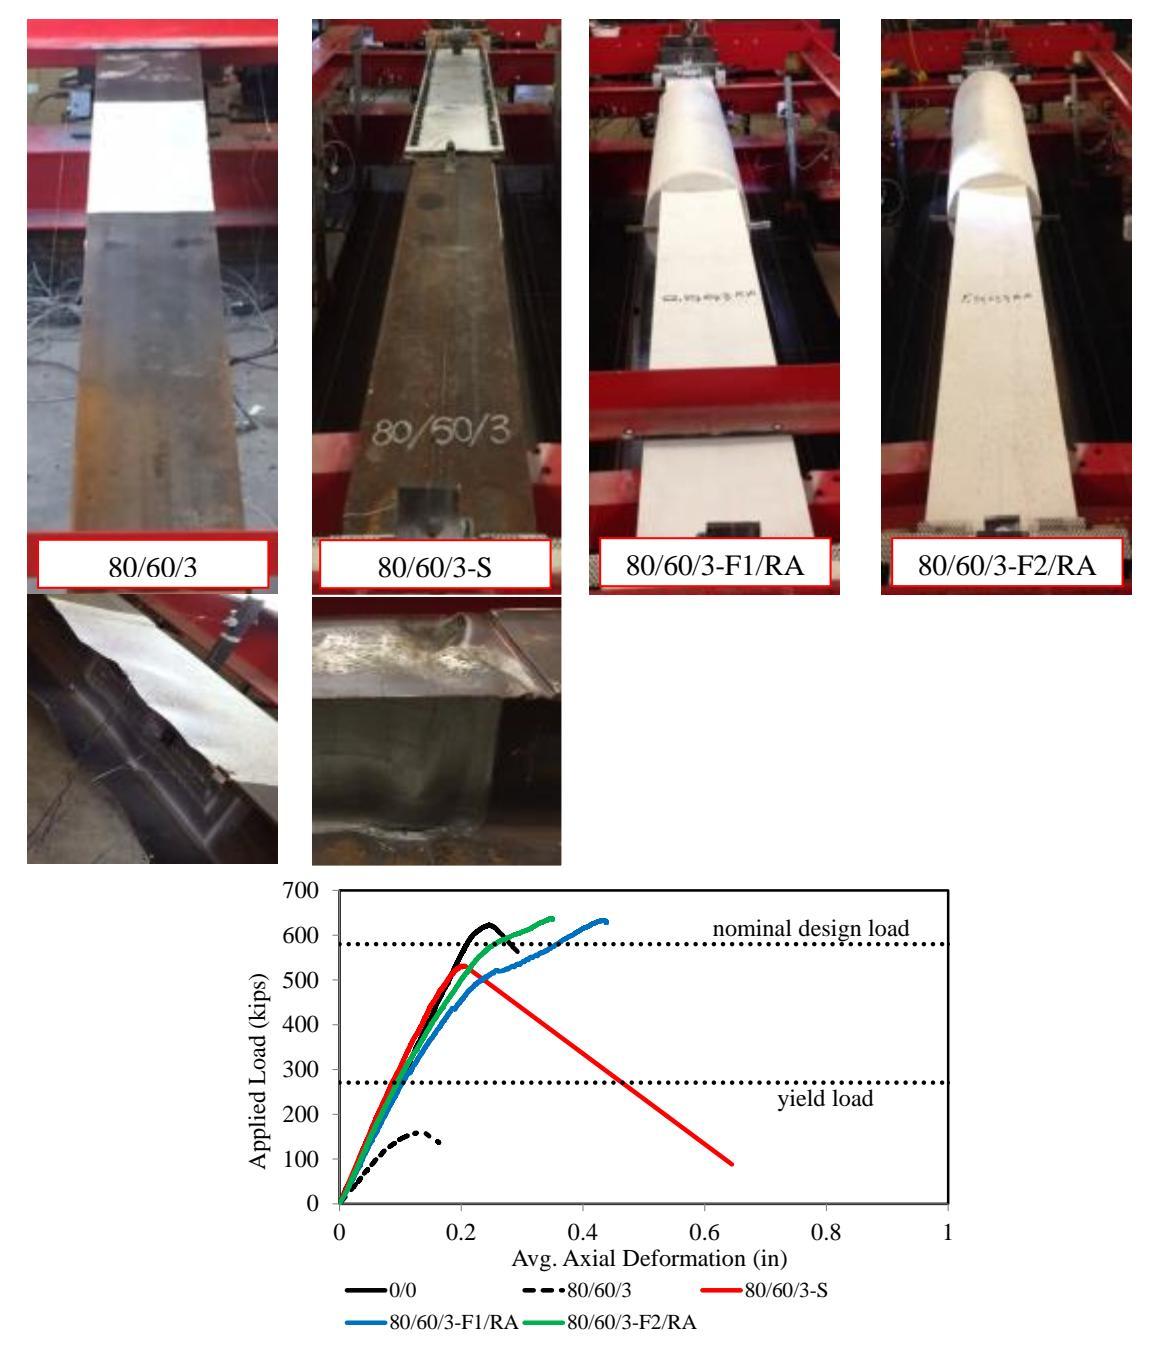
Figure 34: Tested Specimens and Load-deformation Response of the Piles 80/60/3 Repaired with Three Different Systems

Figure 34 illustrates the deformed specimens and axial load-deformation relationships of the 80/60/3 group of piles. The behavior is compared to that of the corroded and uncorroded control piles. Table 10 summarizes the measured axial peak loads, elastic stiffnesses, and failure modes of all of the tested piles.

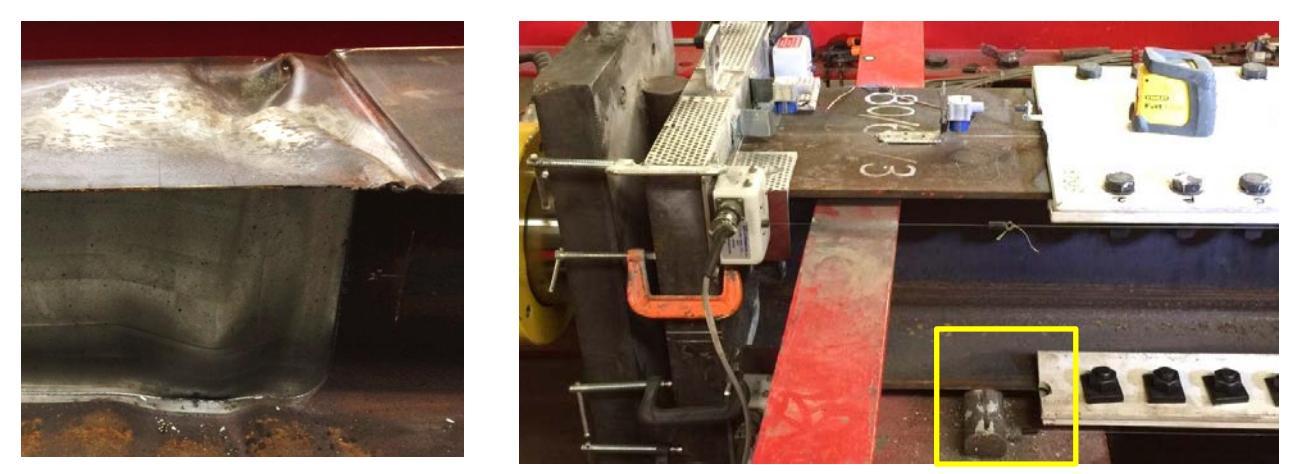
The pile was loaded monotonically up to a load of 532kips at which point the load began to decrease. Removal of the repair plates and inspection of the pile indicated localized crumpling of the pile in the corroded region as shown in Figure 35(a). The capacity of this pile was lower than the retrofitting target, because the location of the rollers of the test frame limited the length of the repair system, as shown in Figure 35(b). Due to this physical constraint, the length of the repair system was less than required by the proposed design procedure to fully restore the capacity of the pile. The predicted capacity of the pile using the applied repair configuration was 496 kips which is 7% less than the measured capacity.

(a)Flange and web deformation

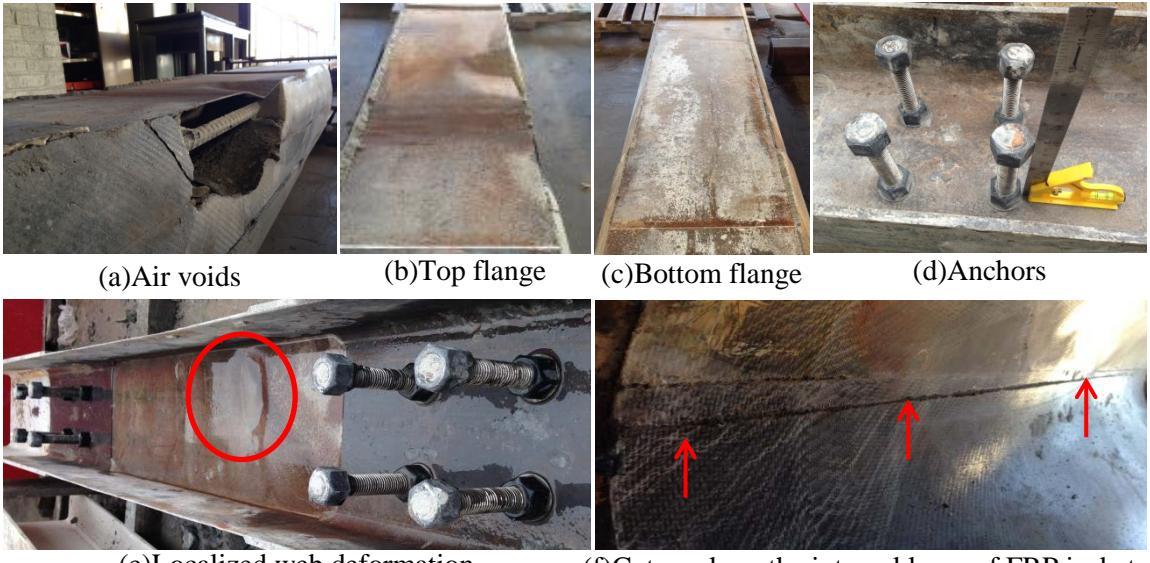
The pile was loaded up to 435 kips beyond which the axial load-deformation response showed a reduction in axial stiffness. The test was terminated when the capacity of the hydraulic loading system was reached at 633 kips before any significant damage of the repaired pile was observed. After removing the FRP jacket, air voids were observed in the grout which caused localized deformation in the adjacent slender flange as shown in Figure 36(a) and (b). The bottom flange and headed-stud anchors demonstrated no visible deformation as shown in Figure 36(c) and (d). Figure 36(e) shows localized deformation in the web which happened adjacent to the air voids in the grout. Figure 36(f) shows a longitudinal cut mark on the internal layer of the FRP jacket. This local scoring of the FRP is expected to have occurred due to friction between the FRP and the steel flange during installation and emphasizes the need for spacers between the steel pile and the FRP jacket.

(e)Localized web deformation
