FIELD TESTS OF TIMBER RAILROAD BRIDGE PILES

A Thesis

Submitted to the Office of Graduate Studies of
Texas A&M University
in partial fulfillment of the requirements for the degree of
MASTER OF SCIENCE

Major Subject: Civil Engineering

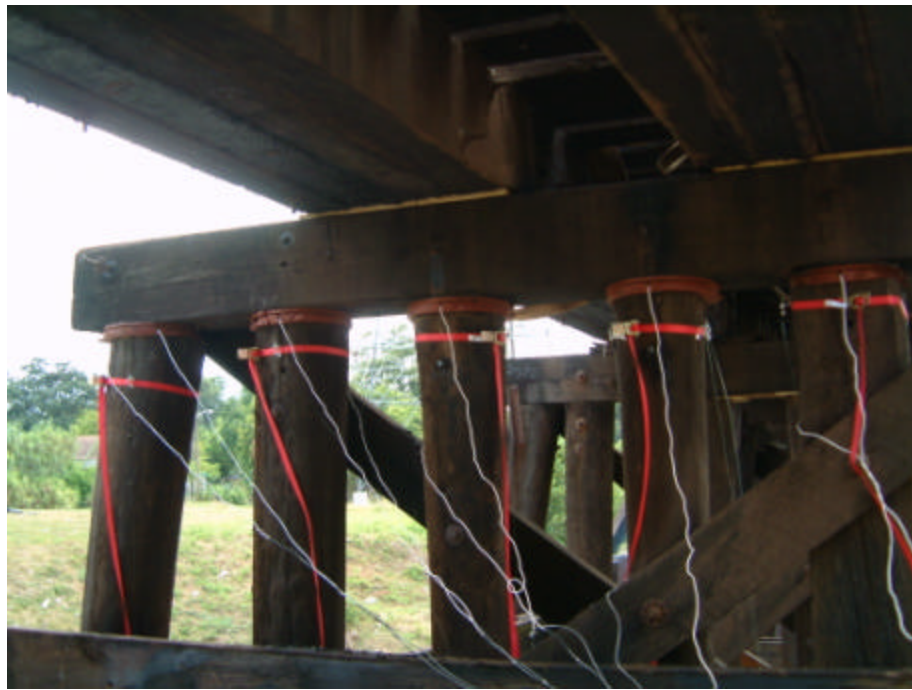
Fig 1.1 Cross section of piles underneath typical bridge bent cap

A typical cross section and lateral view of a timber bridge are shown in Figures 1.1 and 1.2. The load from train axles applied directly to the rails are distributed to the nearest ties which are typically placed 19 to 20 inches apart transversely along stringers (AREA 1997). The stringers are large, rectangular beam-like elements spanning in groups of 4 or 5 per chord between adjacent bent caps where the load is collected and allocated among the supporting piles. “Each bent has four or more vertical members, either wood posts resting on concrete footings or wood pilings driven into the ground to serve both as foundation and vertical member of the bent. Timber piles are column-like elements that transfer vertical and lateral loads into the soil. Usually, the outer pile on each side is battered so that the bent will be able to resist lateral load” (Stalnaker 1997). For the purposes of this report, the foundation beneath all the piles is assumed rigid and sufficient enough to support the self-weight of the timber bridge structure and train loads.

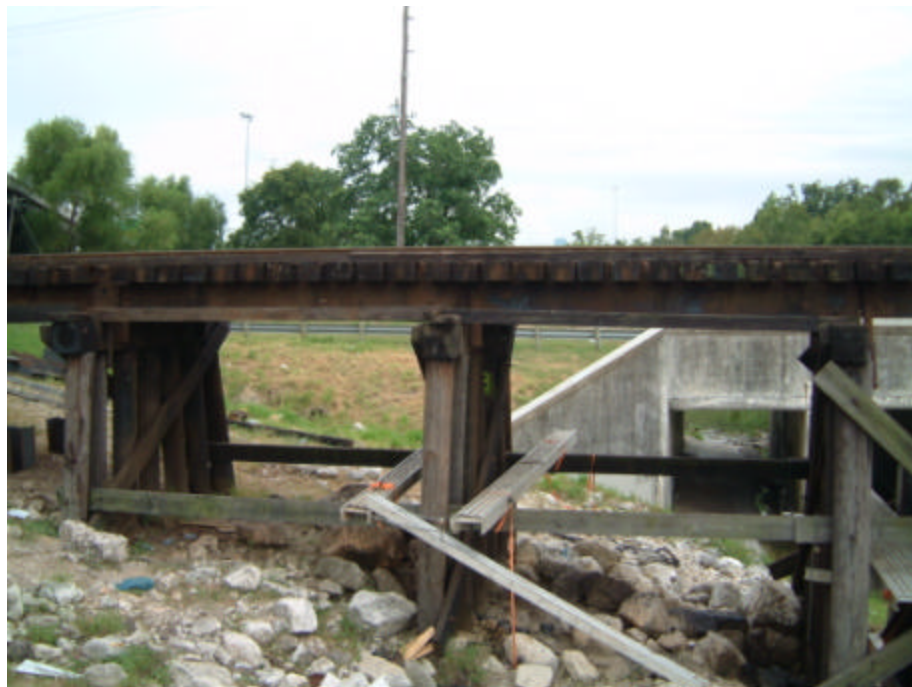
Fig 1.2 Lateral view of piles

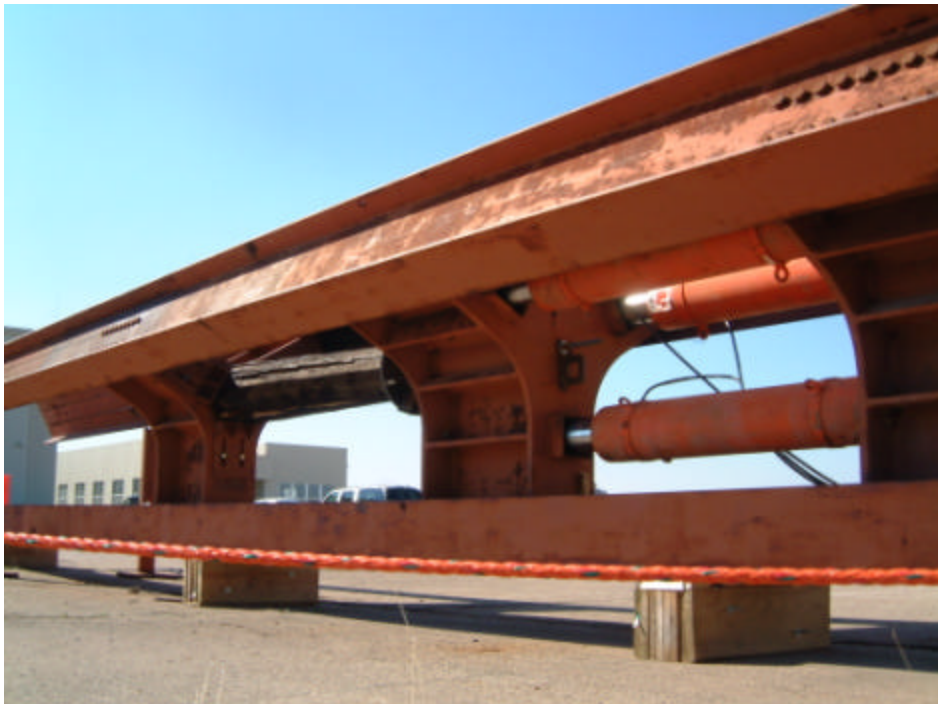
Fig. 1.3 Steel frame used in previous destructive tests

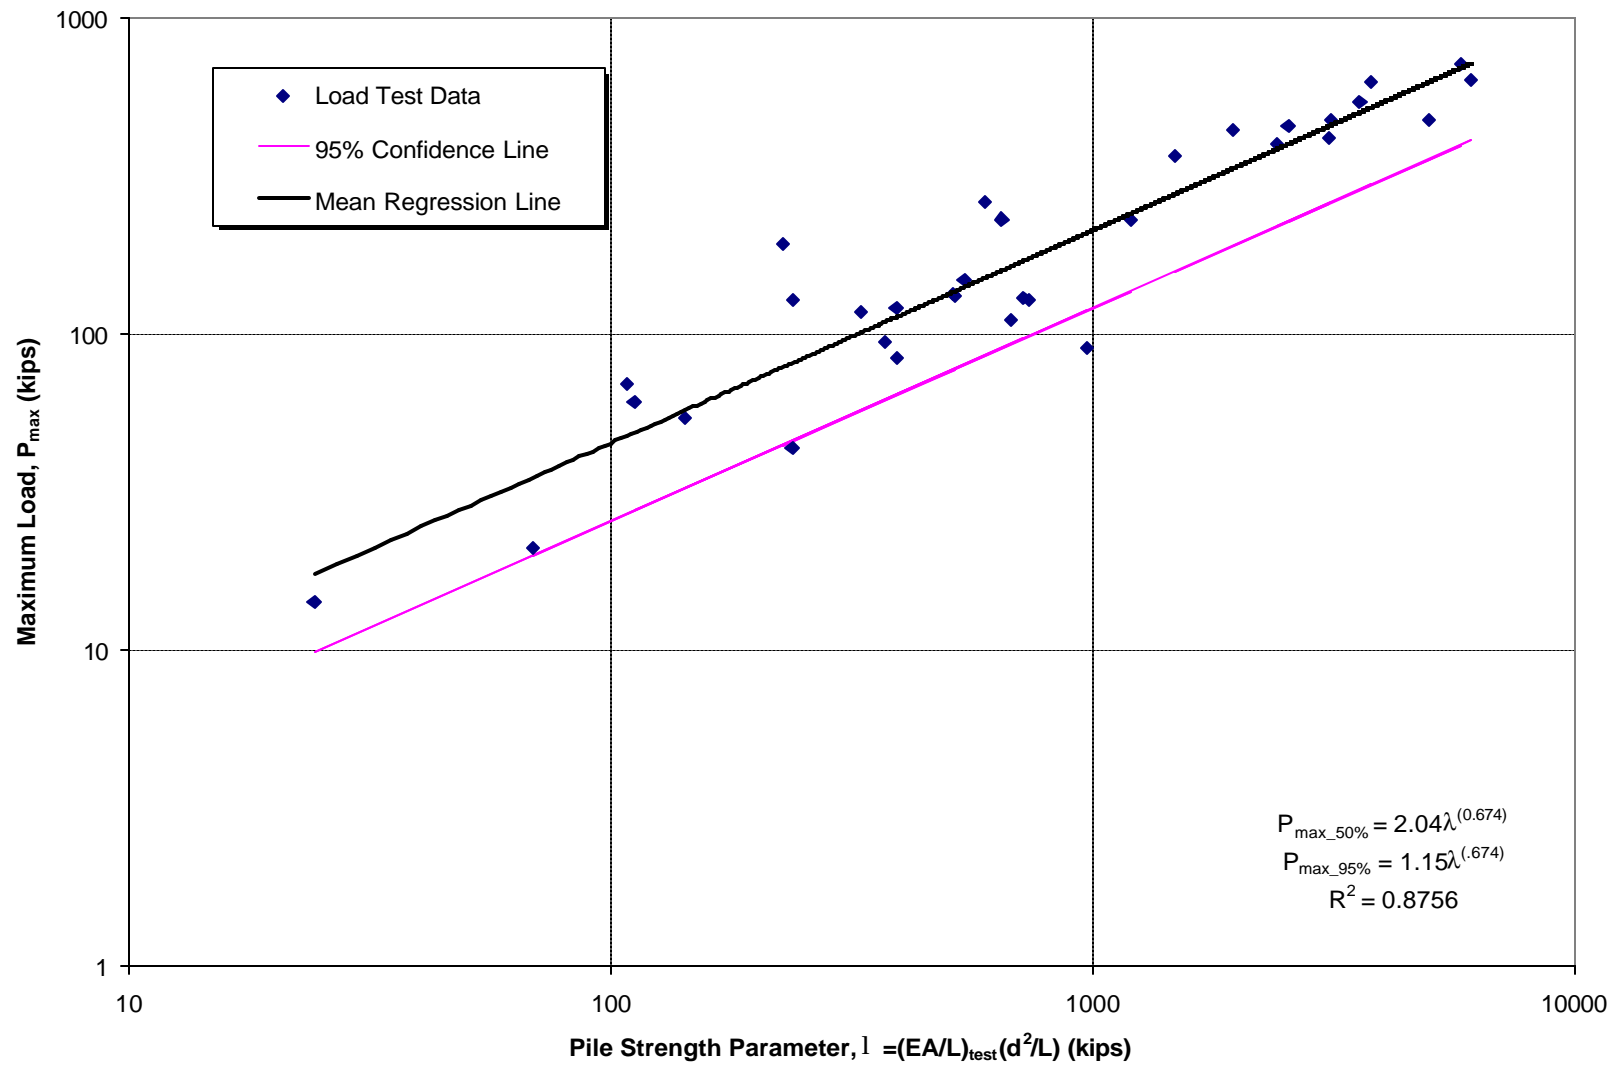
Fig. 1.5 Ultimate load vs. pile strength parameter, λ

The analysis of a 95 percent lower confidence limit shown in Figure 1.5 resulted in the following equation:

$$P_{\max_{95\%}} = 1.15\lambda^{(.673)} \quad (1.5)$$

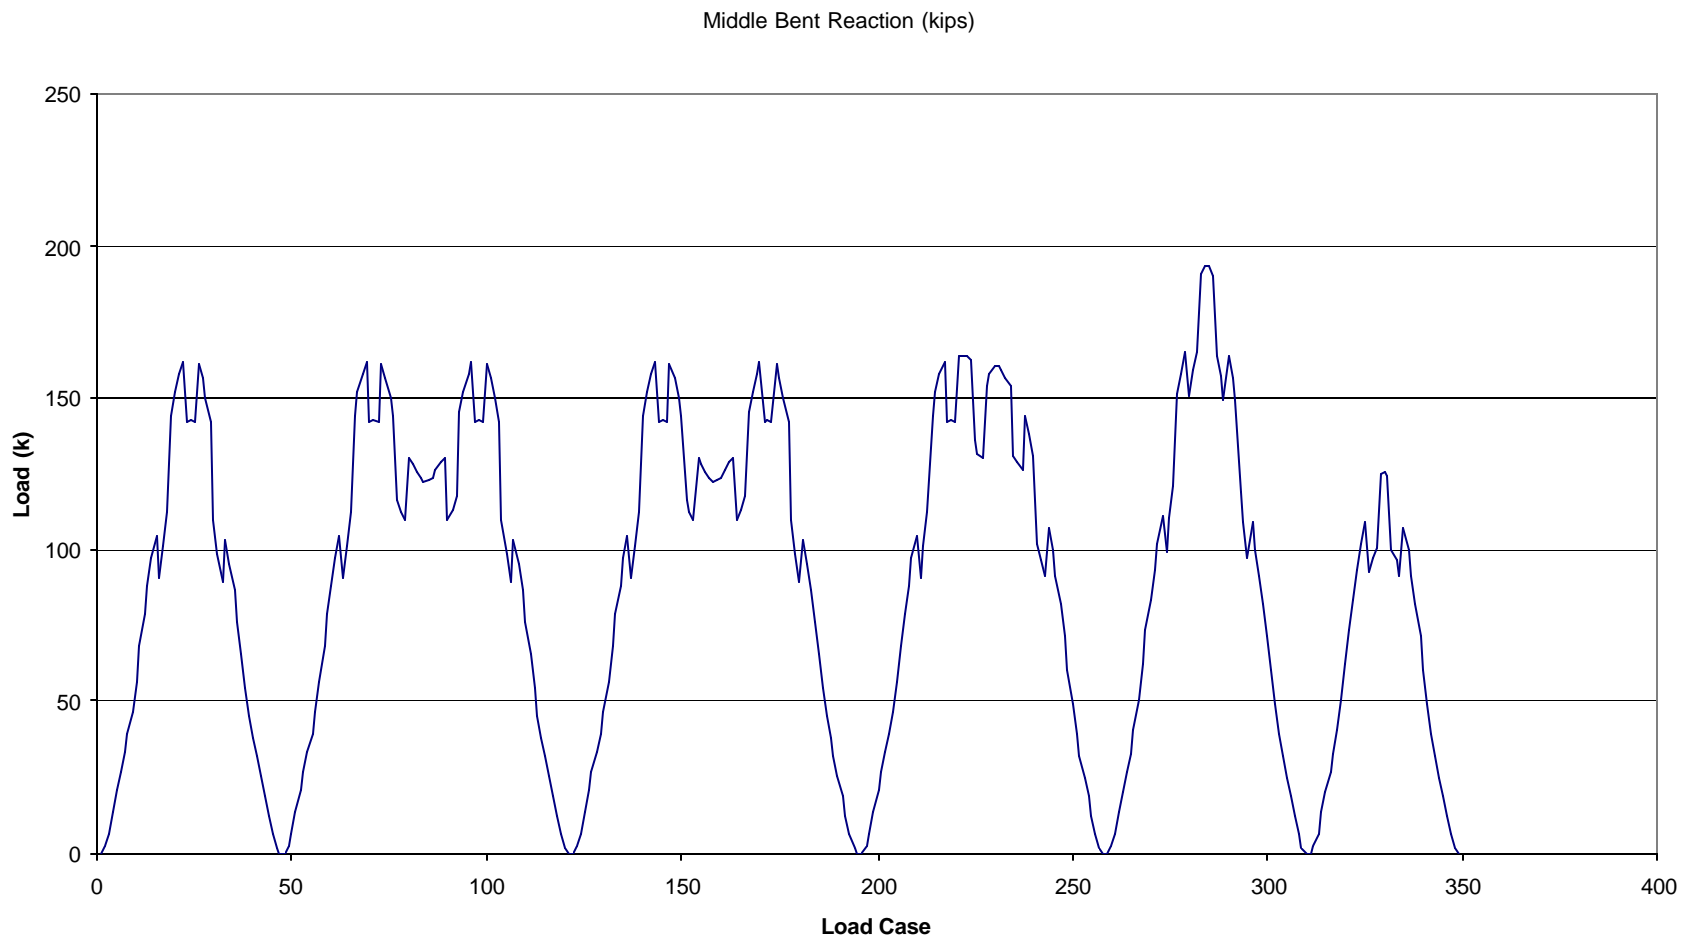
Fig. 1.6 Expected load from computer-generated model of a typical class A train

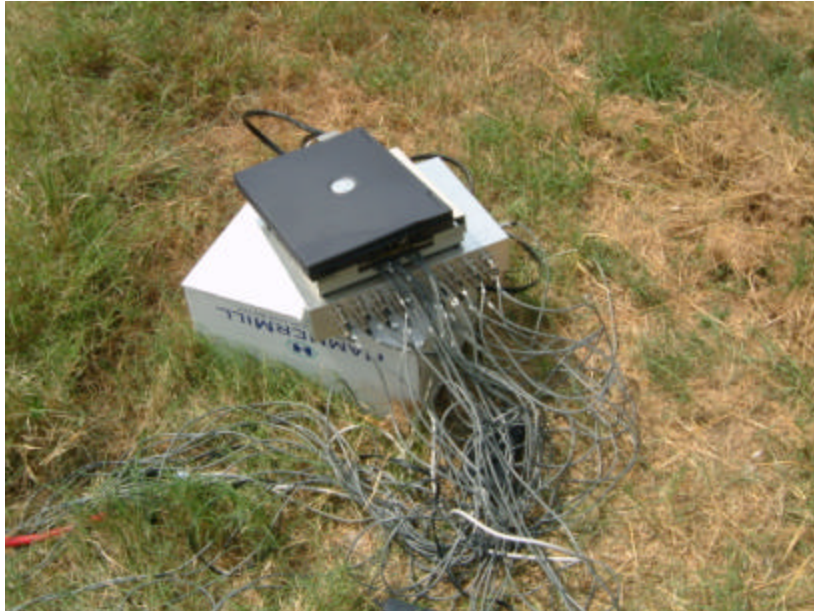
Fig. 2.1 Data acquisition system

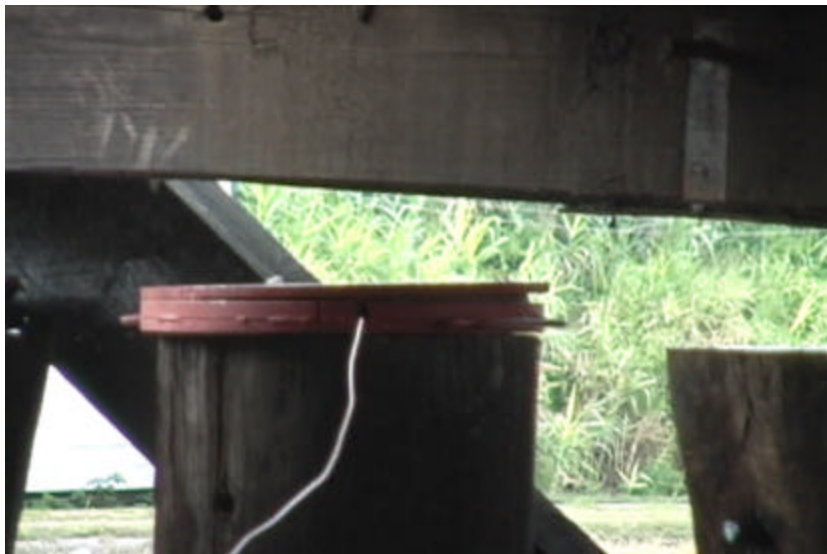
Fig. 2.2 Photograph of load cells in steel bearing plates

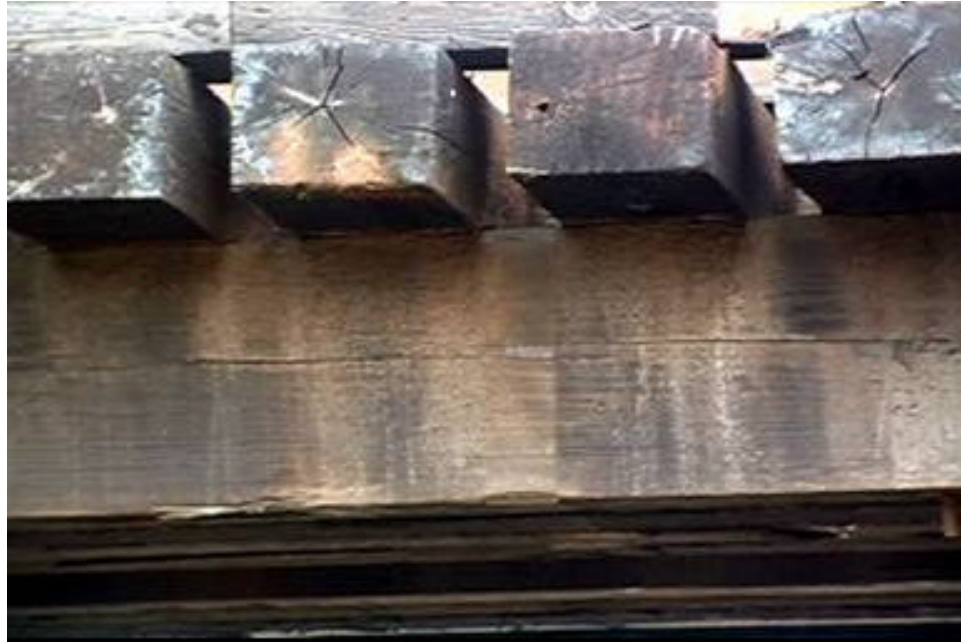
Fig. 2.3 Photograph of horizontal shear crack present in stringer

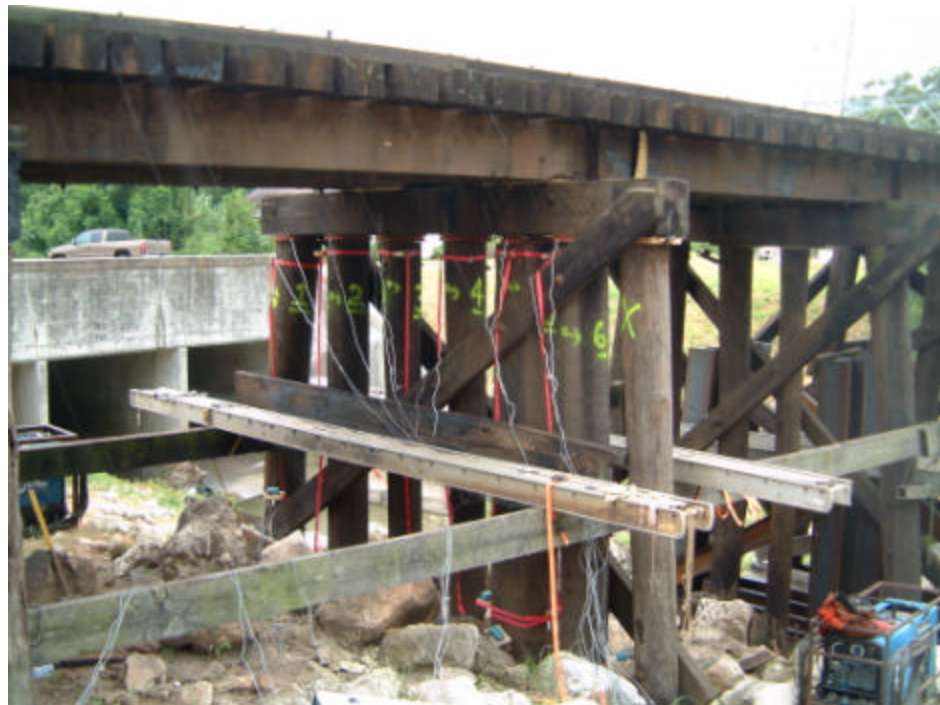
Fig. 2.4 Photograph of piles with identification labels

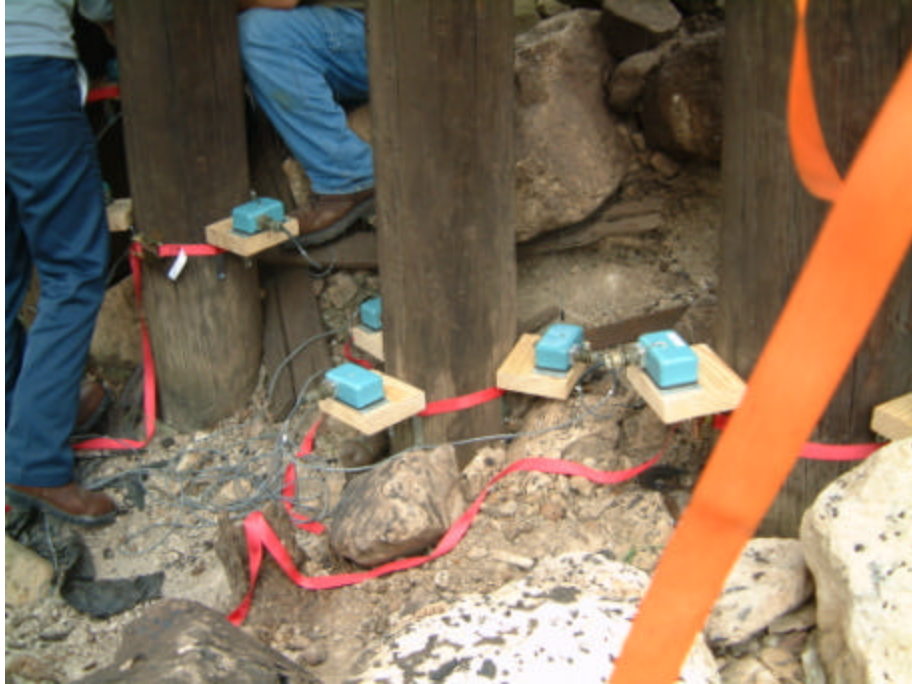
Fig. 2.5 Photograph of string pots installed on pile near the ground surface

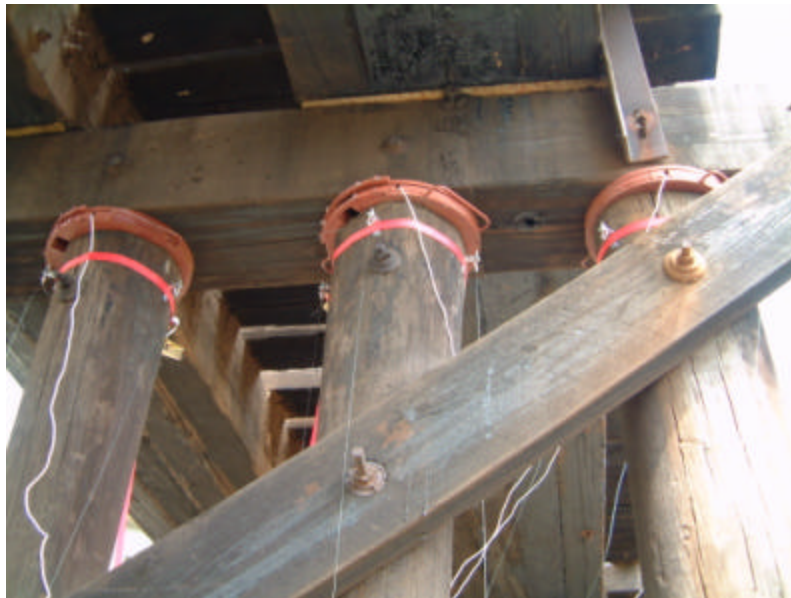
Fig. 2.6 Photograph of eye bolt anchor underneath bent cap

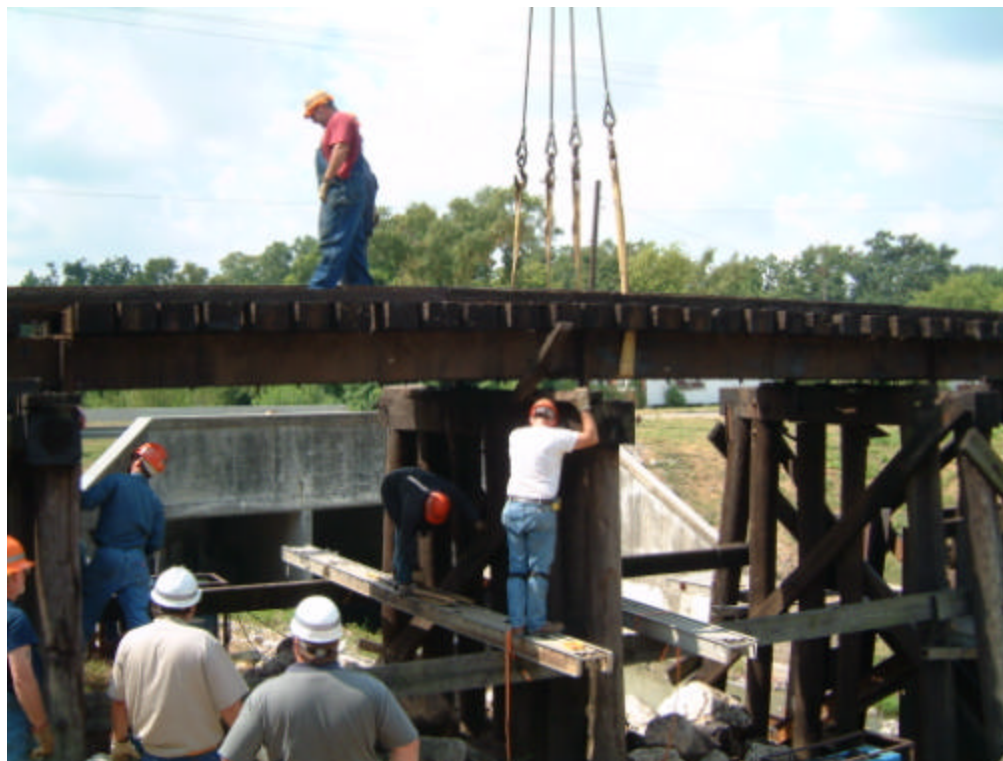
Fig. 2.7 Photograph of load cell installation with crane

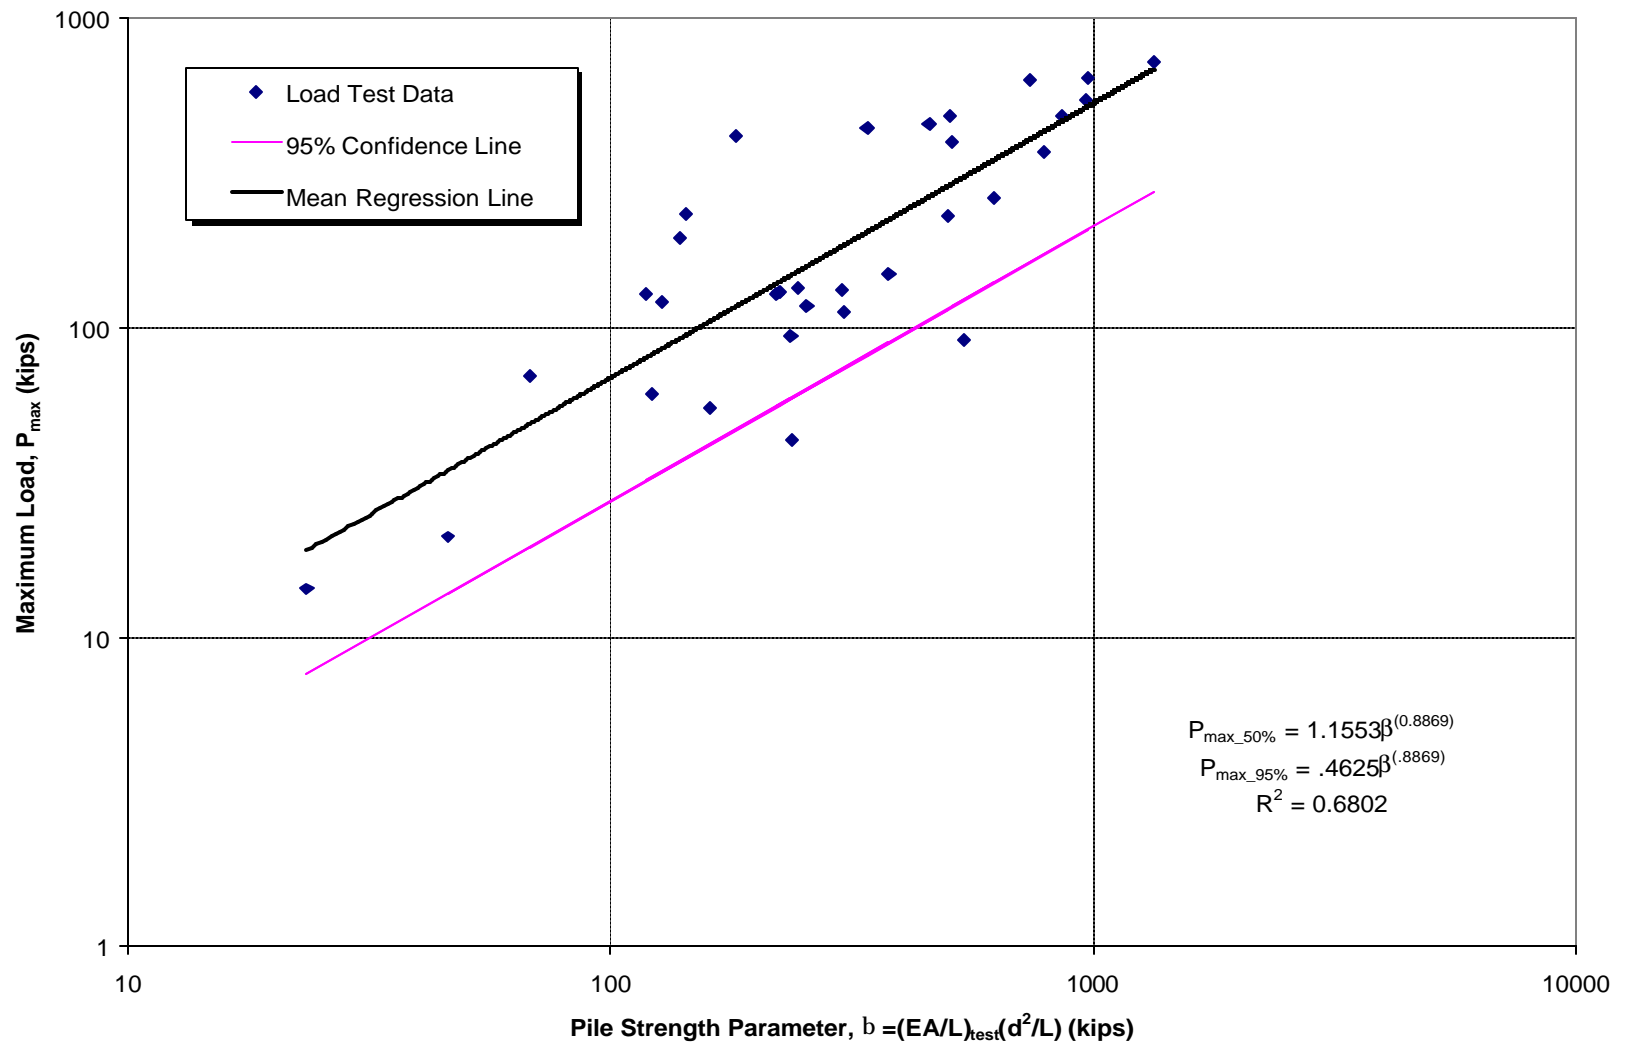
Fig. 3.11 Ultimate load vs. service pile strength parameter, β

The results from the service strength parameter analysis are shown in Figure 3.11 with logarithmic axes due to the linear plot showing a power law regression. The X-axis represents the strength parameter, β for the service loads and the Y-axis is the failure load of the piles, P_{\max} . By a least squares fit estimation, the equation of the mean regression line and coefficient of correlation are:
