*Port Improvement via Exigent Repair (PIER) Joint Capability Technology Demonstration*

## **Pile Wrapping for Expedient Port Repair**

PIER Spiral 1

August 2018

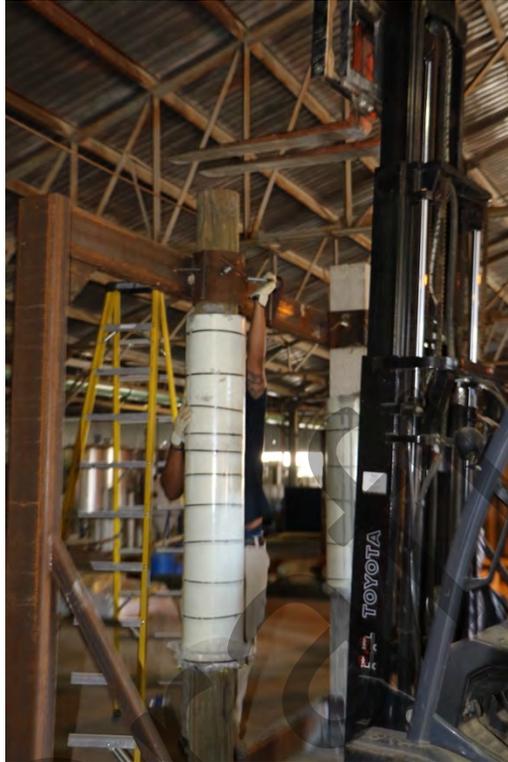
Figure 1. Dry training rack

Training followed a crawl, walk, run approach. The ERDC divers had limited to no construction diving experience and had never installed pile jackets prior to the TD. Training began with the crawl phase two days before the TD. The dive team learned about the pile jacket and watched Quakewrap® representatives install jackets on three piles in the dry on a rack made for dry-side training (Figure 1). Next the ERDC dive team installed jackets on the dry piles under the supervision of the Quakewrap® representatives. For the walk phase of the training, the ERDC divers installed the pile jackets on a rack in the water using the same three pile setup as they would for the TD. The rack was placed in the sump, which was flooded to simulate field conditions (Figure 2). The learning curve for handling the FRP laminate wrap in the water was steep. After practicing and modifying the ap-

proach, the ERDC dive team learned to handle the FRP laminates and wrap the piles efficiently. After completing two days of training and practicing with the FRP laminates in the sump, the ERDC divers were competent to place the wraps during the TD.

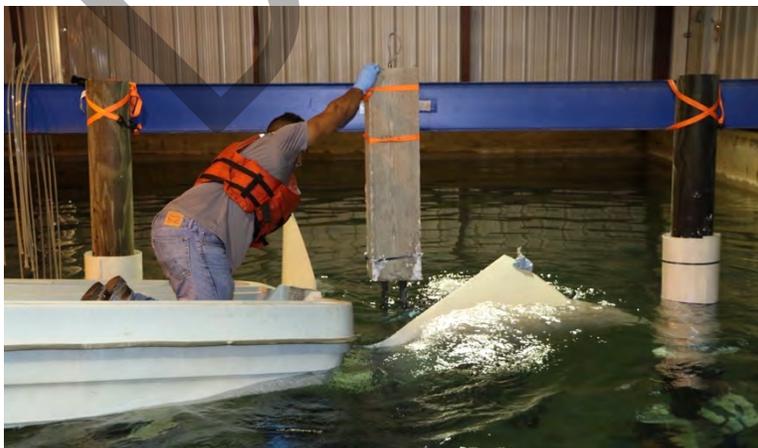
Figure 2. ERDC divers train on wrap installation in the flooded sump

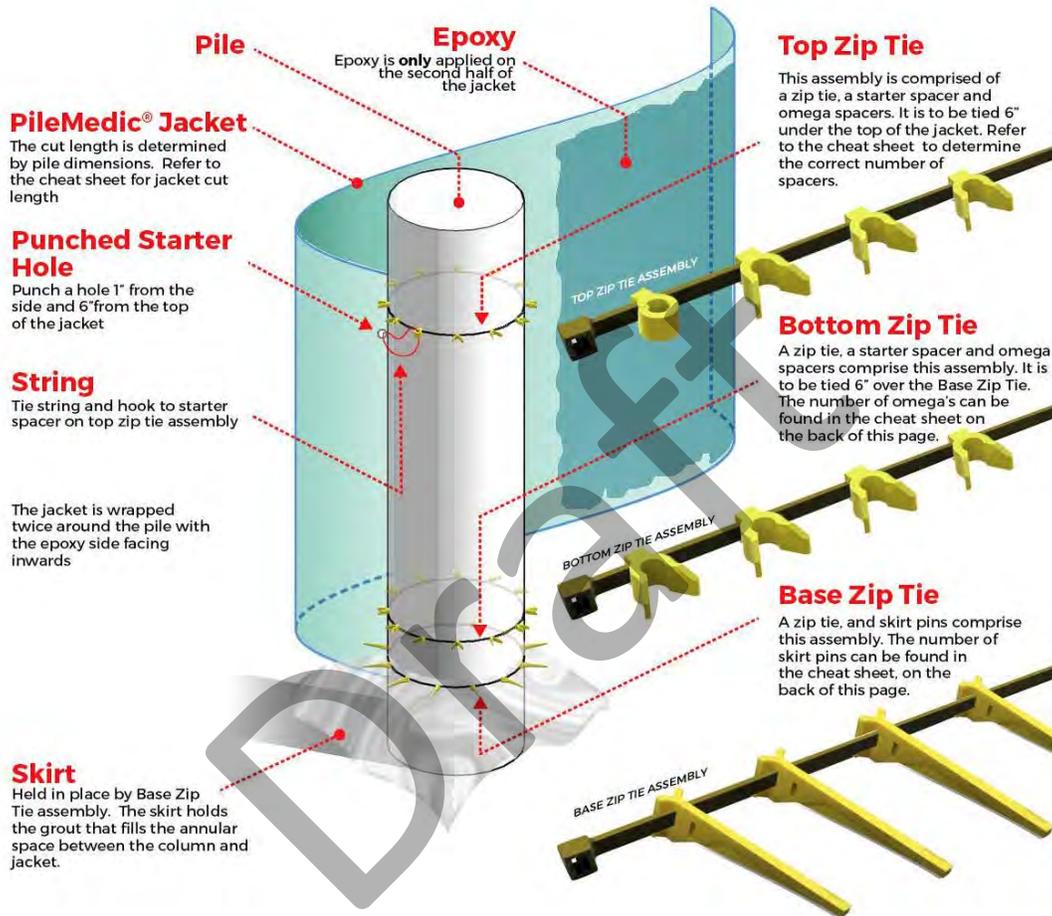
Figure 3. PileMedic® wrap system components

The technology demonstrated consisted of a kitted solution that included the pile wrap, underwater resin, spacers, skirts, Portland cement grout, and group pumps. The components of PileMedic® product are illustrated in Figure 3.

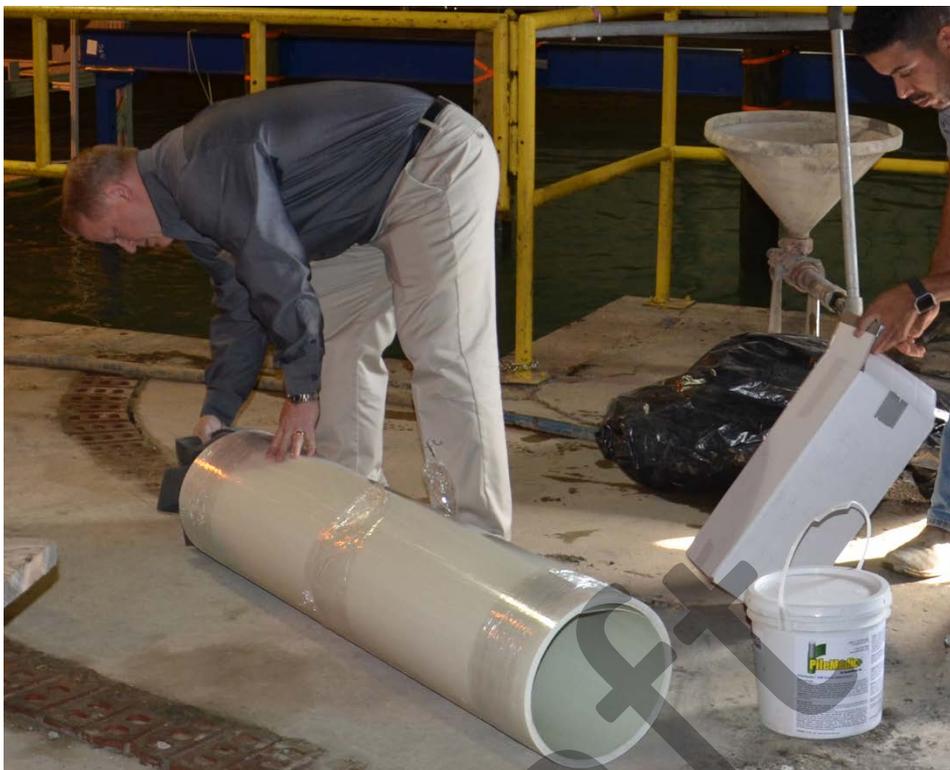
Figure 4. FRP standard roll (4 ft by 150 ft)

The PileMedic® PLG60.60 FRP Laminate Sheets are 0.026 in thick and are packaged in 4 ft by 150 ft rolls as shown in Figure 4. The FRP bidirectional glass laminate contains orthogonal fibers in two directions (longitudinal and transverse to the roll). The sheets are wrapped around the pile two or more times to create a multiple impervious shell providing confinement to the filler material which is subsequently placed in the annular space between the pile and the liner. A significant advantage of the rolled FRP material is that it can be universally applied to piles of various cross-sectional shapes (round, square, rectangular, octagonal, etc.) with minimal impact on installation technique. Also, the FRP can be cut to desired lengths to wrap piles of various sizes. When the length of the repair exceeds 4 ft, the pile jacket segments are overlapped a minimum of 4 in to create a double or triple wrap to extend the repair to as much as approximately 11 ft in length.

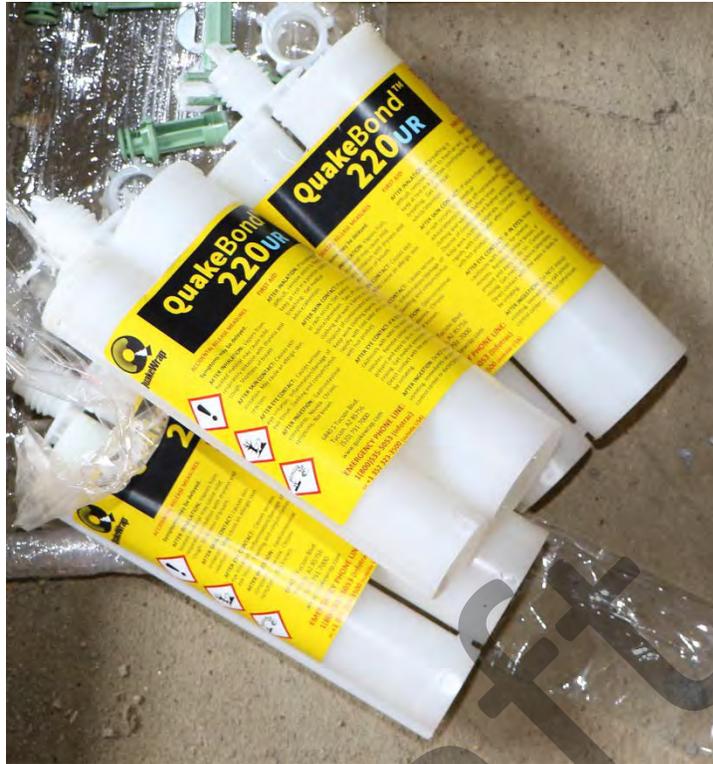
Figure 5. Two-part epoxy adhesive used to bond FRP wraps

The QuakeBond® 220UR Underwater Resin, shown in Figure 5, is a two-component, high-strength, structural epoxy for underwater application. It is used to bond the PileMedic® PLG60.60 FRP Laminate Sheet to itself to create an impervious shell. It is also used in double and triple wraps to form an overlapped watertight joint. The epoxy can be mixed and dispensed onto the laminate sheet either through use of a manual or pneumatic epoxy cartridge dispenser (Figure 6).

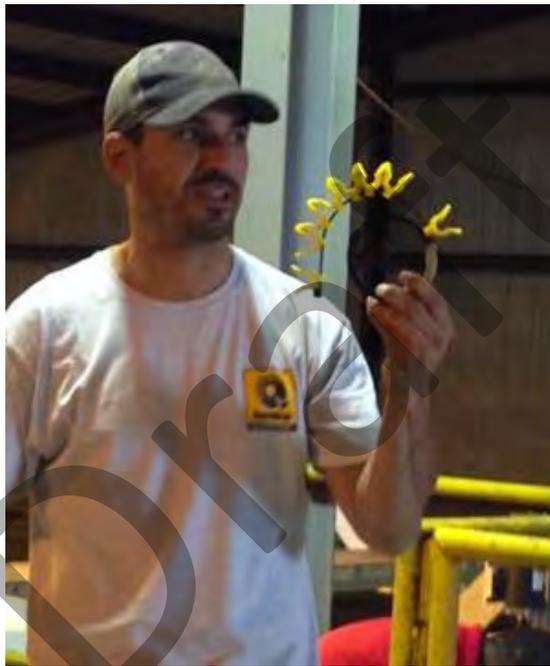
Figure 7. Annular spacers are placed on piles to ensure jacket standoff from pile

Spacers are placed on piles to create a uniform annulus for grouting (Figure 7). The annular spacer size can be adjusted to optimize the volume of grout required for the repair. Different spacers were provided for round versus rectangular (and square) column cross-sections. This duplicity was later found to be unnecessary, and a single spacer could be designed to accommodate both circular and rectangular cross-sections. A semi-rigid foam insert and polyurethane skirt (Figure 8) are installed at the bottom of the pile jacket to prevent grout from leaking or blowing out. This skirt system was shown in later trials to be a source of grout leakage and was modified to improve grout retention. Zip ties are placed around the PileMedic® PLG60.60 FRP Laminate Sheet before grout is pumped into the form and remain in place as the grout cures.

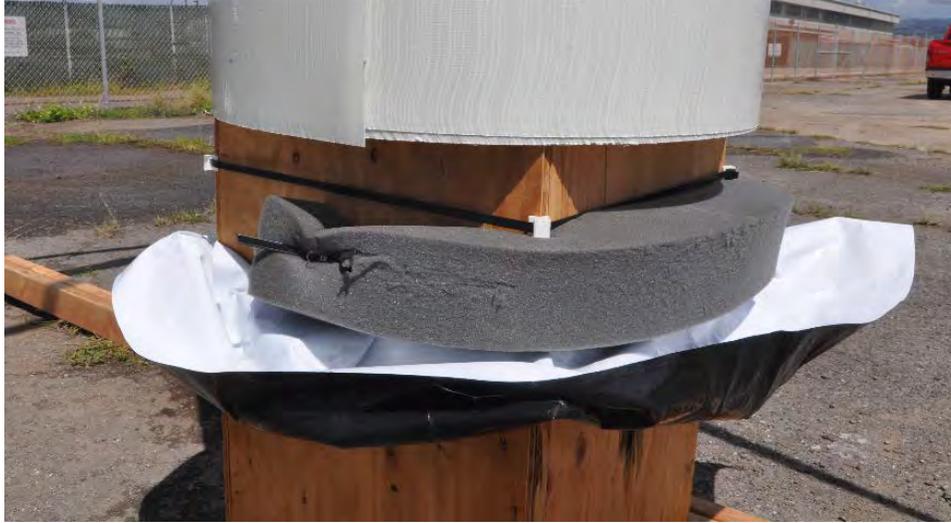
Figure 8. FRP jacket lifted to reveal foam insert and skirt

Next, the divers installed a bottom seal and skirt at the bottom of the pile jacket to prevent grout from leaking or blowing out. During the TD, the divers used semi-rigid foam placed inside the bottom of the pile jacket to help form the bottom seal instead of oakum line which was used in practice the day before. These steps were repeated for the 10 in by 10 in concrete pile and the remaining timber pile. Approximately 20 minutes was required per pile to prepare the pile jacket to receive grout.

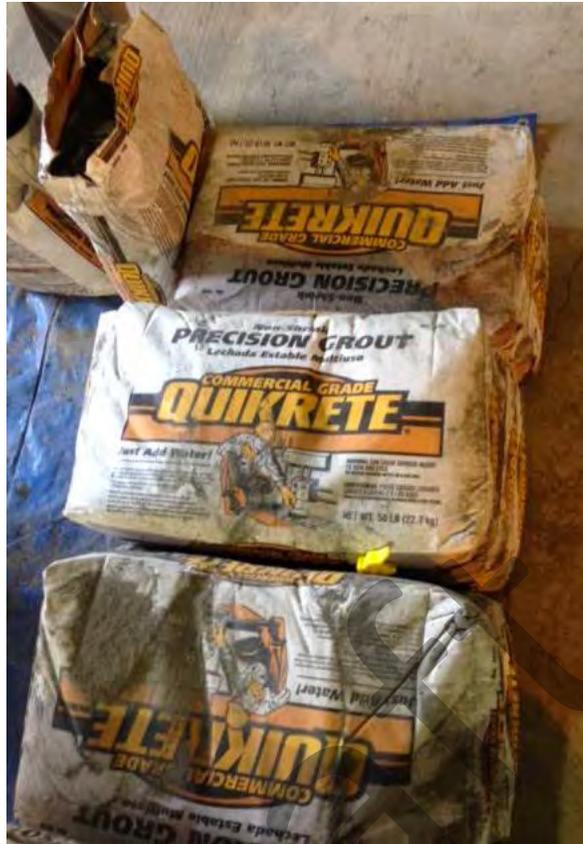
Figure 9. A commercial, non-shrink grout product was used

The PileMedic® system can use Portland cement grout or epoxy resin grout as fill. For the demonstration, a readily available pre-packaged commercial Portland cement grout (Quikrete Commercial Grade Grout) was used (Figure 9). This material was mixed with tap water according to the Quikrete's specifications and pumped into the annular space between the pile and the FRP liner using a tremie method (grout is pumped into the top and the annular opening and allowed to settle into the annular space from the bottom upwards). Later demonstrations and assessment would reveal that this method can result in voids within the grout column. The grout was mixed in 5-gal buckets using a hand-held air-powered drill motor to power a small mixer paddle.

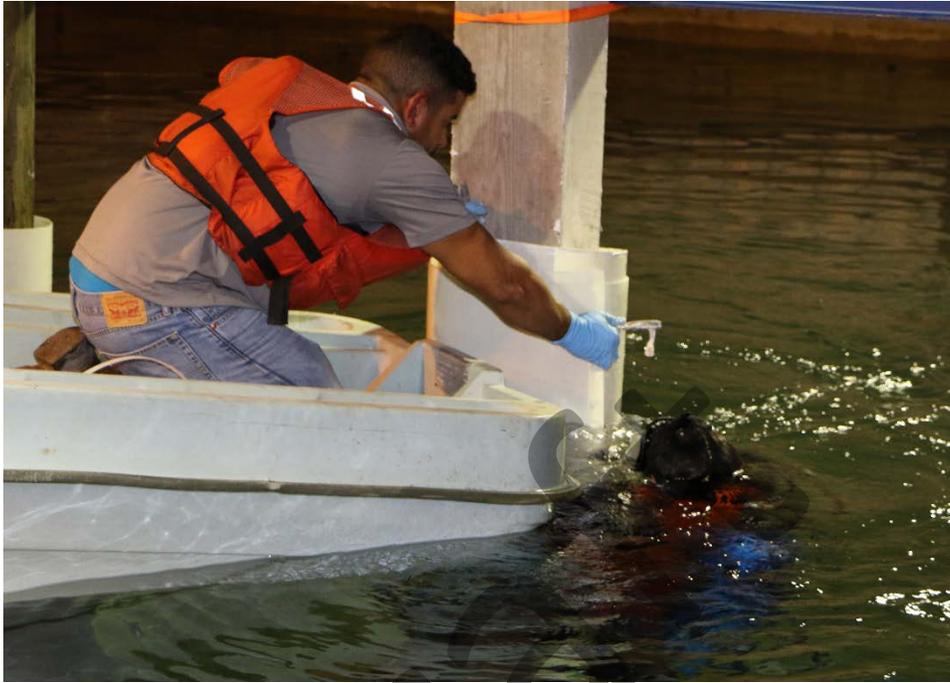
Figure 10. Divers place wrap on pile

The prepared pile jacket was then transferred to the divers and placed around the pile as shown in Figure 10. Once the pile was wrapped, it was secured in place with zip ties to allow the epoxy to cure.

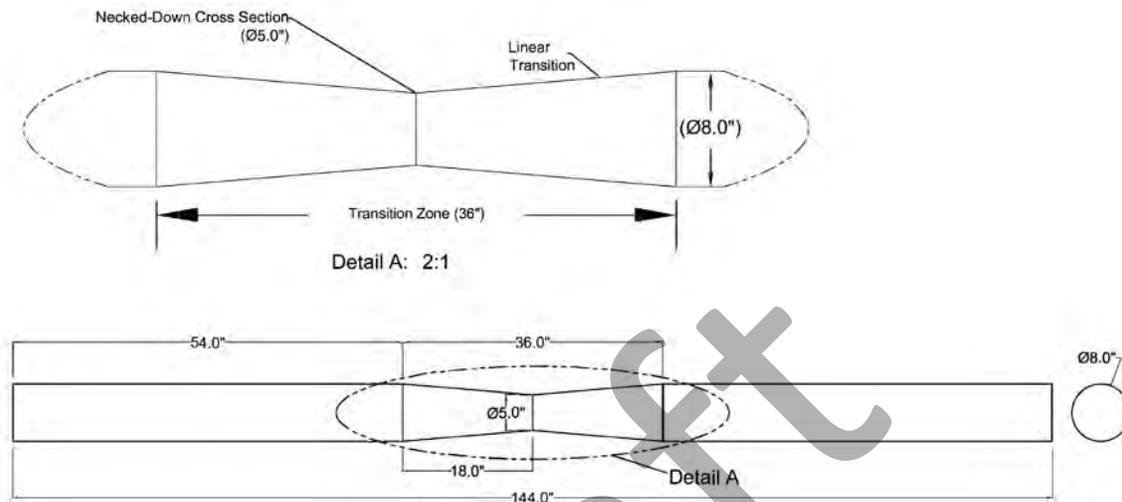
Figure 13. Schematic of tapered timber pile

The tapered pile test determined the capacity of an 8-in.-diameter round column that had been tapered to a diameter of 5 in. (Figure 13). The taper is approximately 36 in. long and is in the center of the pile. This taper is intended to represent in situ timber section loss due to mechanical or biological deterioration.

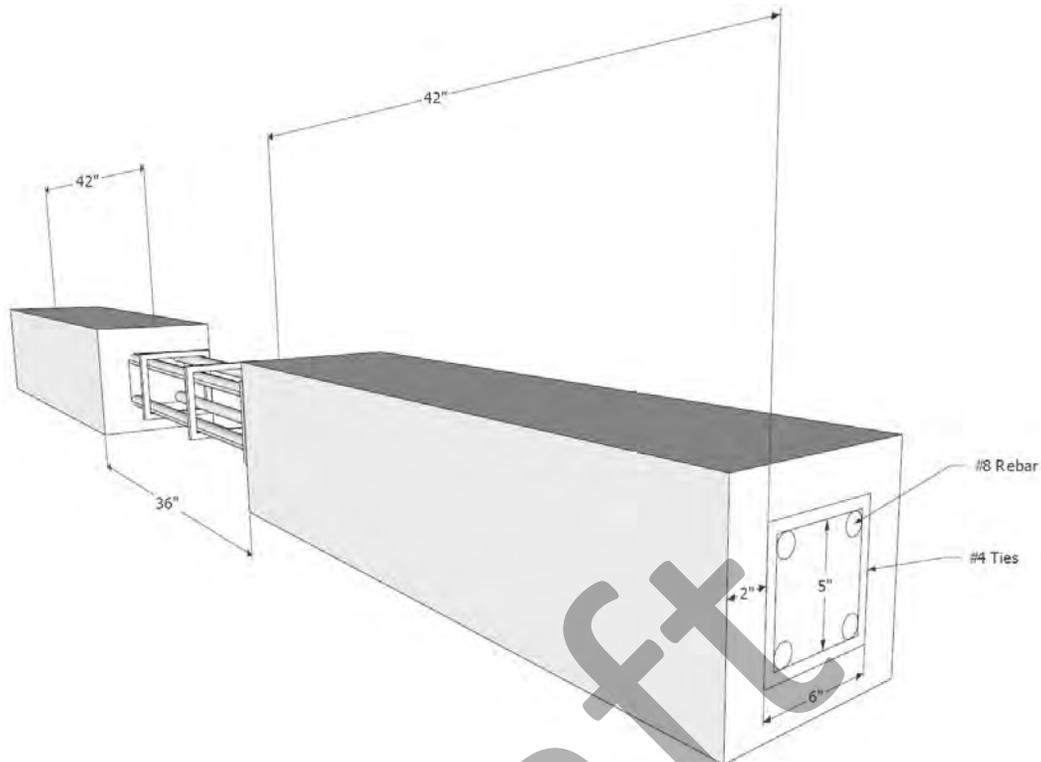
Figure 14. Schematic of concrete pile prepared for retrofit

The concrete piles tested in this test series consisted of a 10-ft long, 10-in. x 10-in. rectangular pile. The design 28-day unconfined concrete compressive strength ( $f'_c$ ) for the concrete was 5,000 psi. These columns are longitudinally reinforced with four No. 8 rebar and transversely reinforced with No. 4 stirrups at 12 in. on center. All reinforcing bars were Grade 60. Figure 14 shows the rebar layout for the concrete piles.

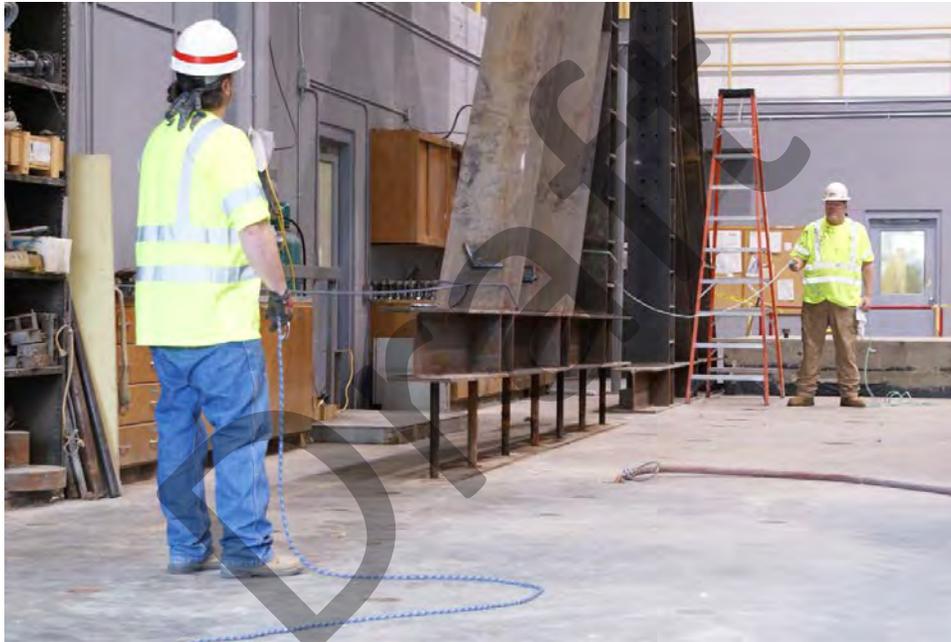
Figure 15. Placing of I-beam supports with threaded bars protruding into strong floor

The loading frame on the GSL Structural Test Floor is a system of large structural steel I-beams capable of resisting at least 600,000 lbf from a hydraulic actuator. The base of the system is made of four separate L-shaped supports made of steel I-beams with internal stiffeners and diagonal bracing. The supports can be moved into various configurations using an overhead crane. Figure 15 shows an I-beam support being moved into position for lowering onto the strong floor. High-strength steel threaded bars are welded to the base of each beam so that the support can be fastened to the strong floor. The rods are secured by installing nuts under the strong floor, as shown in Figure 16.

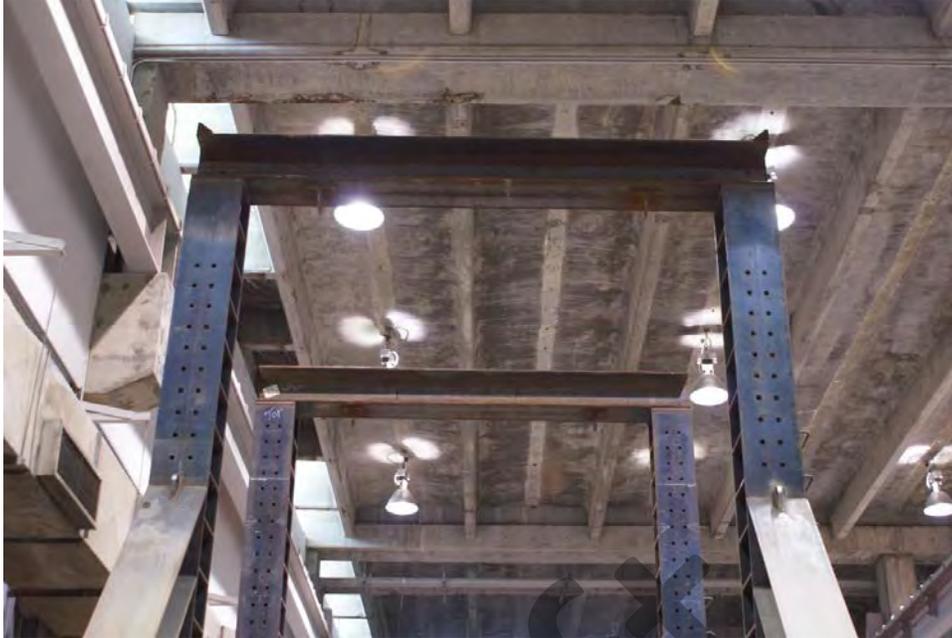
Figure 17. Stabilizer beams on top of the supports

A movable bearing surface was required to adjust the columns and beams to assure they were properly aligned and had uniform loading applied by the actuator. A 2-in.-thick by 10-ft by 8-ft steel plate was used as the base for this series of tests. Enlarged holes allowed for adjustment of the base plate on the test floor. The base plate was secured to the strong floor using similar methods as the test frame. Figure 19 shows the base plate installed on the strong floor. A “knife-edge” support, fabricated of hardened steel, was welded at the midpoint of the plate to serve as a pivot point. An initial eccentricity was built in for two reasons: first, to induce a bending moment along with the axial load and secondly, to ensure failure occurred in a known direction for safety reasons. The knife is square bar stock 2-in. wide by 12-in. in length. One side of the edge was machined flat, as shown in Figure 20, so that when it was welded to the base plate the vertical height of the knife-edge was 2 in. This knife-edge prevents translation of the column bottom during testing while still allowing for rotation.

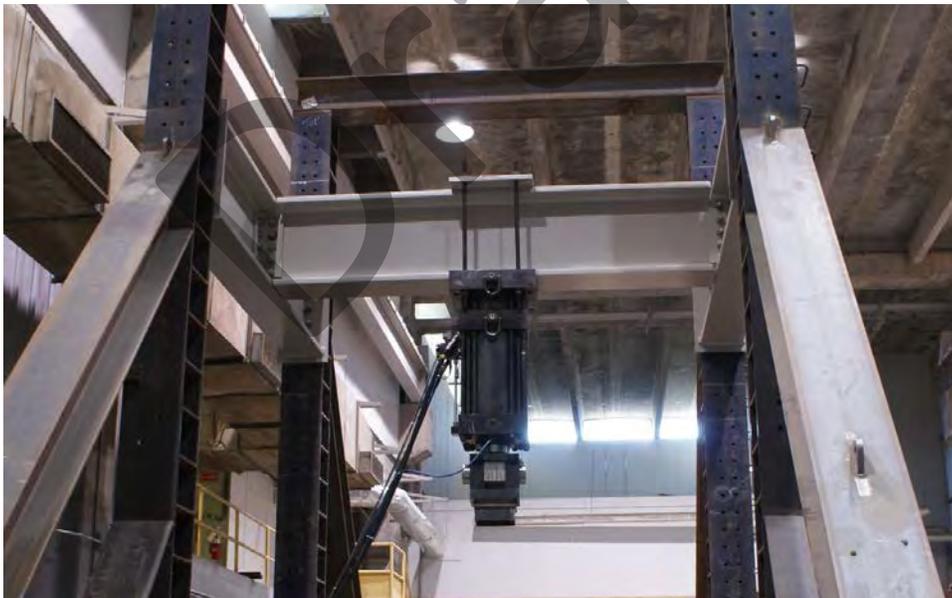
Figure 18. Loading beams installed with actuator

The supports are connected to each other by two steel beams (stabilizing beams) bolted to the very top of the supports, as shown in Figure 17, and two larger beams running perpendicular to the stabilizing beams (loading beams) bolted mid-way down the support height. The hydraulic actuator is attached to one final beam which connects the two loading beams as shown in Figure 18.

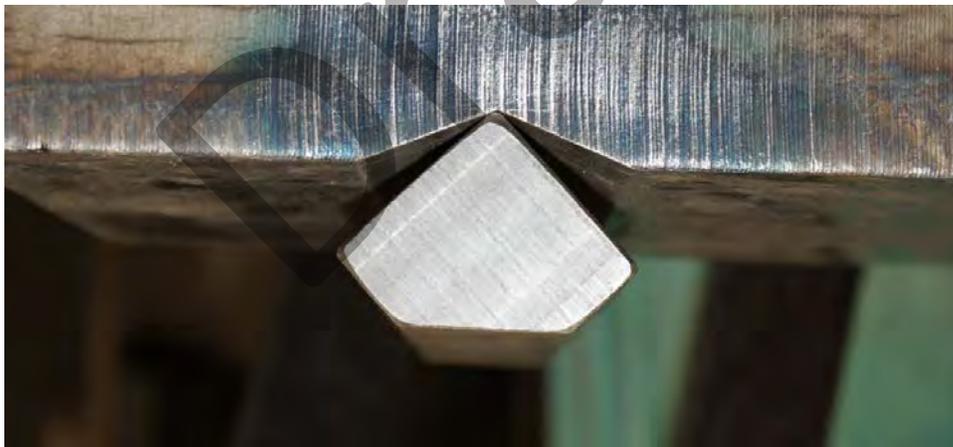
Figure 20. Knife-edge support and channel on bottom base plate

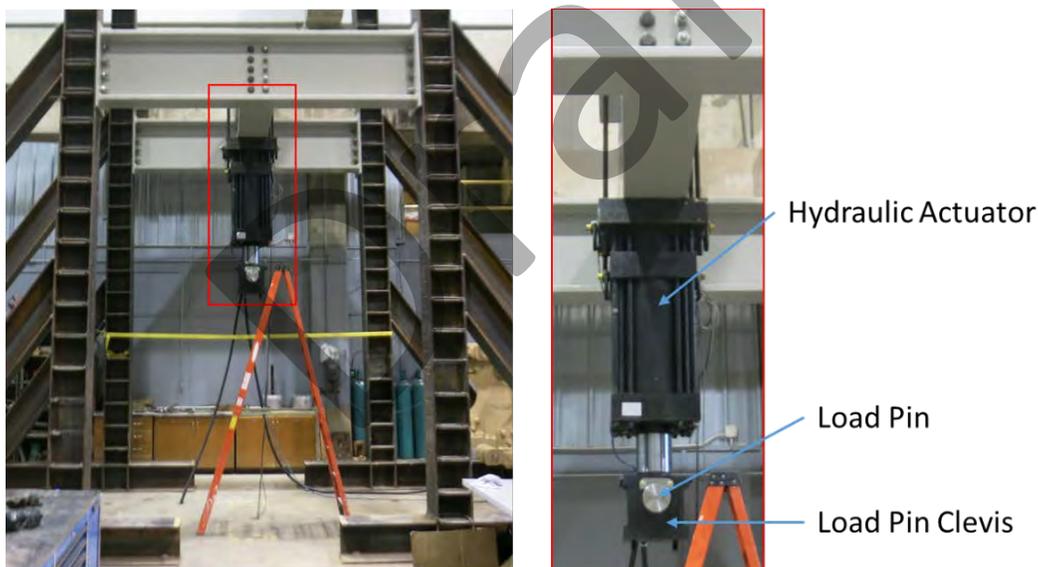
Figure 21. Hydraulic actuator assembly installed on test frame

The timber and concrete piles were tested to failure as a column in axial compression (with eccentricity to induce a bending moment) or as a beam in 4-point bending (placing the section of the beam between the load points in a state of zero shear and constant bending moment). The compression or bending load was applied via an MTS 243.90T Hydraulic Actuator with a 600,000 lbf compression capacity and a 20-in. maximum stroke length. As shown in Figure 21, the actuator was attached to the steel frame discussed in Section 5.3.1. A load pin and load pin clevis were used to transfer load from the actuator to the top column end cap. The clevis eye was threaded into the actuator ram, shown in Figure 22, and connected to the clevis with an instrumented load pin. The clevis only allows rotation about the axis of load pin and is oriented to allow rotation in the same axis as the column rotation/rocking about the knife-edge support, limiting buckling to a predetermined plane to protect the testing frame and other equipment should sudden, catastrophic failure occur.

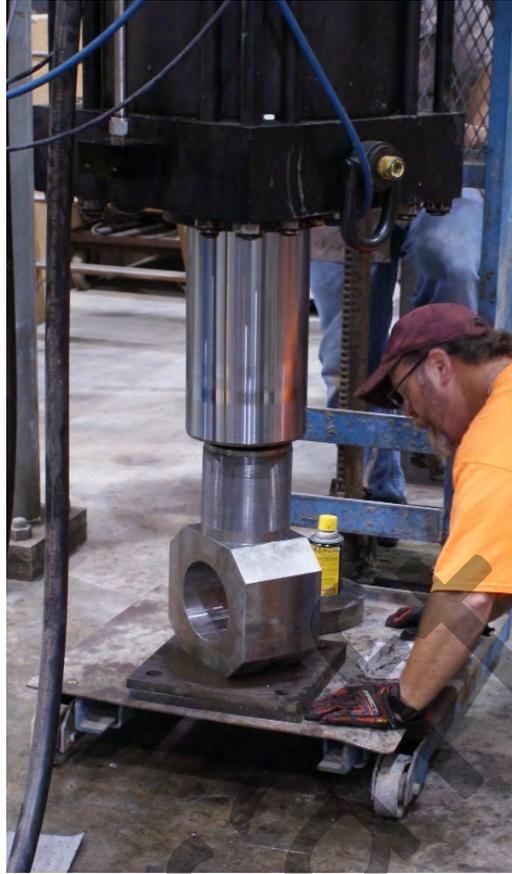
Figure 22. Load pin clevis eye threaded into hydraulic actuator end

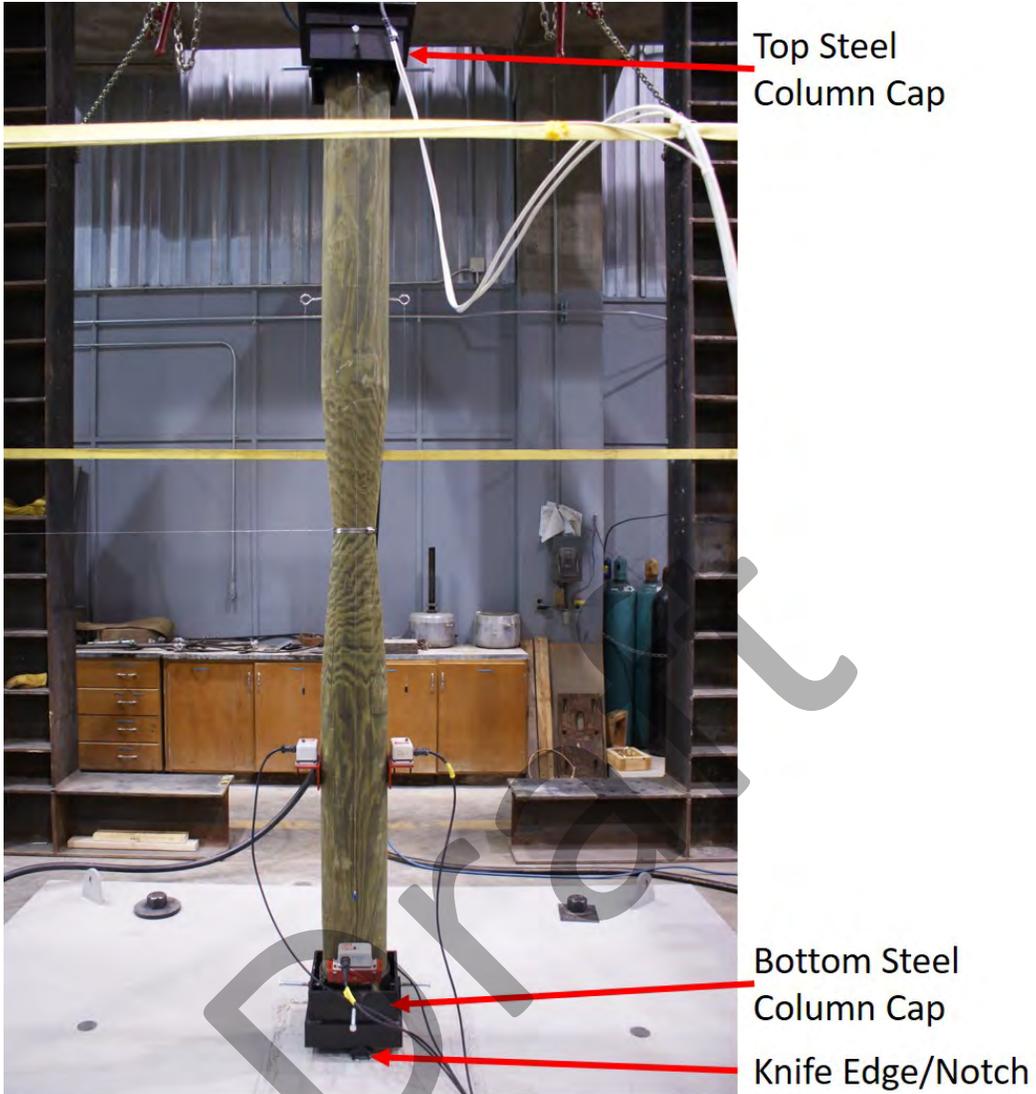
Figure 23. Overall view of column test setup with timber column installed

An overall view of the typical column test setup with an installed pile is shown in Figure 23. To ensure proper load transfer through the pile cross-section from the actuator, a top and bottom column cap were manufactured. The top of the column was held in a steel end cap with a 2-in.-thick base and 4-in.-tall sides and was bolted to the load pin clevis and actuator, as shown in Figure 24. The load pin allowed for the top of the column to rotate about one axis only, i.e., in the plane of buckling failure of the column.

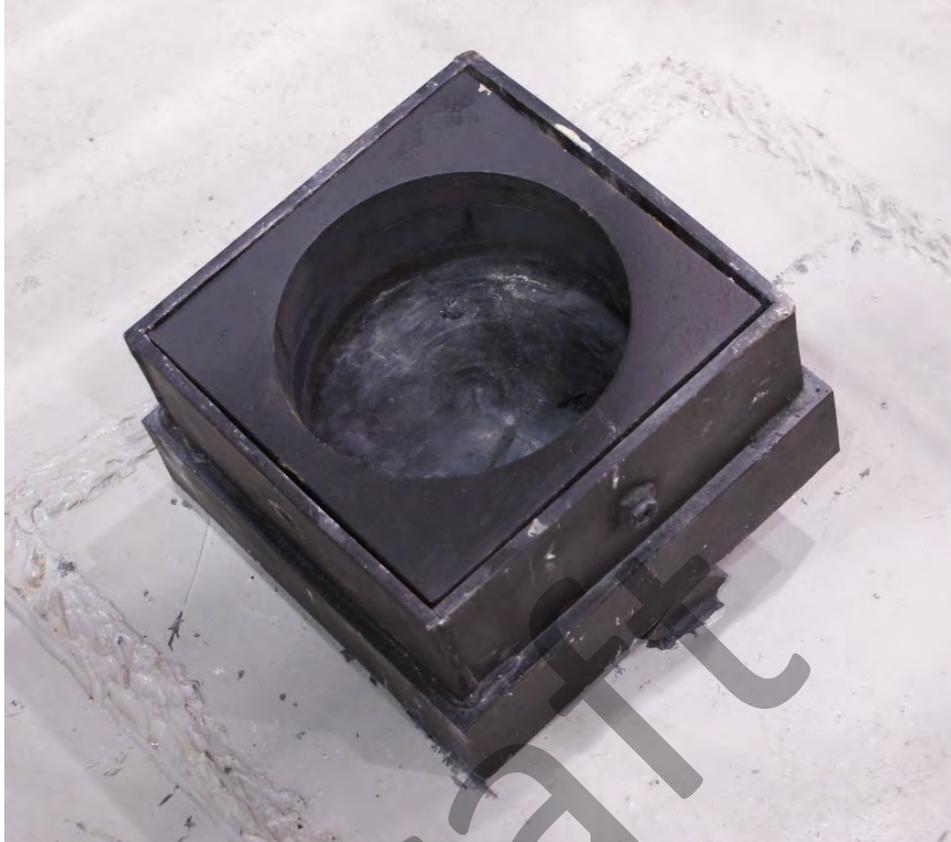
Figure 27. Timber column end cap

The column end caps utilized for the concrete piers were used on the timber piers as well. However, the round shape of the timbers required a steel collar, seen in Figure 27 in each cap to eliminate pier movement and to hinder uneven crushing of the ends of the piers. These collars fit inside of the column end cap and are 4-in. thick with an 8.25-in.-diameter hole to receive the timber column end.

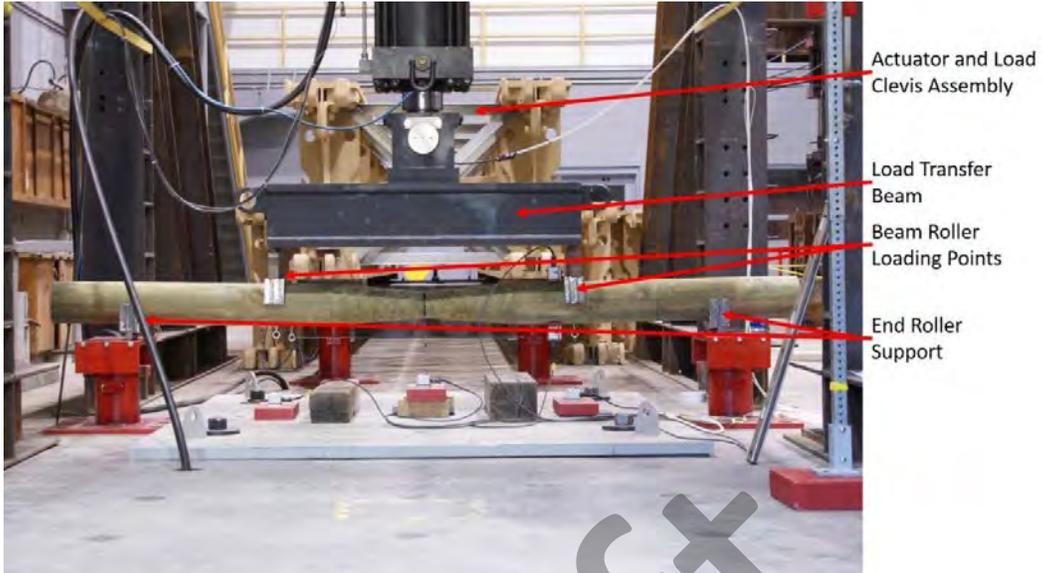
Figure 28. Overall view of flexural testing setup

The overall beam testing setup is shown in Figure 28. The beam testing utilizes a 4-point bending loading setup. All loading points utilized rollers at the supports to minimize any axial restraint resulting in axial loads. A load transfer beam, shown in Figure 29, has loading points approximately 58 in. apart. This distance between the rollers was sufficient to place the loading points on either side of the retrofit/damaged sections of the beam. This setup enforces constant bending moment between the loading points. The ends of the beam were supported by rollers on steel pedestals as shown for the timber beams in Figure 30 and concrete beams in Figure 31.

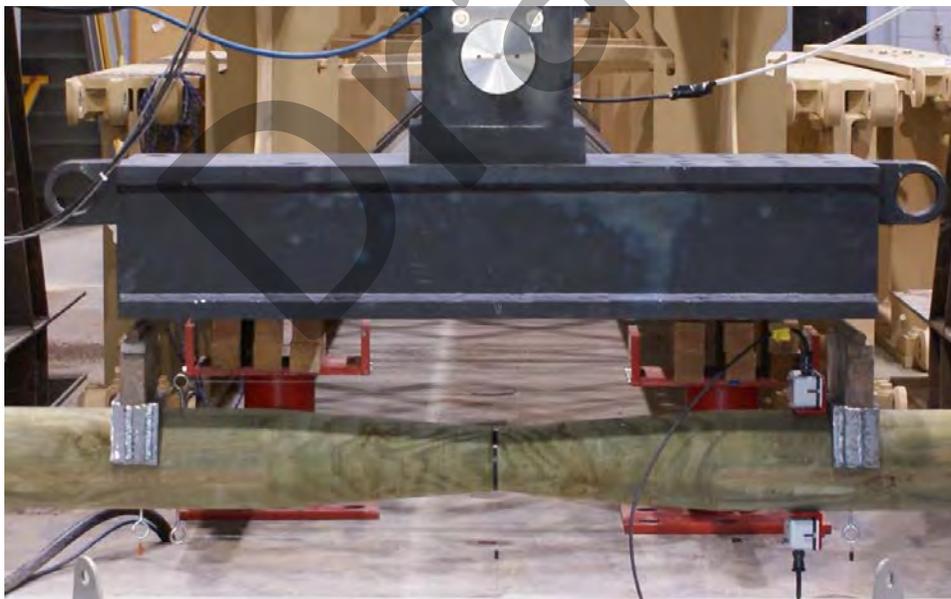
Figure 29. Load transfer beam with typical roller supports

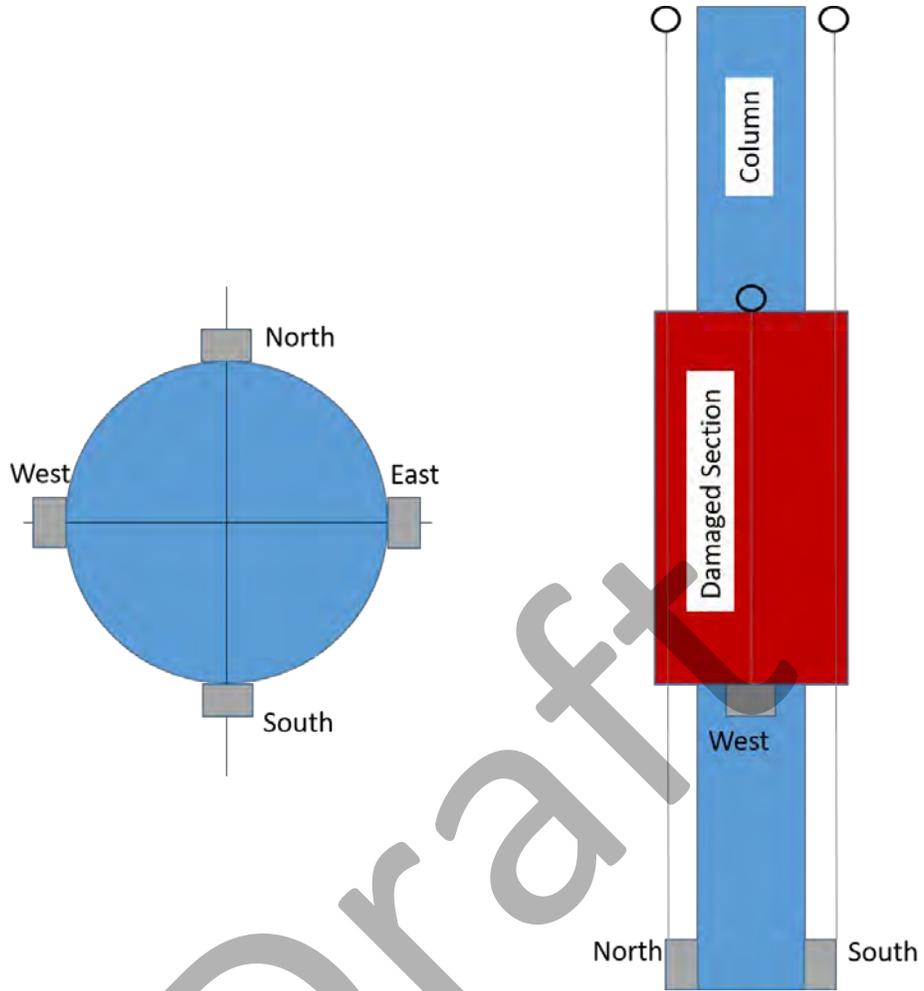
Figure 32. Diagram of string potentiometer locations for axial load testing

In the column testing of the concrete and timber piers, gauges were installed on the north – south – east – west “faces” along the axis of loading and near the center of the column perpendicular to the axis of loading. A diagram showing the locations of the four string potentiometers is in Figure 32. An example of the string potentiometer locations is shown in Figure 33. The north and south string potentiometers were attached at the ends of the column and measured the shortening of the entire column. The east and west string potentiometers were attached just outside the damaged/retrofitted region and oriented along the direction of failure (perpendicular to the knife-edge). These measured the shortening of the “damaged” section of the column. By measuring the lengthening/shortening of the column on opposite faces, possible bending forces could be measured and accounted for in the data analysis.

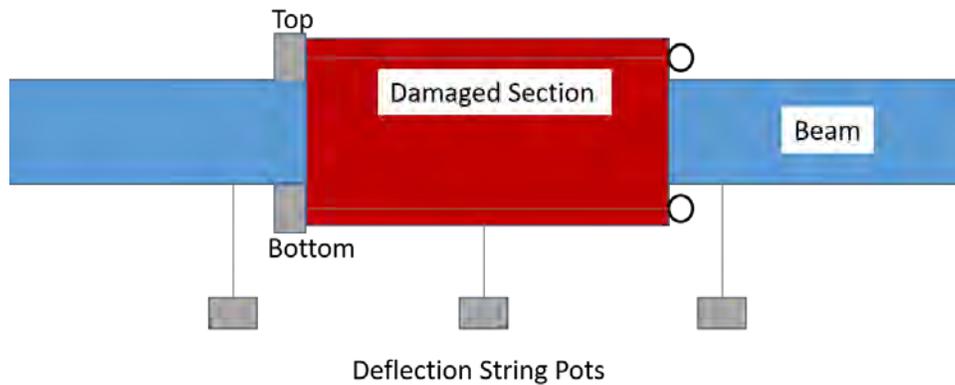
Figure 34. Diagram of string potentiometer locations for flexural load testing

For the flexural load testing of the concrete and timber piers, a diagram of the string potentiometer locations is shown in Figure 34. An example of the string potentiometer locations installed on a flexural load test specimen is shown in Figure 35. Two potentiometers were installed on the top and bottom of the beam, just outside the damaged section, to measure lengthening/shortening along the outer tensile/compressive fibers of the beam, and three gauges were installed on the bottom of the beam to measure vertical deflection, with one underneath each of the loading points and center of beam.

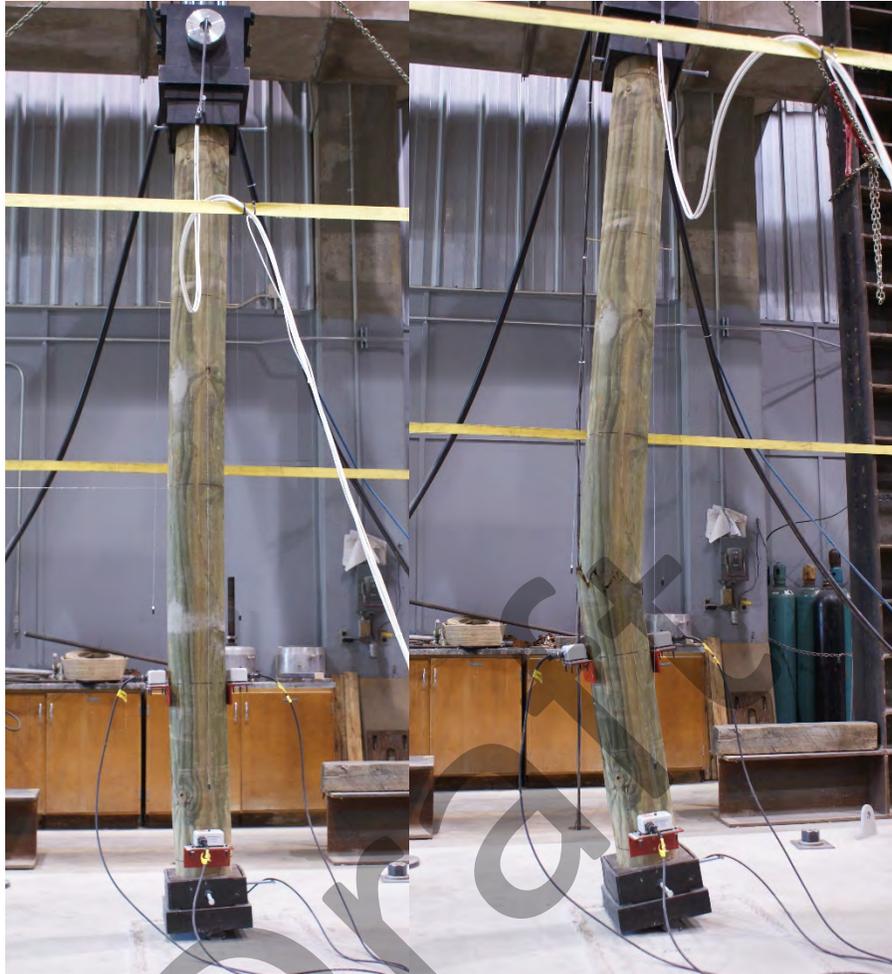
Figure 36. Typical timber control specimen; left: prior to testing, right: after failure

Specimens T-C-1, T-C-2, and T-C-3 were the control timber tests. A typical specimen before and after testing is shown in Figure 36.

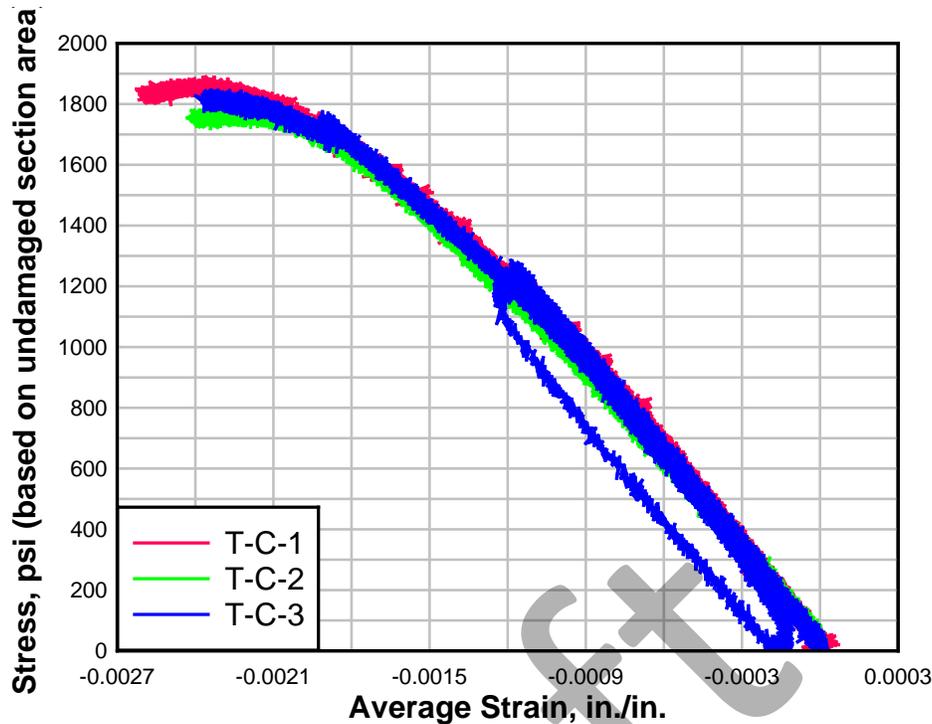
Figure 37. Stress versus strain data for timber control column tests

The stress vs strain comparisons for the tests are shown in Figure 37. The average stress in the columns was 1,800 psi. There was very little deviation in maximum stress (plus/minus 50 psi) for all the tests. The second loading line on T-C-3 is due to recording a cycle of loading and unloading prior to loading to failure.

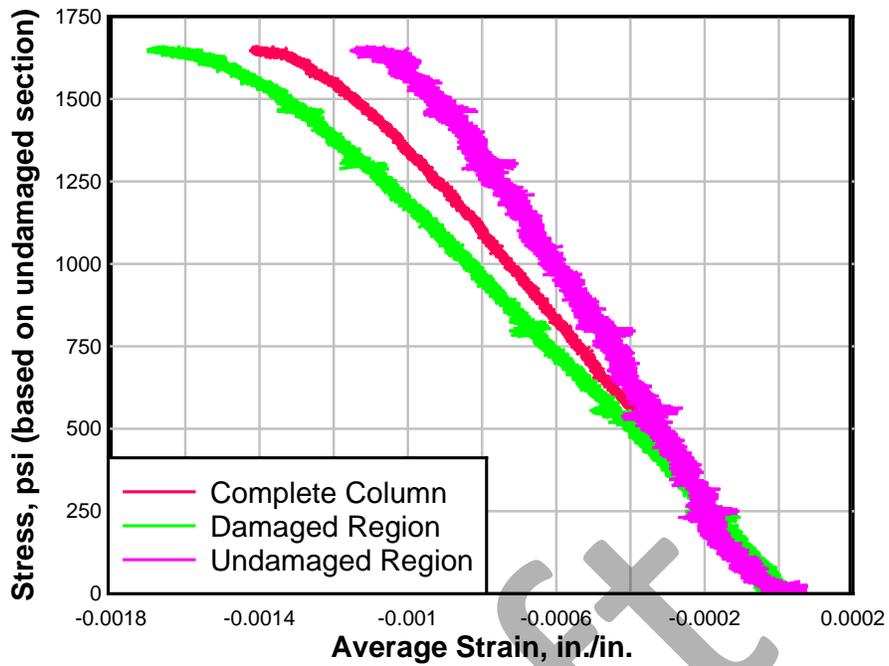
Figure 39. T-T-1 stress versus strain data

The stress vs strain comparisons for the tests are shown in Figure 39 (T-T-1), Figure 40 (T-T-2), Figure 41 (T-T-3), Figure 42 (T-T-4), and Figure 43 (T-T-1 Offset). Generally, the undamaged region was stiffer than the damaged region, as would be expected. The range of maximum stress in the timber pile was from 750 psi to 1650 psi. This large range is expected due to the organic nature of the timber resulting in naturally-occurring variability. The average stress, based on undamaged cross-section, was 1150 psi, an approximately 35% reduction in strength from the control tests, but nearly the same value as the design maximum capacity. Note that the data shows positive strain in tests T-T-3, T-T-4, and T-T-5. Theoretically, this is not possible. The positive strain is likely due to the alignment of the string potentiometers and the calculations used to determine the strain in the undamaged region. It is likely that when the column begins to fail and crack, the displacements measured across the damaged region are larger than the displacements along the length of the column, as they have to travel “around” the crack.

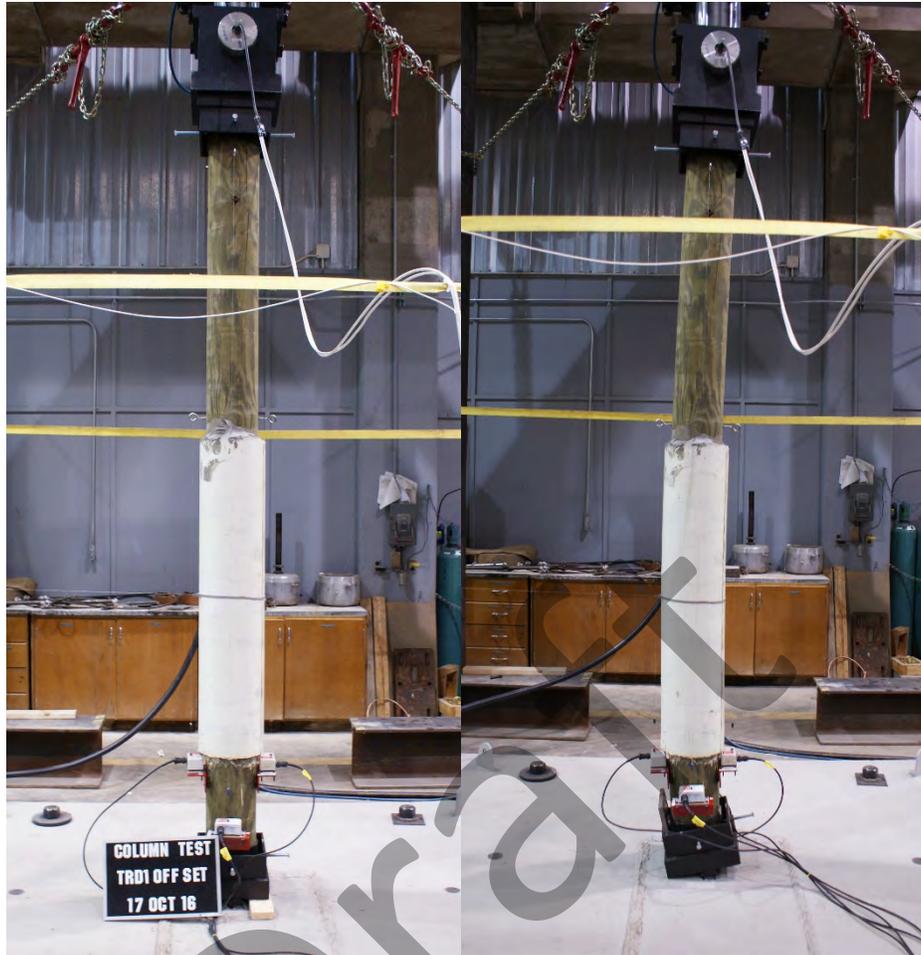
Figure 44. Typical retrofitted, dry timber specimen; left: before testing, right: after failure

Specimens T-RD-1 and T-RD-1 (Offset) were the retrofitted dry timber tests. A typical specimen before and after testing is shown in Figure 44.

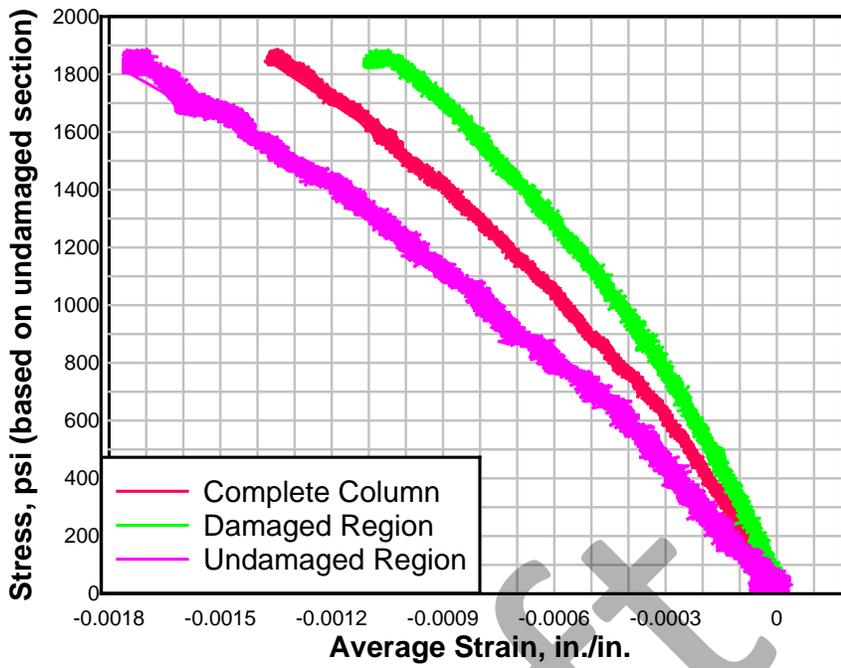
Figure 48. T-RW-1 stress vs strain data

The stress vs strain comparisons for the timber, wet-retrofitted tests are shown in Figure 48 and Figure 49. The average stress, based on undamaged cross-section, was 1,800 psi, an approximately 45% increase in strength compared to the design strength, as well as nearly the same strength compared to the average control strength.
