*Port Improvement via Exigent Repair (PIER) Joint Capability Technology Demonstration*

## **Pile Wrapping for Expedient Port Repair**

PIER Spiral 1

August 2018

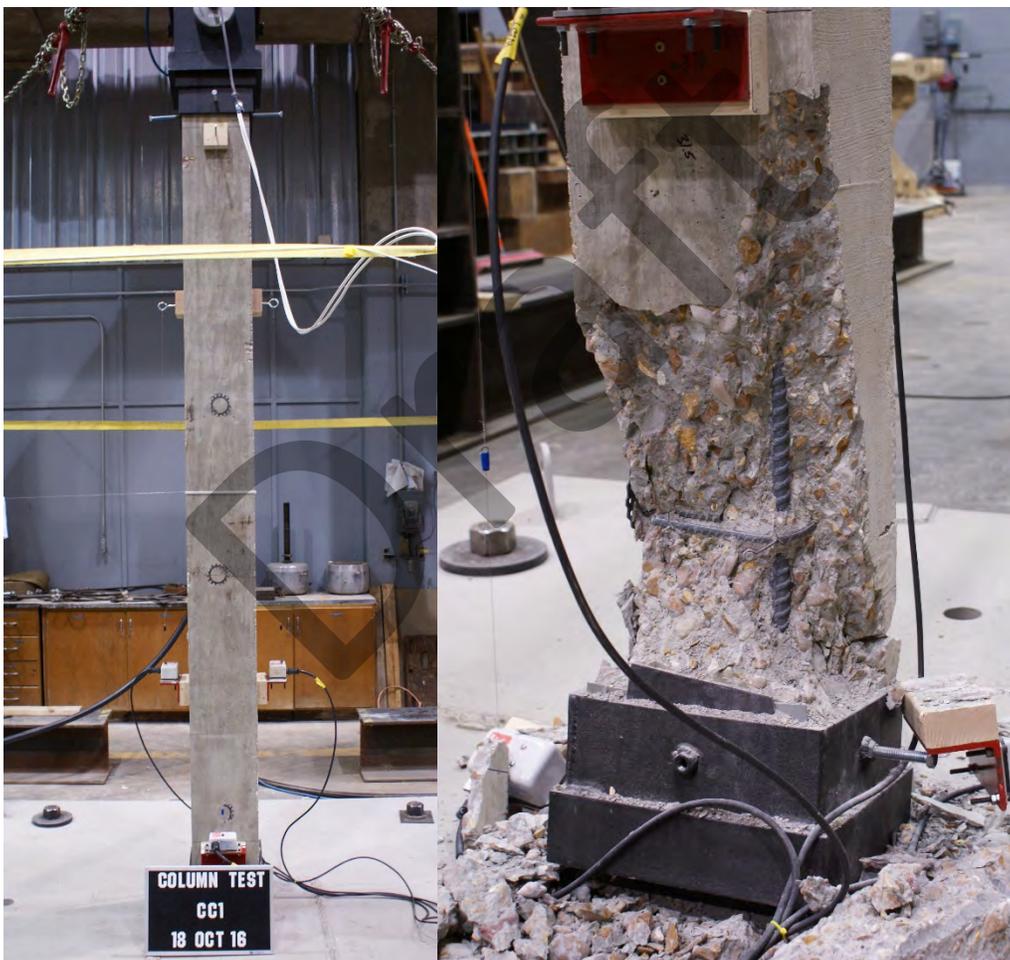
Figure 50. C-C-1; left: prior to testing, right: end crushing of column after load testing

There were two concrete column tests performed. The tests consisted of one with a concrete control column and one with a concrete dry-retrofitted column. The axial stress at failure of both tests was around 2500 psi, well below the expected failure stress of over 5000 psi. This was due to the end crushing and/or rebar pullout in the end region. The remaining scheduled concrete columns were tested using a 4-point beam bending test. The photos of the tests and test data are shown in Figure 50 and Figure 51 for test C-C-1 and Figure 52 and Figure 53 for test C-RD-1. Note that the data shows positive strain in test C-C-1. Theoretically, this is not possible. As was the case for the timber columns (Section 5.4.1.1), this result is an artifact of testing method at failure conditions.

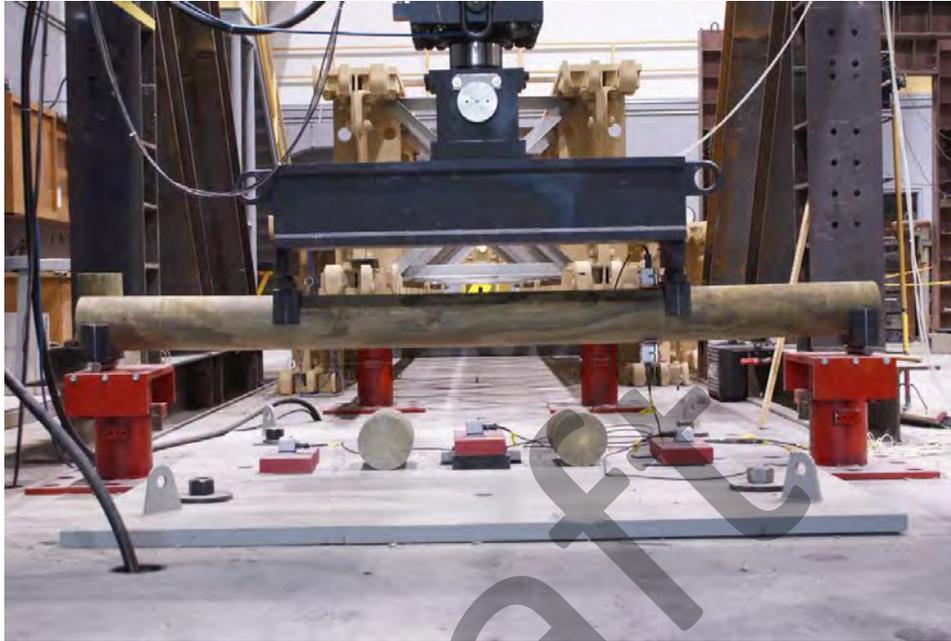
Figure 54. Typical timber control specimen prior to flexural testing

Specimens T-C-4, T-C-5, and T-C-6 were the control timber specimens for the 4-point bending tests. The typical specimen before and after testing is shown in Figure 54 and Figure 55.

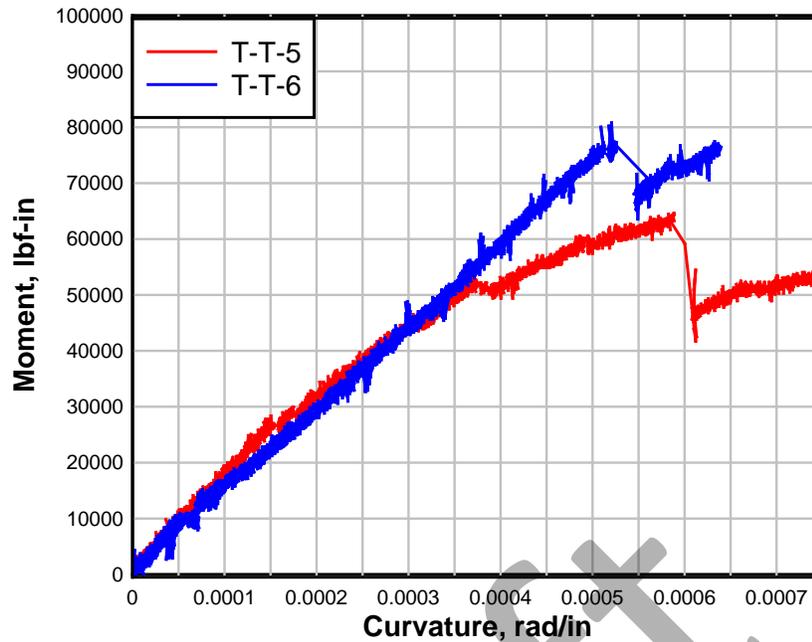
Figure 59. Tapered timber specimens moment versus curvature data

The moment versus curvature comparisons for the tapered timber tests are shown in Figure 59. The average moment capacity for the tapered timber beams was 72,500 lbf-in, an approximately 63% decrease in capacity compared to the design strength, as well as an approximately 72% decrease in capacity compared to the control beams.

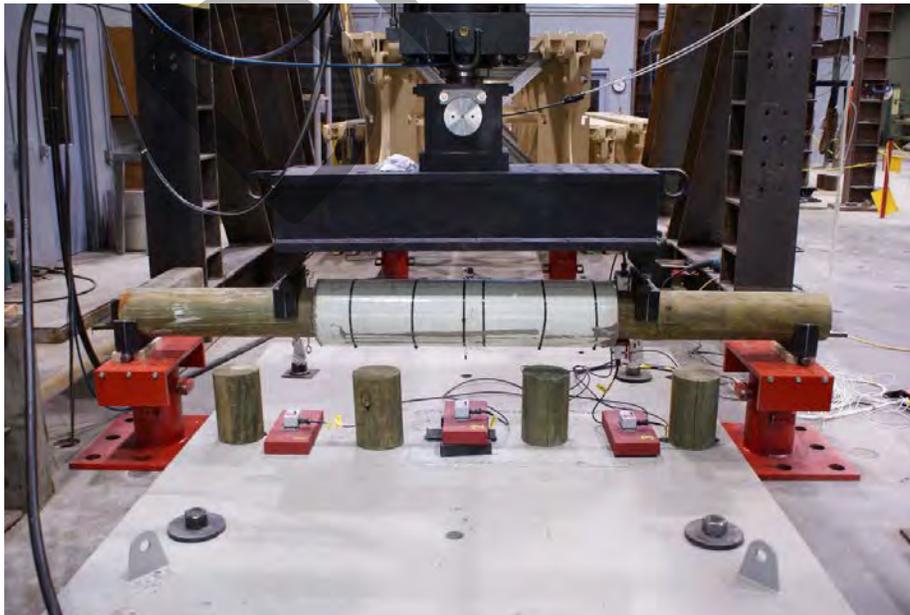
Figure 60. T-RD-2 timber specimen prior to flexural testing

Specimen T-RD-2 was the damaged and dry-retrofitted timber specimen for the 4-point flexural bending tests. The typical specimen before and after testing is shown in Figure 60 and Figure 61.

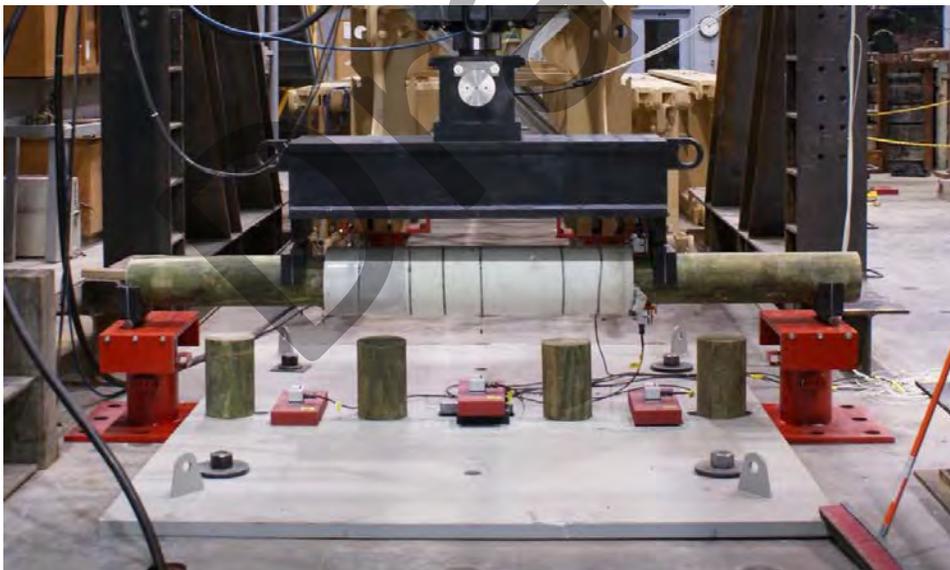
Figure 63. Typical tapered and wet-retrofitted specimen prior to flexural testing

Specimens T-RW-3 and T-RW-4 were the damaged and wet-retrofitted timber specimens used for the 4-point bending tests. The typical specimen before testing is shown in Figure 63, and the after test photos of T-RW-3 and T-RW-4 are shown in Figure 64 and Figure 65, respectively.

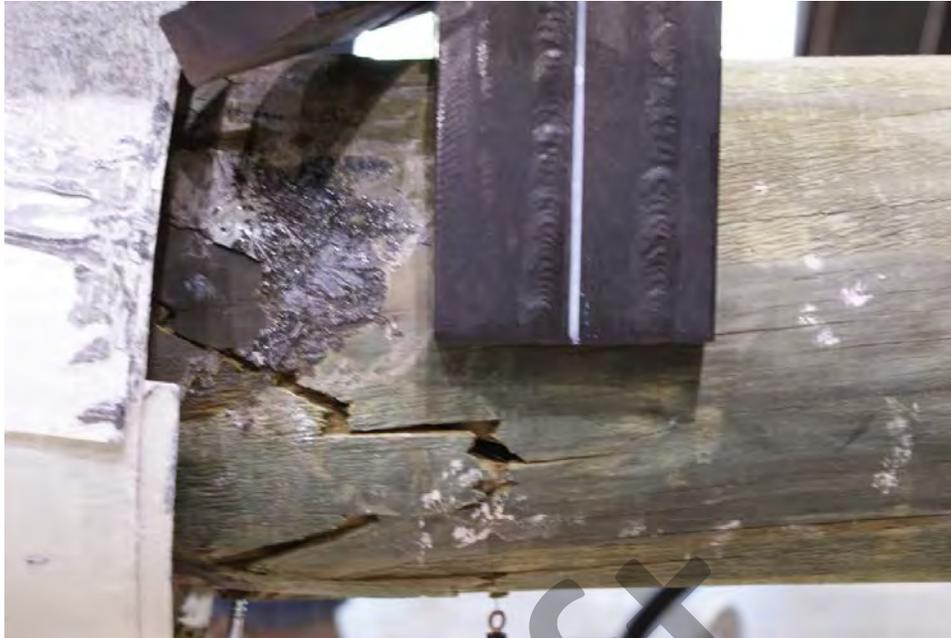
Figure 64. Point of failure for T-RW-3

repair and the loading location, whereas the failure in T-RW-4 occurred in the repaired region, which led to the much more ductile failure of the beam.

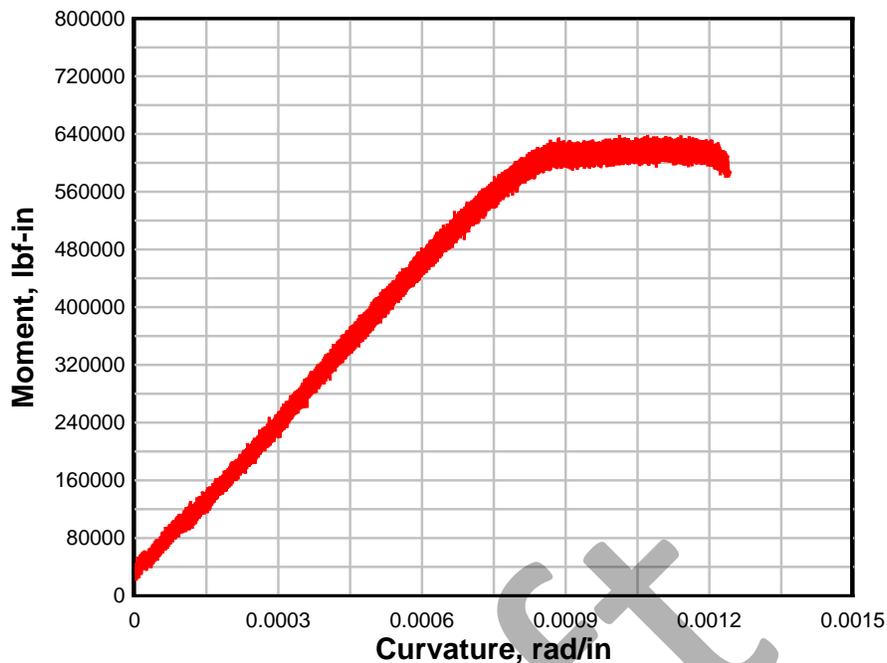
Figure 67. C-C-2 moment versus curvature data

Specimen C-C-2 was the control, undamaged concrete pile specimen for the 4-point bending tests. The moment versus curvature data for the control test are shown in Figure 67. The moment capacity for the tested beam was 615,000 lbf-in, an approximately 34% increase in strength compared to the factored design capacity.

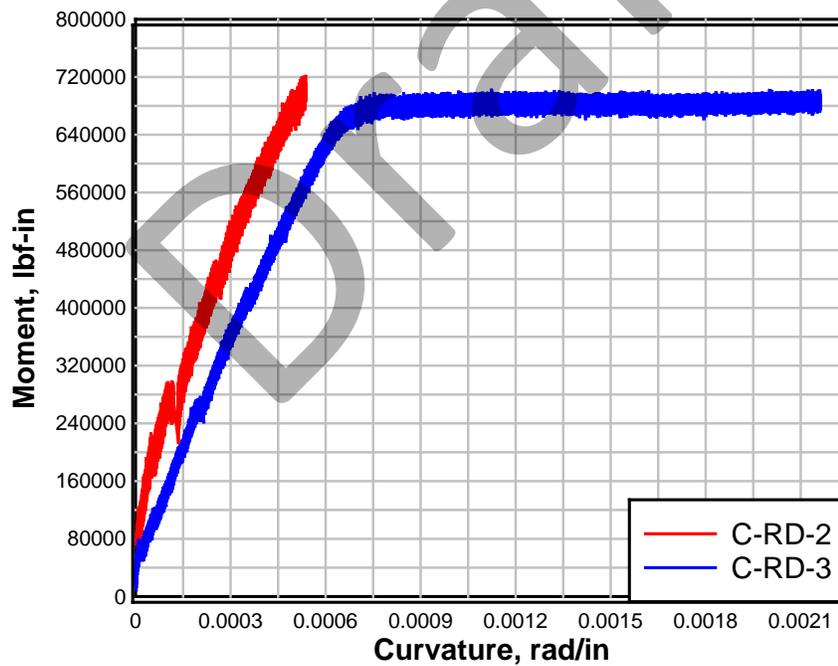
Figure 71. Damaged and dry-retrofitted concrete specimen moment versus curvature data

The moment versus curvature data for C-RD-2 and C-RD-3 is shown in Figure 71. The moment versus center deflection data for all the damaged and dry-retrofitted concrete beam tests is shown in Figure 72. The average moment capacity for the beams was 740,000 lbf-in, an approximately 67% increase in capacity compared to the factored ACI 318-14 design moment capacity, as well as an approximately 20% increase in capacity compared to the control beam capacity. In test C-RD-2, one end of the beam sheared off and fell off the support, as shown in Figure 73. The repair and loading sections of the beam were checked for failures, and none were observed. A second test on the same beam (C-RD-2 B) with supports moved 6 in. in on each end was performed. No string potentiometers were installed for test C-RD-2 B; therefore, there is no data for moment versus curvature for this test. For comparison, a data set of applied moment versus center deflection from all three tests is presented.

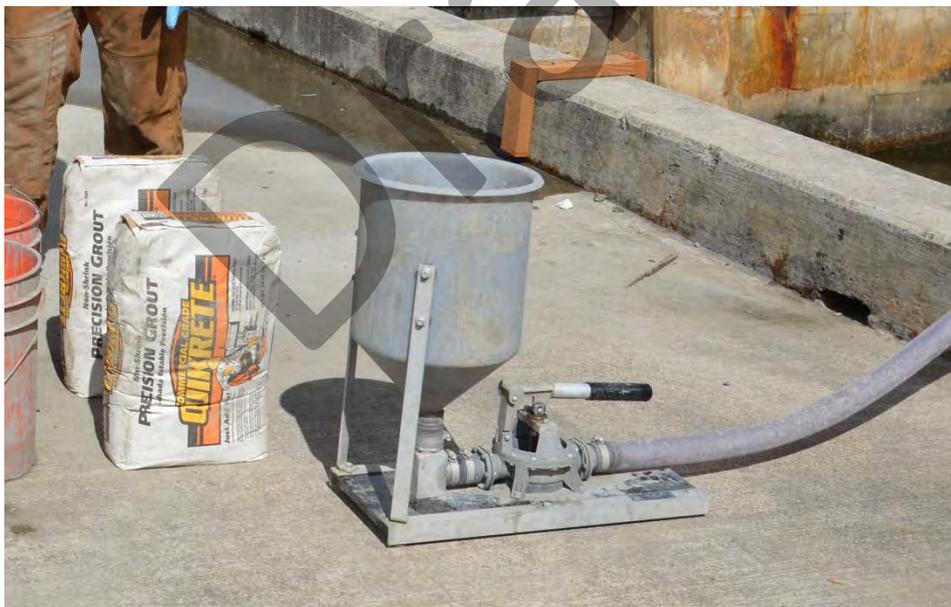
Figure 82. Manual grout pump used at LOUA 1

The PileMedic® kits as described in Section 4.4 were employed for the LOUA. Two types of grout pumps were employed. The first, an AIRPLACO HGA-530 pump, was powered by compressed air (Figure 81). The portable HGA-530 has a 30-gal mixer, 8-gal hopper, and 5-HP compressed air motor powered by an external air compressor. The pump features an air cylinder system, ball-check manifold, pressure gauge, and wide hopper for easy loading. The second pump type was a manually-operated AIRPLACO Handy-Grout HG-9 Pump shown in Figure 82. The HG-9 has a 5-gal hopper and 15 cu ft/hr production capacity. The pump has a self-priming manifold, an in-line pressure gauge, and does not require a power source.

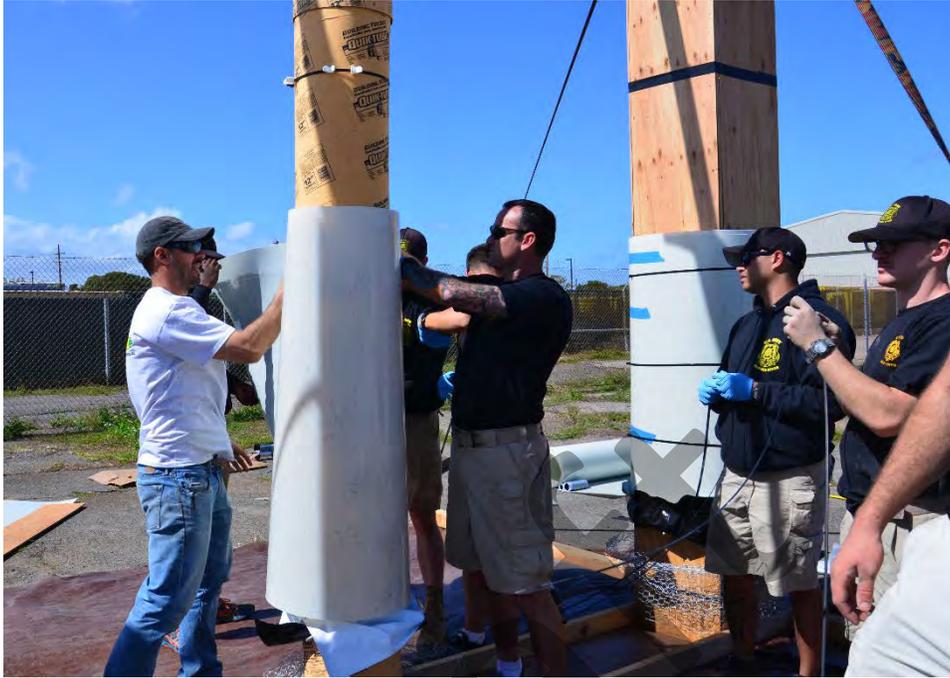
Figure 83. Dry-side training

On the first day of training, a classroom orientation session was conducted to familiarize the warfighters with purpose and objectives of the LOUA and to introduce the pile jacketing TTPs developed by the technical management team. Immediately after the classroom session, instructors from the technical management team demonstrated the TTPs on a dry-side training mockup constructed by the ERDC team for that purpose. The warfighters

were subsequently allowed to practice the TTPs on the dry training site with instructor guidance (Figure 83).

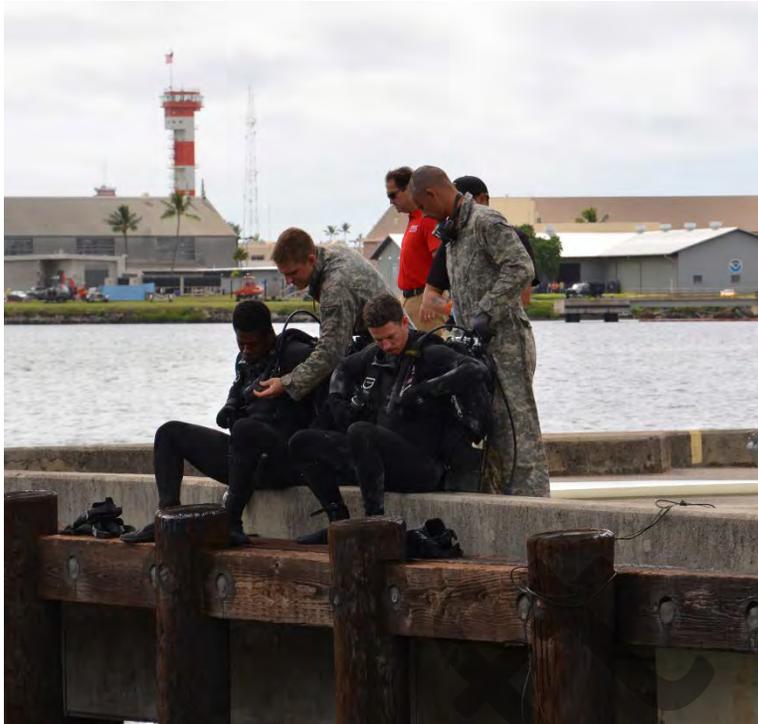
Figure 84. Divers prepare to enter the water

On the second day of training, the warfighters trained in the water and applied the TTPs to piles from the Victor 3 wharf. A third and final day of wet training was conducted in the wet (Figure 84 through Figure 86) in which each of the Army and Navy dive teams completed repairs on two additional piles on Victor 3.

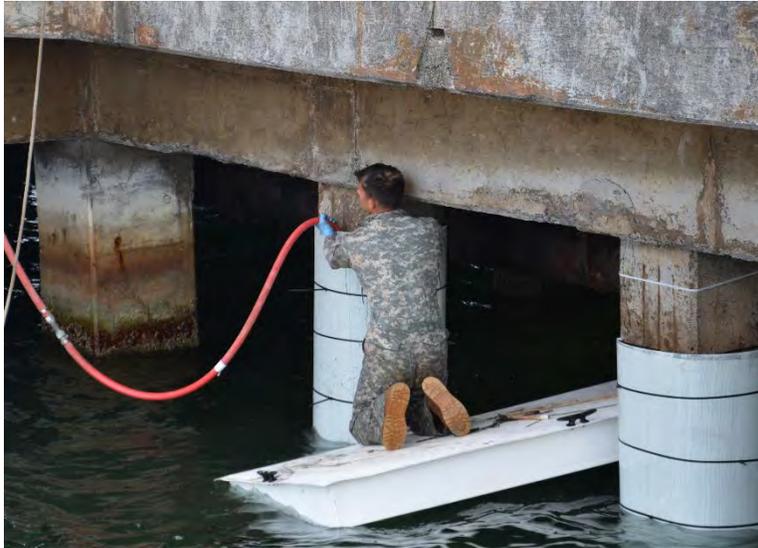
Figure 86. Grout placement

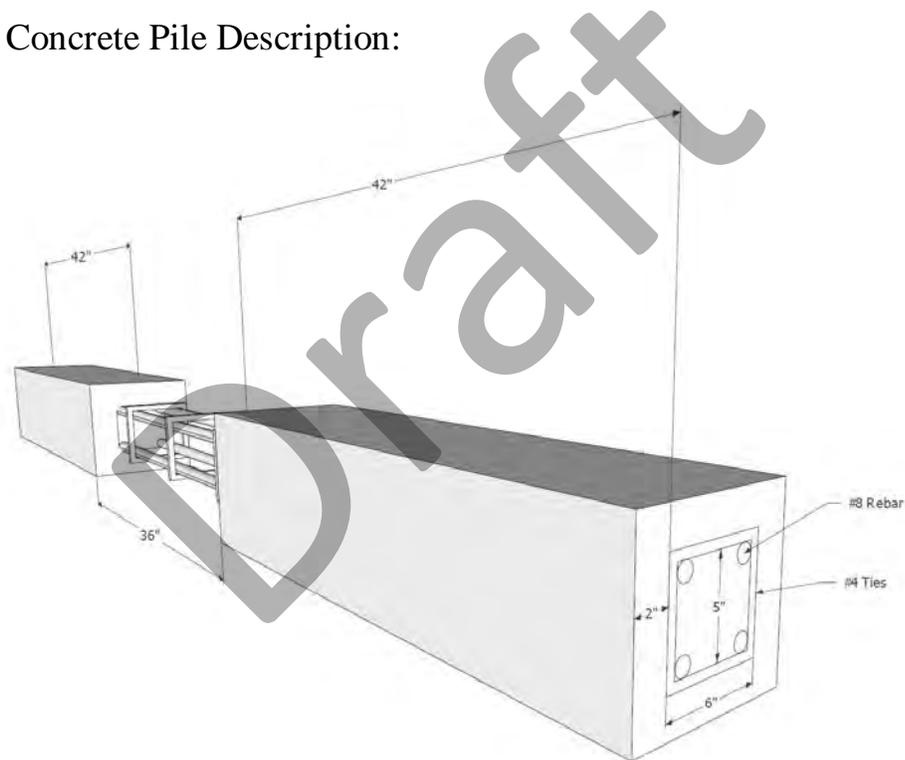
Concrete Pile Description:

Pile Cross-Section: 10 in. by 10 in.

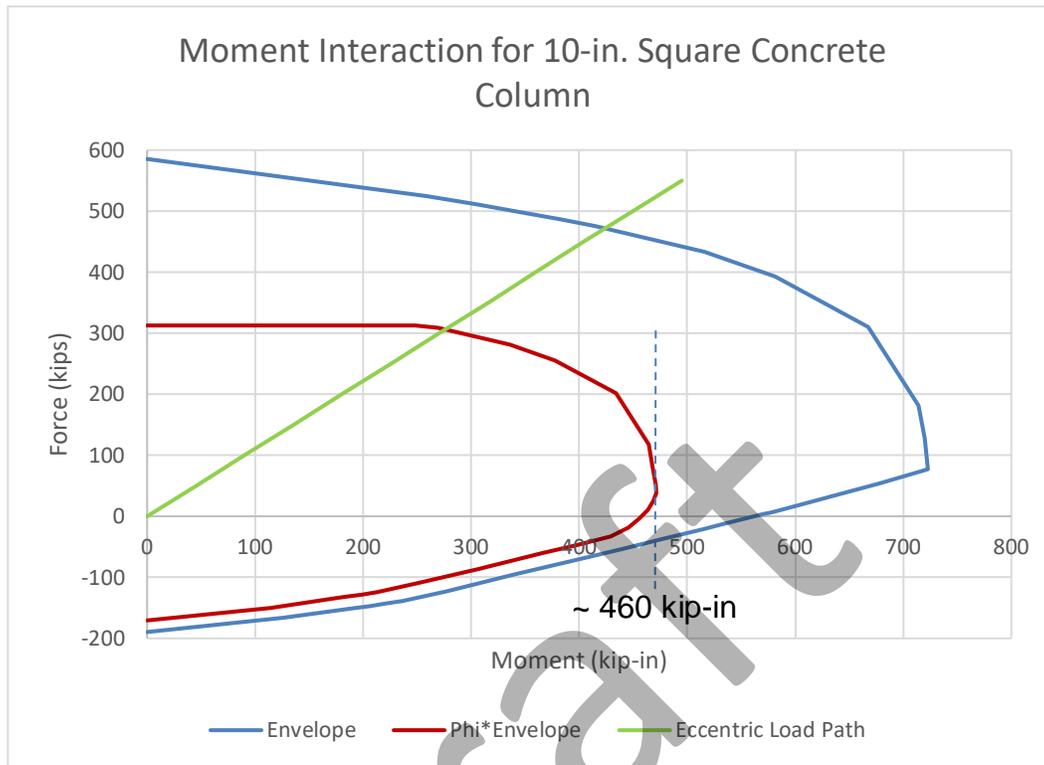
The interaction diagram envelope, shown above, represents the locus of all combinations of axial load and bending moment that cause failure in the 10-in.-square reinforced pile. The curve labeled “Phi\*Envelope” incorporates a capacity reduction factor,  $\Phi$ , which accounts for variability in materials and construction practices consistent with the ACI318-14 code.

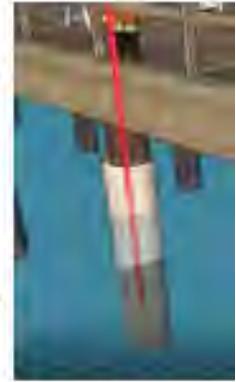
Figure 15

For tremie grouting, place the end of the grout hose on the inside of the jacket, making sure it runs all the way to the bottom. Pump the grout until the inside level of grout is approximately six inches above the hose nozzle (*Figure 15*). Continue pumping while lifting the nozzle of the hose at the same rate, until the entire annular space between the pile and the jacket is filled. The water inside the jacket will turn grey during this process, so make sure you feel for sand when the grout level reaches the top of the annular space to make sure it is completely filled with grout.

Mix a Non-Shrink grout and pour it into the space between the pile and the PileMedic® jacket. Be sure to mix the grout according to manufacturer's recommendations. For applications below water level, you will need to use the **tremie grout placement method**.
