## Strengthening of Timber Utility Poles with Pilemedic™

*In collaboration with Tucson Electric Power Company, we are testing a patented technology for insitu repair & strengthening of timber utility poles.*

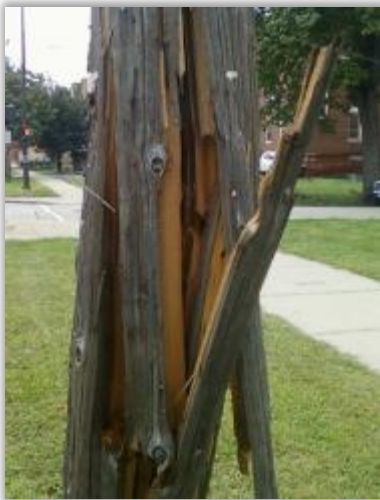
Timber utility poles weaken with age and often break and collapse during storms.

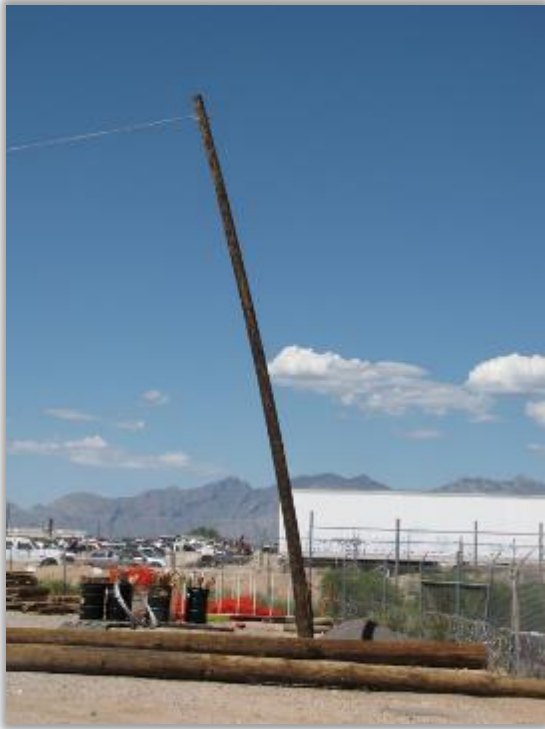
A Class III 45ft- wood distribution pole was tested in the field.

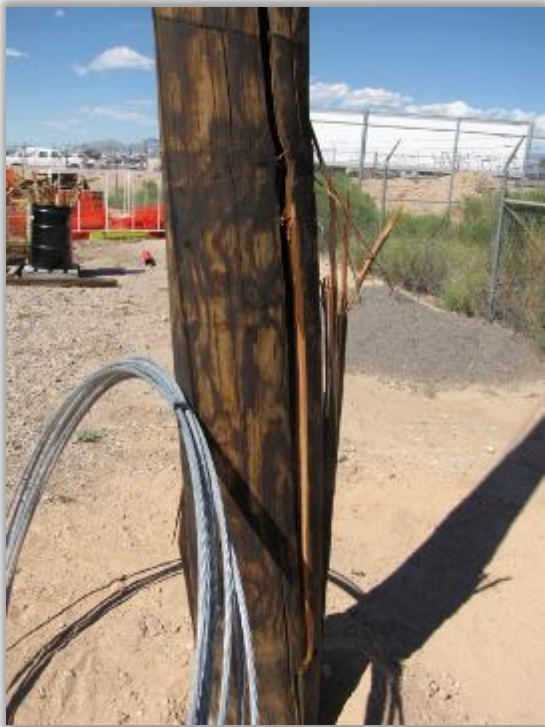
The pole broke at approximately 5 feet above ground at a load of **1,070 pounds.**

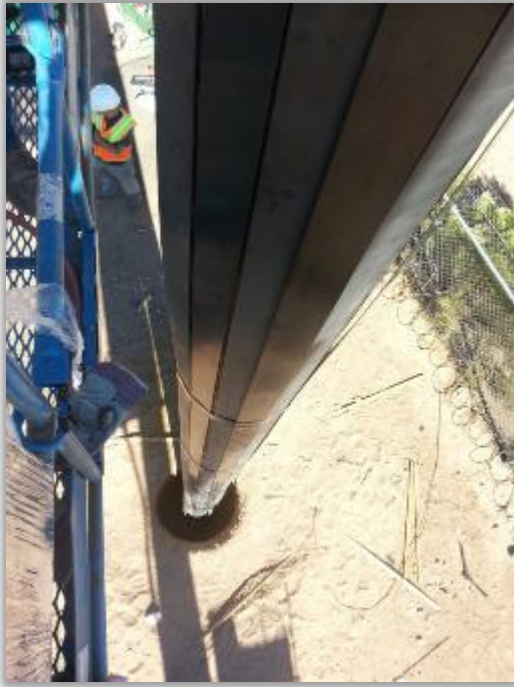
1. Provide longitudinal carbon strips along the height of the pole

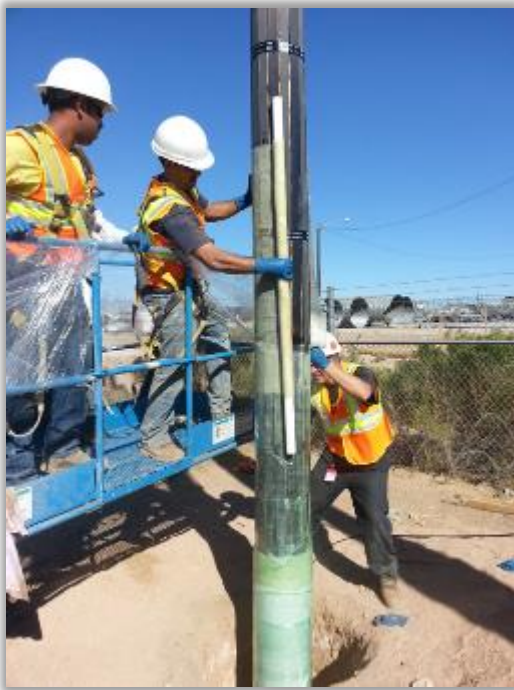
2. Wrap the pole with PileMedic™ laminates or QuakeWrap® FRP fabric

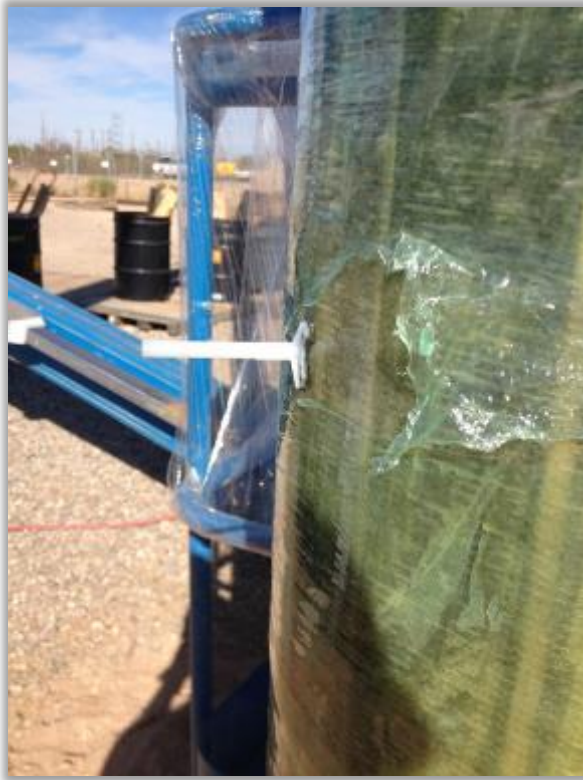
3. Inject our low viscosity resin to fill all the voids and cracks in the pole

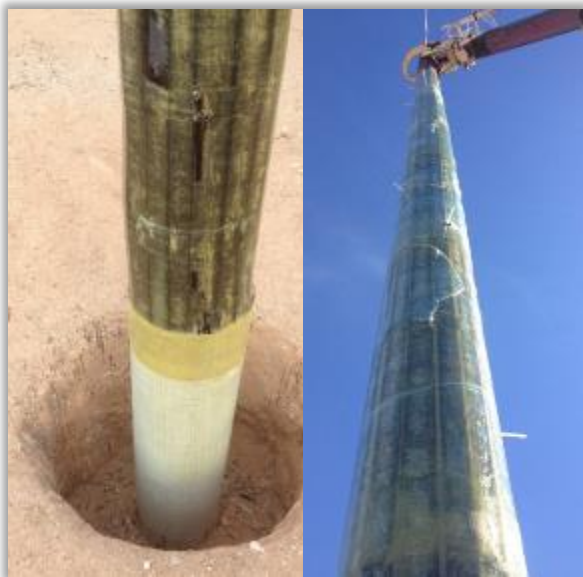
4. The repair covered the elevations from 2'-9" below ground to 25'-9" above ground. This procedure allows the pole to remain in service during the repair.

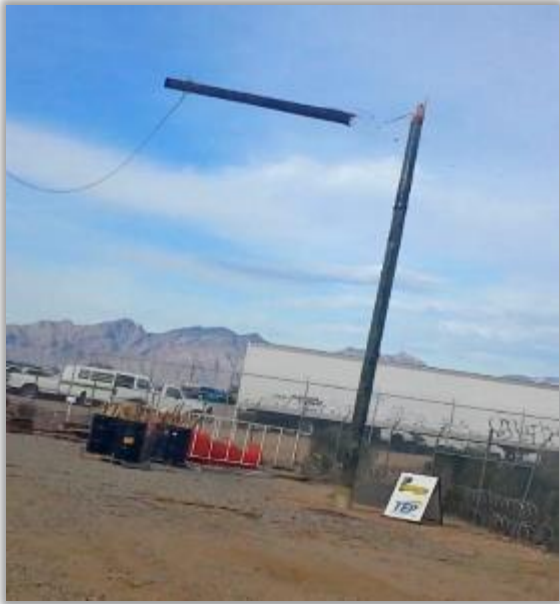
The strengthened pole was tested and it broke at a load of **2,400 pounds**, exactly at the point where the repair had stopped.

This load was 2 1/4 times the original failure load.

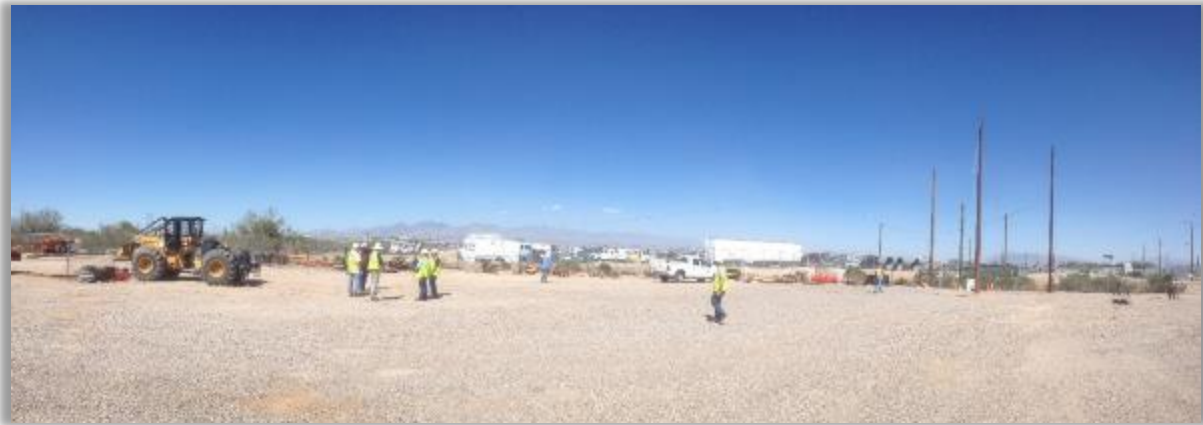
The broken pole was re-tested on March 12, 2014 by applying the load at 24-ft above ground which was 1'-9" below the point where the pole had broken before.

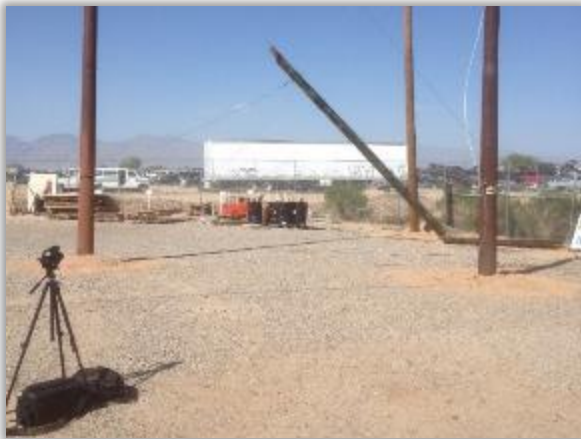
This time, the pole failed at a load of **3,200 pounds** and at a point 2-feet 9-inches below ground where the PileMedic™ jacket was terminated.

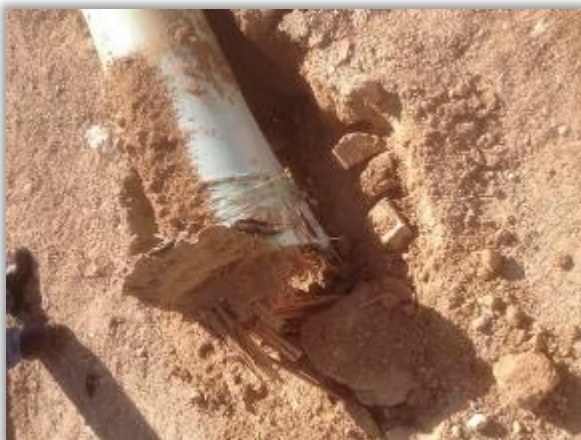
The end of the broken pole is shown here.

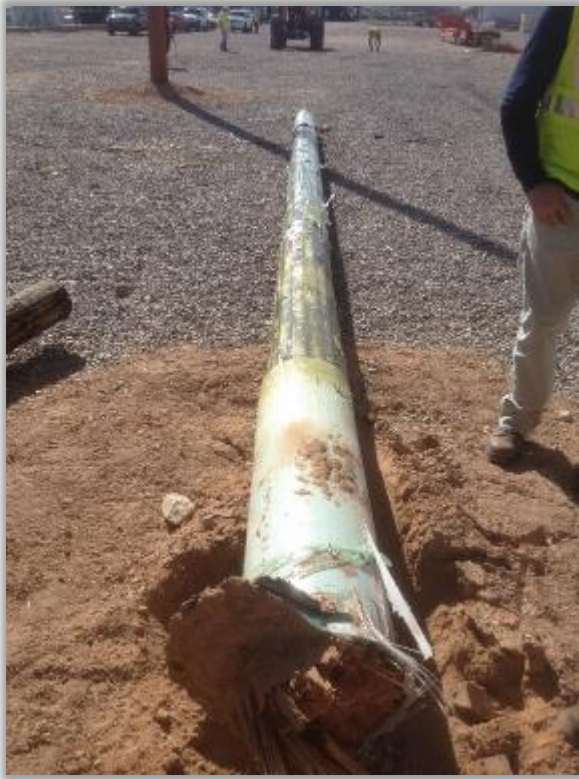
The 28.5 feet long portion of the pole that was wrapped with PileMedic™ remains undamaged and is shown in this photograph. We plan to test this piece as a simply-supported beam subjected to a concentrated load at midspan to determine its flexural capacity.
