A Novel Solution for Restoration of Deteriorated Piles

Missouri DOT pioneers the implementation of the next generation of FRP products.

By Mo Ehsani, and Mark Croarkin

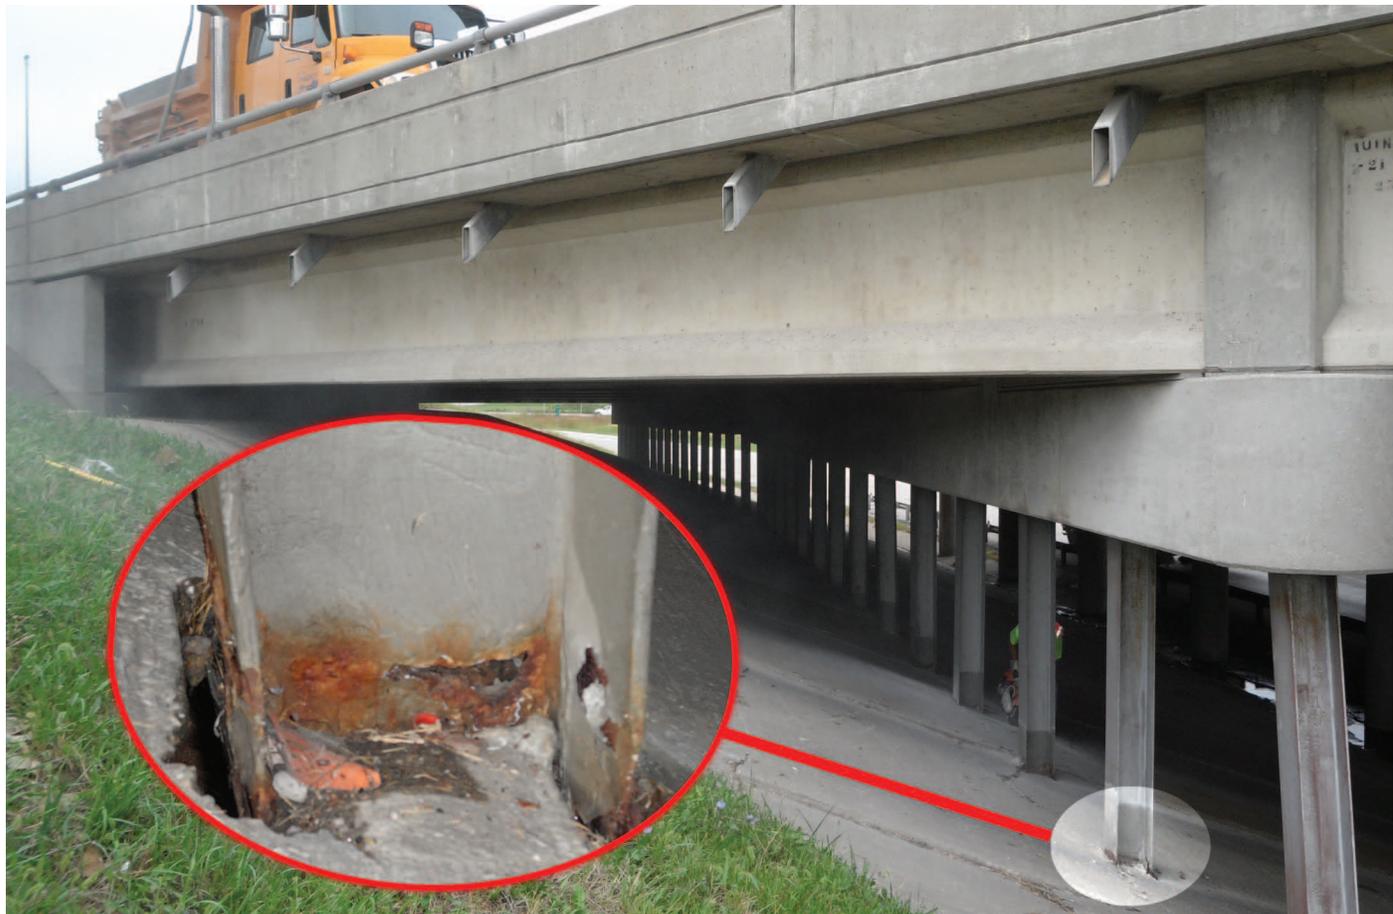
One of the 49 corrosion damaged piles in I-70/I-270 Interchange that were repaired with this technique.

A total of 49 piles near the edges of four bridges in St. Louis at the I-70 and I-270 interchange were severely corroded, with the section loss of the piling to be repaired varying from 20 to 80 percent. The four structures are five span bridges that carry I-270 traffic and two of the intermediate bents are constructed of exposed H piling. The H piling bents allow for expansion between the cap and the deck while the other two intermediate bents on these bridges are constructed of concrete columns that are integral with the deck. The H piling bents had 26 to 32 10 x 42 steel piles that are located behind barrier wall on a 3:1 concrete slope with limited overhead space, so all work had to be performed by hand. The pile lengths in place varied between 30 and 46 ft. Damage, caused by polluted rain run-off, was concentrated over a one-ft high section at the base of the piles.

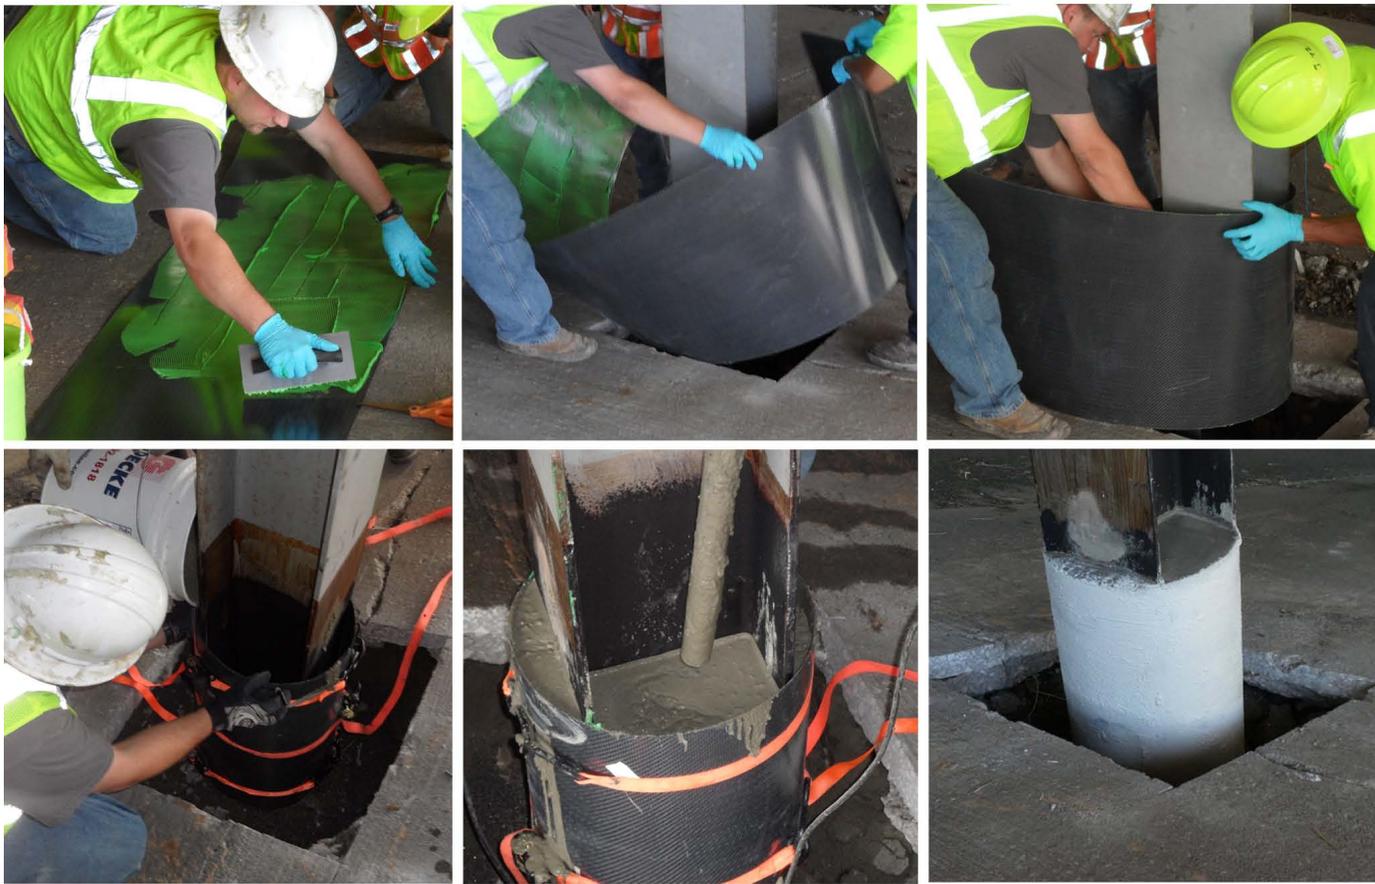
PileMedic installation steps, from upper left: application of epoxy to laminate, creating the shell around the pile, positioning the shell, filling with grout and vibrating, finished painted shell.

to about a two-ft by five-ft section of the laminate. The mixed epoxy has a paste-like consistency and is applied with a trowel to a thickness of 30 to 40 mil. The laminate is then wrapped loosely around the pile to create a two-ply shell. The nine-ft length of the laminate allows creation of a two-ply 16-in. diameter shell with eight in. of overlap beyond the starting point.

At this stage, before the epoxy cures, ratchet straps must be used to hold the shell in a cylindrical shape and to maintain the diameter of the shell. The shell can be moved up or down to be centered about the damaged portion of the pile. In this project the soil below the slab formed the seal at the bottom of the shell.

The annular space between the shell and the pile was filled with a high-strength non-shrink cementitious grout. The grout was mixed in a five-gal pail with a hand-held jiffy mixer and required no special heavy equipment. Consolidation of the grout was completed with a small vibrator and the top of the grout was finished with a trowel. Before the grout sets, the hydrostatic pressure from the grout pushes the inner layer of the shell outward against the outer layer and forces the two plies of the laminate to be tightly pressed against each other. After several hours, the ratchet straps are removed and if desired the exterior of the shell can be painted. **The entire repair operation excluding the painting was completed in about two hours.**
