A JACKET FOR ALL OCCASIONS

Newly developed system offers unique solution for quick retrofit of deteriorated columns

Mo Ehsani, PhD, PE, SE, Majid Farahani, PE, and Eric Raatz, PE

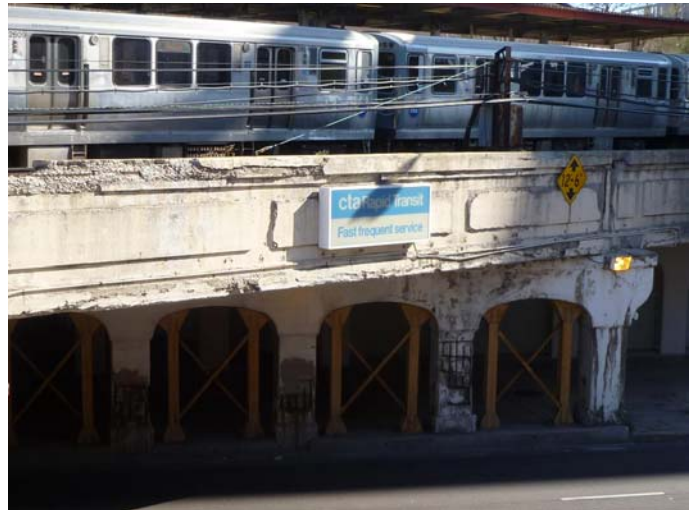
Fig. 1. Corrosion-damaged concrete piles in Chicago being assisted with steel trusses

Loss of load-carrying capacity in columns and piles in bridges is a major concern worldwide. In coastal regions, the dry-wet cycles lead to corrosion of reinforcing steel in concrete piles and bridge piers. In cold climates, the use of deicing chemicals results in corrosion of steel. Figure 1 shows one of many such cases in Chicago where reinforced concrete columns are severely weakened by corrosion and steel trusses have been added to carry the load. In fact, the problem is not limited to only bridges. In industrial facilities such as mines, aggressive chemicals cause premature corrosion of steel columns.

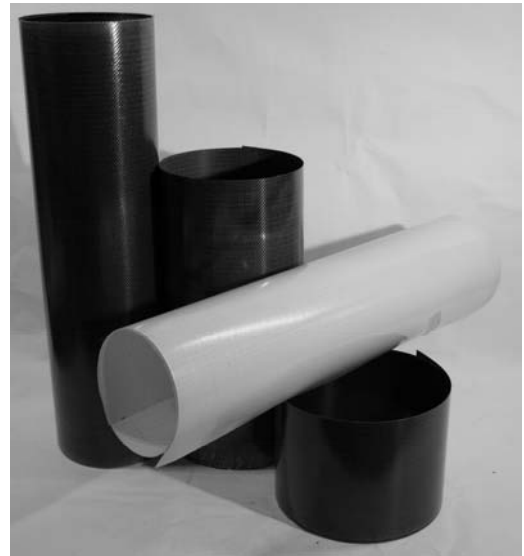
Fig. 2. Carbon and Glass PileMedic™ Laminates

To overcome the above shortcomings, a new form of FRP products called, PileMedic has been developed (Ehsani, 2010). During the manufacturing process, one or more layers of carbon or glass fabric are saturated with resin and subjected to heat and pressure to construct pre-cured laminate sheets as thin as 0.01 inches. The precision required to produce such a thin laminate is not a trivial matter but one that was finally achieved after an extended R&D process. The laminates are 4 to 5 ft wide and are supplied in rolls as long as 300 feet. The tensiles trength of these laminates ranges between 60,000 and 155,000 psi depending on the number of layers of fabrics and the orientation of the fibers.

Unlike the wet layup system, the laminates are stiff enough to stand on their own (Fig. 2). In the field, an appropriate length of the laminate is cut and wrapped around the deteriorated column to create a structural shell that is not bonded to the host column. A thin layer of epoxy is brushed over the overlapping portion of the laminate to create a two- or three-ply shell in the field – similar to a sonotube. The annular space between the shell and the host column is filled with resin or grout to make the host column and the shell work compositely.

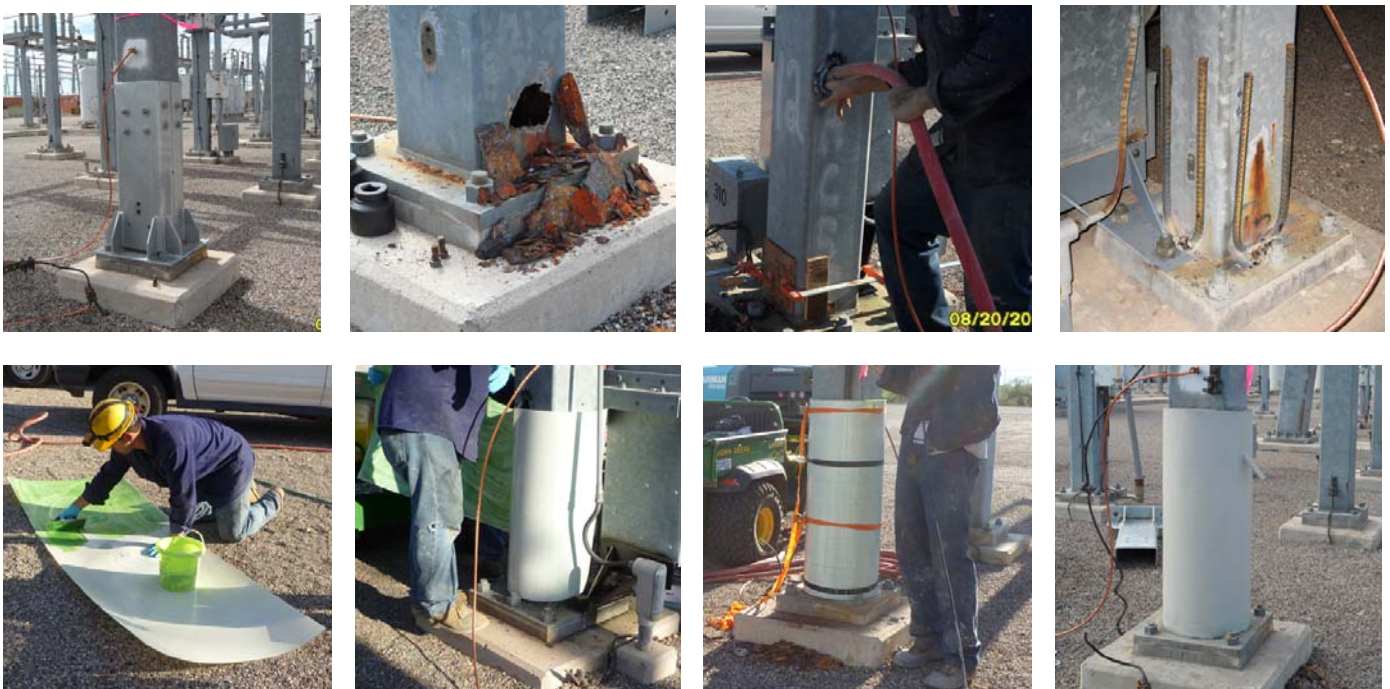
Fig. 3. Repair of steel poles at TEP substations: original repair concept; corroded pole; filling the pole with grout; reinforcing steel welded to base plate; applying epoxy to the laminate, wrapping it around the pole and holding it with straps while grout is placed; finished and painted jacket

Earlier attempts to remedy the problem called for steel plates that were externally bolted to the lower 3-ft of the structures (Fig. 3). However, these repairs would hide the corroded portion of the structures from view and inspection, while the corrosion process continued inside the poles. Additionally, in utilizing the FRP system, no outage was necessary to repair the structures thus resulting in continuing system reliability. Rather than replace the structures and take a costly outage, the structures could be repaired in place with proper safety personal overseeing the repairs.

The repair of the poles with PileMedic™ was aimed at strengthening the lower 3-ft of the structures. An access port about 3 inches in diameter was cut at an elevation of 33 inches from the base. All loose rust was removed from inside the structure and the openings were temporarily sealed with plywood and clamps. A non-shrink high-strength grout was mixed and pumped into the structure from the access port.

Four No. 5 U-shaped reinforcing bars were welded to the base plate; these bars were primarily for enhanced flexural capacity of the structure.

Due to its dielectric properties, a glass laminate with tensile strength of 62000 psi and thickness of 0.026 inch was used. A 3-ft wide x 8.5-ft long piece of laminate was used for each structure. A special two-component epoxy was mixed in the field and applied to an approximately 5 ft long section of the laminate. The mixed epoxy has a paste-like consistency and is applied with a trowel to a thickness of 30-40 mil. The laminate is then wrapped loosely around the structure to create a two-ply shell. The 8.5-ft length of the laminate allows creation of a two-ply 15-inch diameter shell with 8 inches of overlap beyond the starting point.

At this stage, before the epoxy cures, ratchet straps must be used to hold the shell in the desired shape. The bottom edge of the jacket was sealed with tape atop the base plate.

Consolidation of the grout was completed with a small vibrator and the top of the grout was finished with a trowel. Before the grout sets, the hydrostatic pressure from the grout pushes the inner layer of the jacket outward against the outer layer and forces the two plies of the PileMedic™ laminate to be tightly pressed against each other.

A 1-inch diameter PVC pipe was installed to make sure no rain water will accumulate inside the structure. After several hours, the ratchet straps were removed and the exterior of the shell was painted. All of these repairs were performed while the substation remained fully operational.

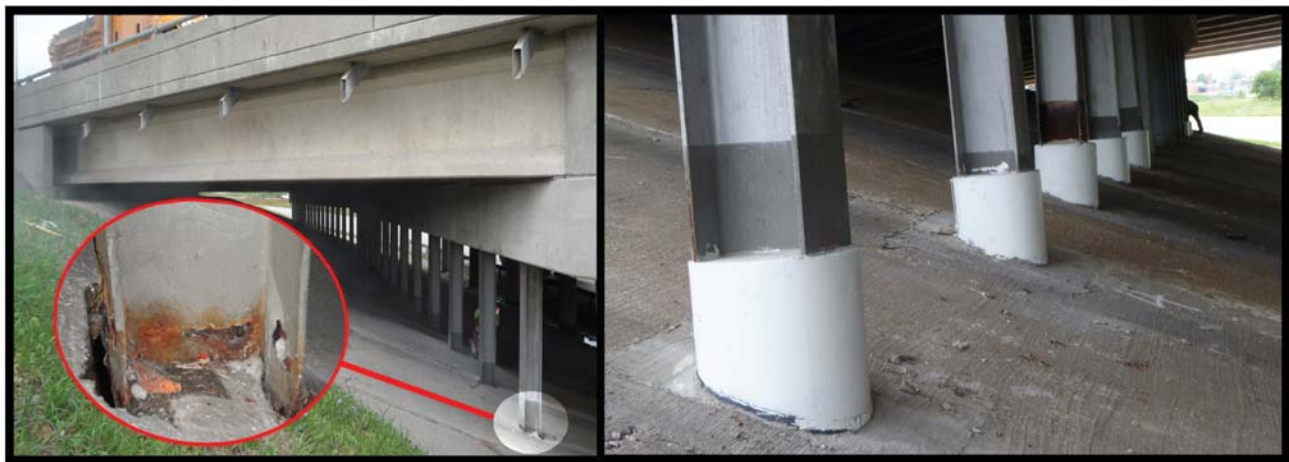
Fig. 4. The I-70/I-270 interchange in St. Louis, MO where 49 corroded bridge piling were recently repaired with PileMedic™ jackets.

A similar approach was used to repair 49 steel H piling in four bridges at the intersection of I-70 and I-270 in St. Louis, MO (Ehsani and Croarkin, 2011). Routine inspections had lowered the substructure condition rating of this bridge to poor (National Bridge Inspection rating of 4 on a 9 point scale). This meant these bridges were considered Structurally Deficient due to the number of piling with significant section loss (Fig. 4). The repairs were completed in just two weeks, improving all 4 bridges to a Satisfactory Condition Rating (NBI rating of 6). All of this was affordable enough to be funded with the
