An Economical Solution for Repair of Seawalls and Bulkheads

*Mo Ehsani, PhD, PE, SE, President, QuakeWrap Inc. and
Centennial Emeritus Professor of Civil Engineering, The U. of Arizona*

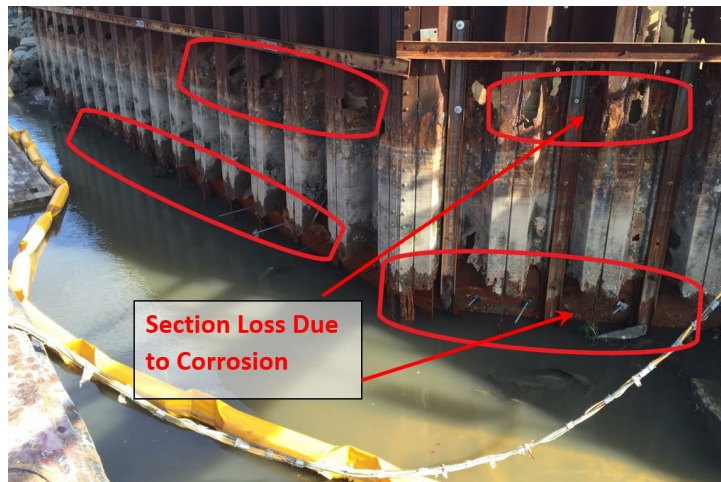
Fig. 1. Corroded seawall with section loss

Sheet piles and bulkheads are frequently used in waterfront construction to retain and prevent erosion of soil. In most cases, the dry/wet cycle near the splash zone, defined as the region between the low and high tide water levels, gets damaged with age. If the seawall is made of reinforced concrete, water penetrates through the cracks in concrete, causing corrosion of the reinforcing steel. Similarly, walls made with steel or timber get damaged and weakened with age. In extreme cases, the section losses are large enough to allow soil to wash out through cracks and holes in the wall (Fig. 1), that could cause settlement in the ground supported by the bulkhead. In most cases, the portion of the seawall that is embedded in soil remains relatively undamaged because the lack of oxygen at those depths cannot support the ongoing corrosion of the wall.

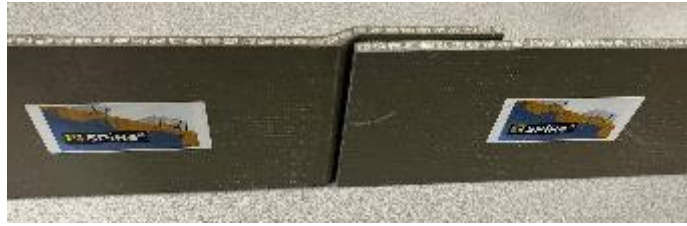
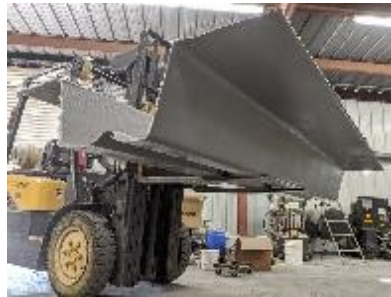
Fig. 2. Close-up view of SPIRe® panels and different custom-made shapes

follow the sandwich construction technique that is commonly used in aerospace and shipbuilding industries. A proprietary lightweight core around 0.2-0.3 in. thick is sandwiched between one or more layers of unidirectional or biaxial glass or carbon fabric. The core thickness and the type and strength of the fabric layers is a function of the project requirements and will be designed for each application. The overall thickness of the product is typically less than 0.5 in. (Fig. 2).

The panels are made using a resin infusion process. As shown in Fig. 2, these could be custom made to any shape to match the existing wall geometry. However, the most common are the flat panels that are 4 ft wide. They can be manufactured in any length and can also be cut to the desired length in the field. While the panels can be used for structural strengthening, the projects completed to date have been for providing a corrosion protective system for the walls only.

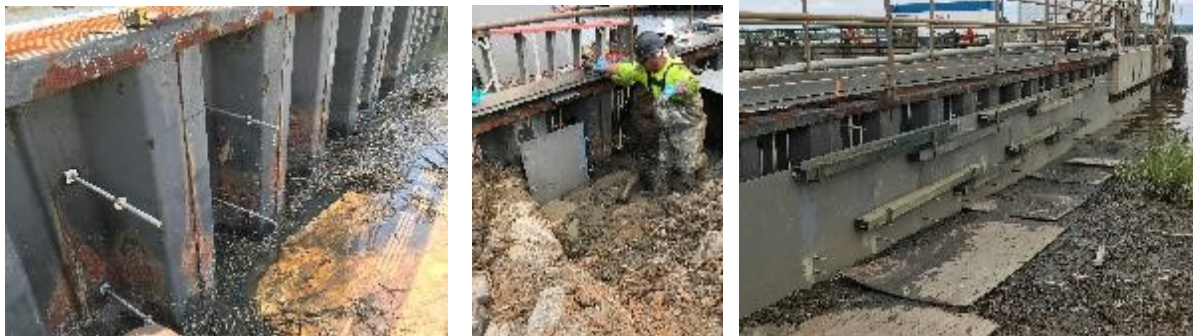
Fig. 3. Steps in repair of a corroded seawall including attachment of J-bolts, placement of GFRP rebar, and connecting the SPIRe® panels and walers prior to placement of grout

The construction steps are shown in Fig. 3. Holes are cut in the steel sheet pile and stainless-steel J-bolts are used as tie-down elements. The J-bolts are secured to the wall using a washer and a nut. When required, reinforcing bars can also be placed in the cavity of the wall. It is preferred to use glass FRP bars for such applications to eliminate any concern for future corrosion of these bars. The panels have a 4-in. wide depressed lip along one of the long edges (Fig. 2) that is used for connecting the panels together. A special underwater epoxy paste is applied to create a sealed overlapping region. The panels are also secured to the seawall along those overlapping edges with the J-bolts at predetermined locations. This creates an impervious stay-in-place form in front of the deteriorated seawall. If necessary, walers can also be

temporarily placed horizontally to prevent excessive deflection of the panels during the placement of the grout.

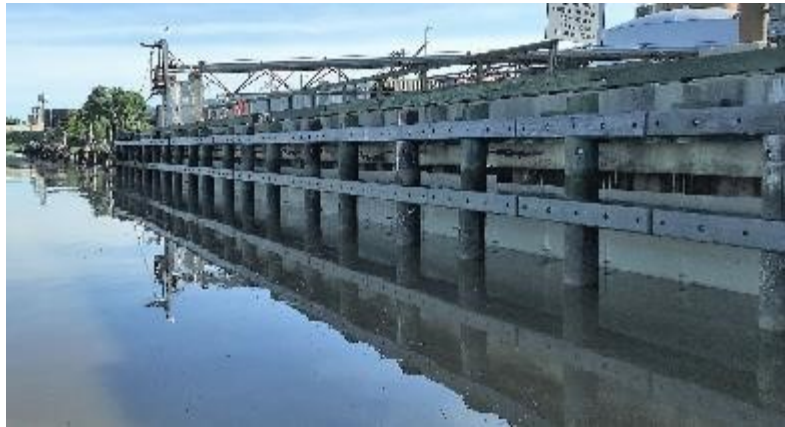
Fig. 4. Completed installation prior to placement of grout

The bottom of the panels can penetrate by about 16-20 in. into the soft silt at the riverbed. In other applications, a temporary seal can be produced at the lower elevation where the panels end. When placing the grout by the tremie method, about 6 to 12 inches of grout is placed along the base of the wall and allowed enough time for this grout to harden and create a seal. The remaining height of the wall can be filled with grout in a single lift if desired. The whalers are removed, and the ends of the J-bolts can be trimmed and if desired, covered with a cap.
