(R) A Joint Publication of NCSEA | CASE | SEI January 2012

Repair of Columns with FRP Laminates

By Mo Ehsani, Ph.D., P.E., S.E., Majid Farahani, P.E. and Eric Raatz, P.E.

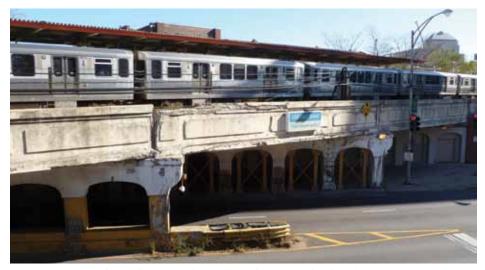
oss of load-carrying capacity in columns and piles in bridges is a major concern worldwide. In coastal regions, the dry-wet cycles lead to corrosion of reinforcing steel in concrete piles and bridge piers. In cold climates, the use of deicing chemicals results in corrosion of steel. Figure 1 shows one of many such cases in Chicago where reinforced concrete columns are severely weakened by corrosion and steel trusses have been added to carry the load. Similarly, in industrial facilities such as mines, aggressive chemicals cause premature corrosion of steel columns.

Figure 1: Corrosion-damaged concrete piles in Chicago being assisted with steel trusses.

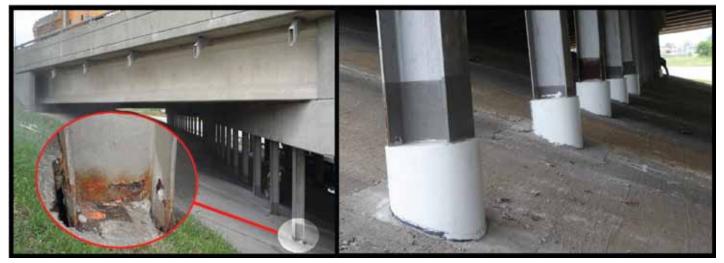
Figure 4: The I-70/I-270 interchanges in St. Louis, MO where 49 corroded bridge piling were recently repaired with FRP laminates.

A similar approach was used to repair 49 steel H piling in four bridges at the intersection of I-70 and I-270 in St. Louis, MO (Ehsani and Croarkin, 2011). Routine inspections had resulted in lowering the substructure condition

rating of this bridge to poor (National Bridge Inspection rating of 4 on a 9 point scale). This meant these bridges were considered Structurally Deficient due to the number of piling with significant section loss (*Figure 4*). The repairs were completed in just two weeks, improving all four bridges to a Satisfactory Condition Rating (NBI rating of 6). All of this was affordable enough to be funded with the region's operations budget, and repairs took place on one of the busiest highways in Missouri without causing any delays or distractions to the traveling public.
