PileMedic, LLC. | QuakeWrap, LLC.

This video demonstrates how the patented PileMedic technology developed by Professor Mo Ehsani can be used to quickly repair and strengthen concrete bridge piers that may get damaged in an earthquake.

The project was initiated by the U.S. National Science Foundation and the California Department of Transportation (Caltrans).

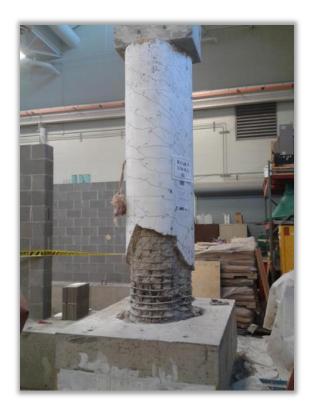
The 24-inch by 36-inch column specimen was first subjected to cyclic earthquake motion such that three longitudinal reinforcing steel bars on each face of the column were fractured.

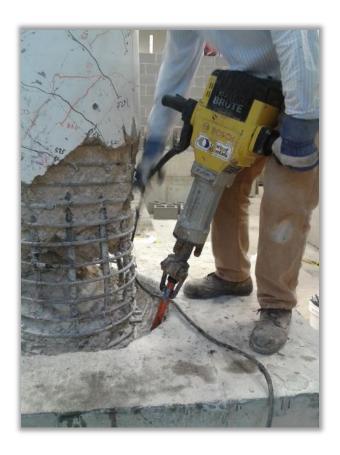
Using a jackhammer, a 10-inch deep narrow trench was cut around the column in the foundation

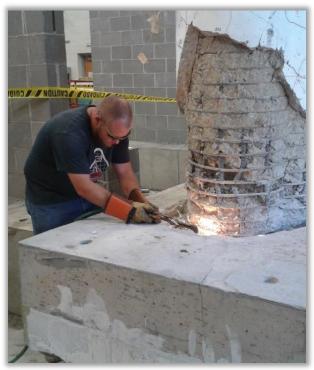
A torch was used to cut the longitudinal steel bars in the foundation.

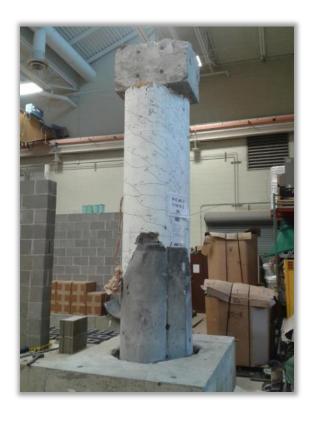
The spalled concrete was repaired to bring the column back to its original size and shape. While the researchers chose this approach, our recommendation is to wrap the PileMedicTM laminates shown on the next page around the column as formwork (without any epoxy between the layers) and fill it with grout; the laminate can be easily formed to the same shape and size of the pier. Then the laminate can be removed and used as the reinforcing material for the pier.

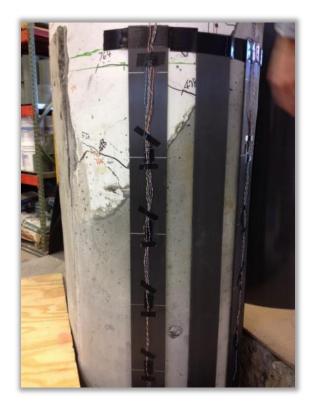
On each face of the column, 4 QuakeWrap® GU50C strips each 4 inches wide by 4.5 feet tall were attached above the foundation level.

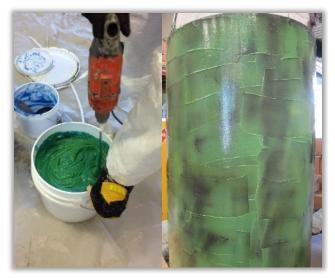
QuakeBondTM J201TC Tack Coat was mixed and applied to the surface of PileMedicTM PLC100.60 carbon laminate

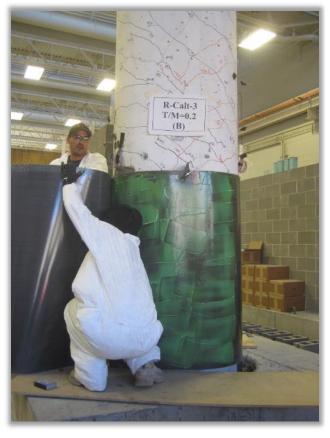
The PileMedicTM laminate was tightly wrapped around the column, creating a 4-ft tall 7-ply thick jacket with a total thickness of approximately 0.3 inches.

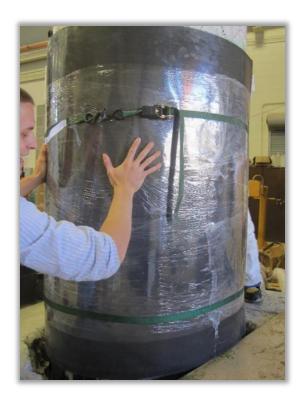
The jacket can be temporarily held together using shrink wrap or ratchet straps.

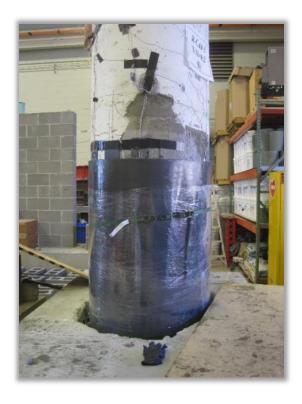
The PileMedicTM jacket was then pushed down about 10-inches into the cut trench.

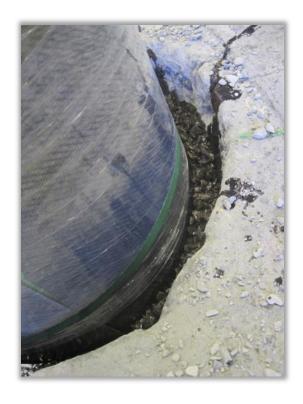
QuakeBondTM 320LV Low Viscosity resin was mixed and blended with aggregate and placed to fill the trench

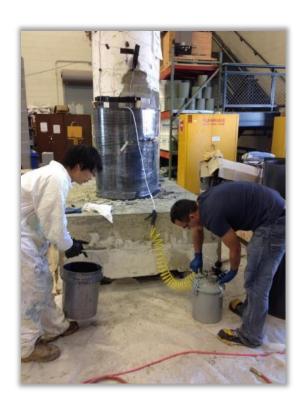
Using the previously positioned plastic tubes, QuakeBondTM 320LV Low Viscosity resin was mixed and pumped into the annular space.

This bonded the carbon strips, the concrete column and the PileMedicTM jacket together so they could resist the applied loads simultaneously.

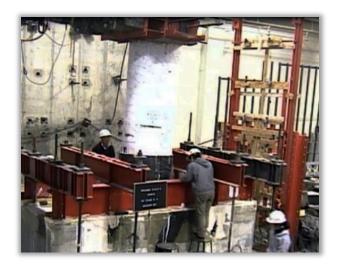
The repaired column was subjected to reversed cyclic loading.

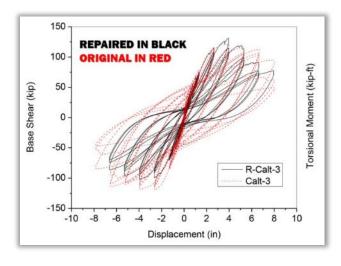
The load-deformation hysteretic response of the original column (shown in red) can be compared with the repaired and strengthened column (shown in black color).

"..... The most significant finding of the test was that the PileMedic system in combination with carbon FRP strips effectively restored the strength of the column and most of its ductility capacity.

The jacket system failed at the column-footing interface indicating that the embedment length of 10 inch into the footing was sufficient.
