# Repair of Timber Truss Bridge Substructure at Valvoline River Dock

project location: St. Louis MO

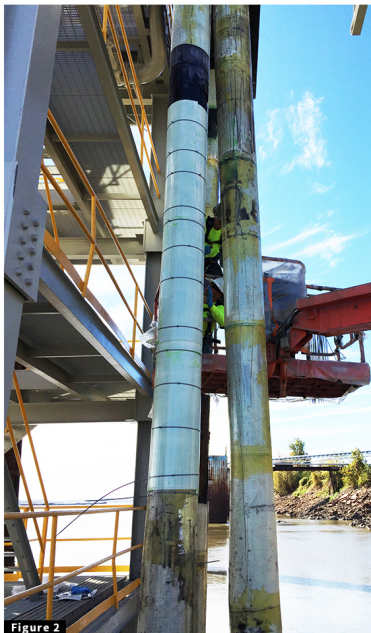
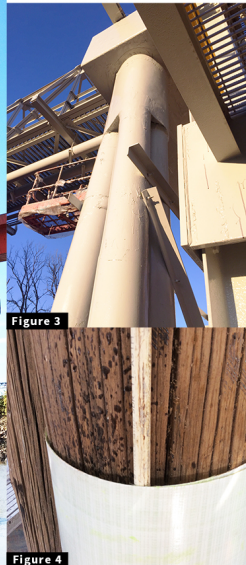
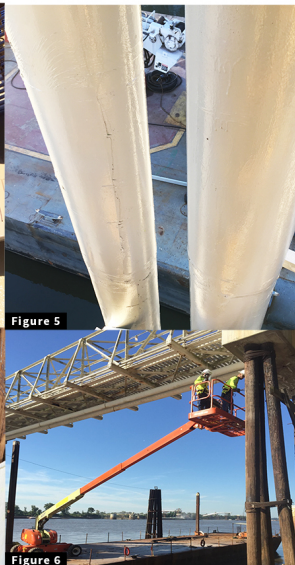
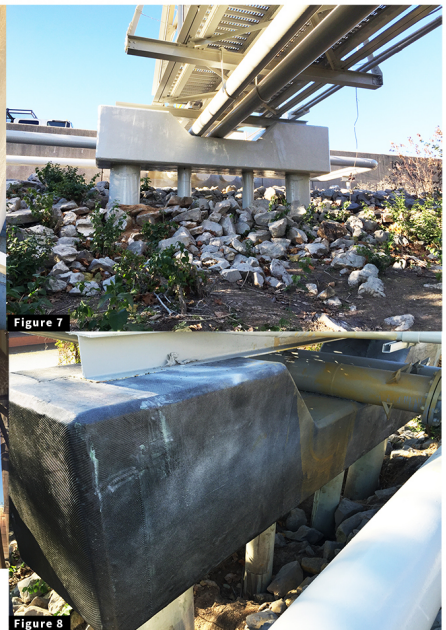
Figure 1, Figure 2, Figure 3, Figure 4, Figure 5: Use of spacer between PileMedic jacket and voided timber piles, Figure 6: Access to the timber piles from the barge,

**Implemented Solution:** A total of 18 timber piles on this project were encapsulated from a height of 5' below grade to the pile cap in PileMedic® bi-axial glass laminates. These laminates are supplied in 4-ft wide rolls. The rolls were cut in 9-ft long pieces that were coated with an epoxy paste. When wrapped around the 16-inch diameter piles, this creates a 2-ply shell with an 8-inch overlap at the end. Subsequent shells were overlapped 4-inch with the previous shell in the vertical direction. Small diameter tubes were used to inject a low viscosity resin into the annular space between the pile and the jacket. The resin fills all the voids in the timber pile. Since the resin is about 3 times stronger than the wood in compression, this operation adds significant axial capacity to the piles. The upper ends of the battered piles were wrapped together and the space between them was also filled with resin (Fig. 5). In the pile caps, the reinforcing steel were coated with corrosion inhibitor, new concrete was placed by patching and all cracks greater than 1/8" injected with low-viscosity resin. Furthermore QuakeWrap® Carbon fabrics wrapped around the pile caps to make up for the lost area in the reinforcing steel and protect against future corrosion and degradation.
