Repair of ASR-Damaged Piles

Challenges included limited working space and a crocodile-infested river

by Mo Ehsani, Stephen Day, and Tony White

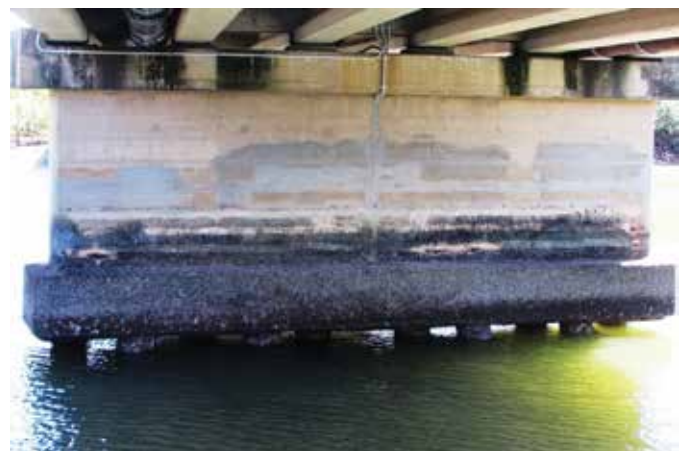
Fig. 1: View of a typical blade pier rising from a pile cap supported on 10 closely spaced PC piles

The octagonal piles have minimum diameters of just under 21 in. (533 mm), and the clear spacing is as low as 12 in. (305 mm). The upper 4 ft (1.2 m) of the piles are within the tidal range. However, the piles are generally underwater, and it is rare for more than 20 in. (508 mm) of a pile to be exposed (Fig. 1).

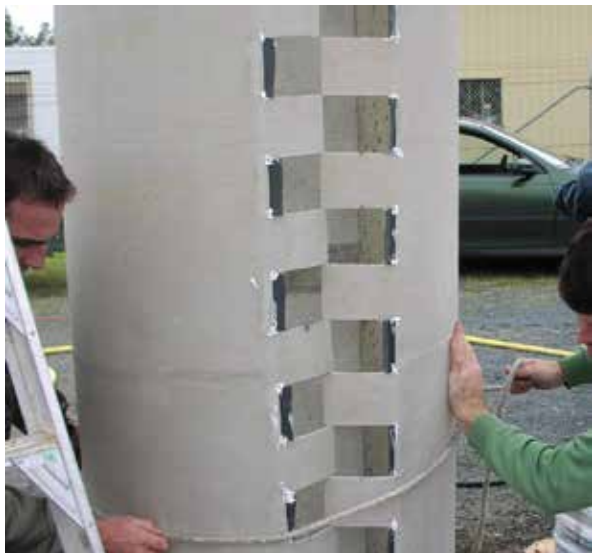
Fig. 2: The 2003 prototype FRP jacket used finger joints bent inward to be embedded in the grout, subsequently placed in the annulus formed between the pile and the jacket

A prototype FRP jacket was subsequently designed and tested. At the time, epoxies promoted as capable of underwater curing were not considered to be sufficiently advanced to meet the project objectives, so a mechanical jointing system was sought. A prototype was designed with a finger joint system. The “fingers” were turned in so that they

could be anchored in the hardened grout that would be subsequently placed in the annulus between the pile and jacket (Fig. 2). In trials, however, the prototype was unable to withstand the hydraulic pressure of the fresh grout—the project was terminated.

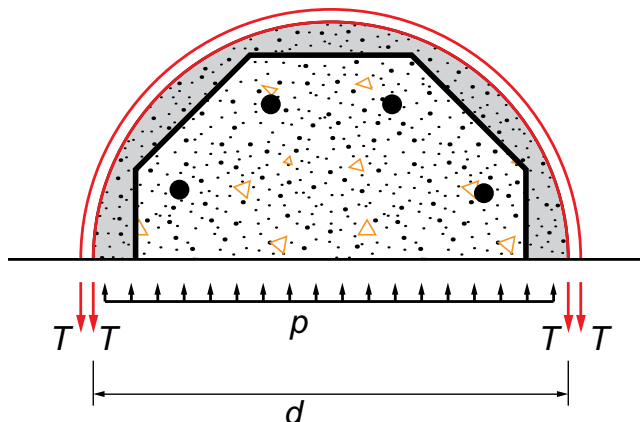
Fig. 3: Free body diagram for calculation of confining pressure provided by two layers of the laminate system

For confinement of a column or pile, the jacket is designed using a hoop stress analysis (Fig. 3). For example, a PileMedic PLC150.10 laminate has a breaking strength T of 4050 lb/in. (709 kN/m) of width. If two layers of the laminate are used to create a jacket with $d = 25$ in. (635 mm) around a pile and the grout infill in the annular space, the laminate can provide a confining pressure p given by

$$p = 4T/d = 4 \times 4050/25 = 648 \text{ psi (4.5 MPa)}$$

This confining pressure increases the compressive strength of the original pile and the newly placed grout. The pressure can be changed by using different types of laminates that have different tensile strengths, and by changing the number of layers that are wrapped around the pile. Safety factors and durability considerations must also be included by applying reduction factors to the breaking strength values. Guidelines

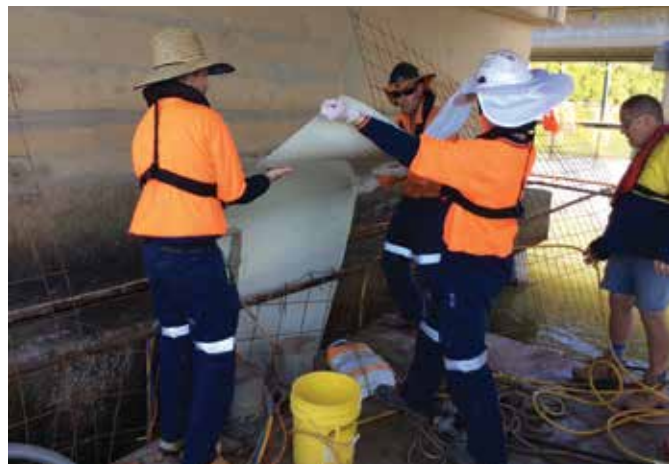
Fig. 4: Coated laminate being passed to the diving crew for installation

Next, the coated laminate was passed over the cage to the diving crew (Fig. 4). The lightweight jackets are relatively easy to handle once they are submerged. The crew wrapped the laminate around the pile and previously installed spacers. The epoxy adhesive serves as a lubricant and allows easy adjustment of the size of the jacket. Ratchet straps can also be temporarily wrapped around the shell to maintain its shape and diameter while the epoxy cures. Because the resin cures underwater, installation can be completed without the need for cofferdams and dewatering.
