Repair of Deteriorated Bridge Piles in a Crocodile-Infested River

Presented at the International Bridge Conference, Washington, DC June 2016

IBC-16-19

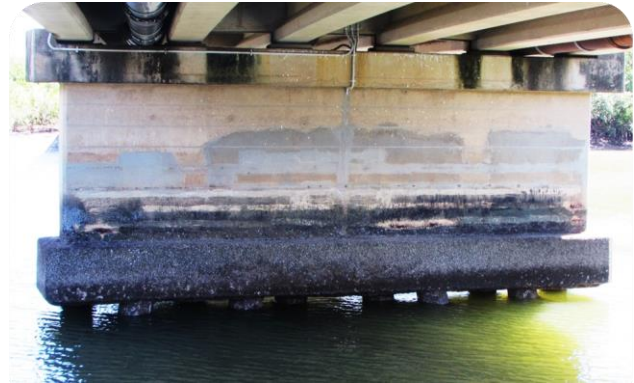
The top of the pile cap is nominally at mid-tide. Tidal range is around 15 feet (4.5m) and the upper 4 feet (1.25m) of piles is within the tidal range. However, the piles are generally underwater and during normal tidal movements, it is rare for more than 20 inches (0.5m) to be exposed (Fig. 1).

Figure 1 - View of typical pier

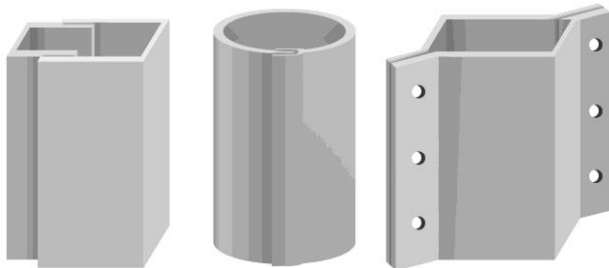
Having utilized Fiber Reinforced Polymer (FRP) jackets in above-water pile remediation works, DTMR was interested in exploring the feasibility of utilizing FRP jackets in underwater environments. Sample of FRP jackets that were common for pile encasement projects are shown in Fig. 2. There are several inherent problems with these products:

- a) The vertical seam along the side of the jacket allows ingress of moisture and oxygen so the corrosion process will continue;
- b) The vertical seam and bolts introduce a plane of weakness in the jacket that limit the confining pressure exerted by the jacket to the swelling pile; and
- c) The jackets must be manufactured for a specific size; this delays project scheduling and construction time

Figure 2 - Samples of earlier generation of FRP Jackets

The fiberglass jackets depicted in Fig. 2 are basically a stay-in-place form for placement of grout. They offer virtually no structural benefit to the pile. For example, the tensile strength of some of the most popular fiberglass jackets is compared to PileMedic® laminates in Fig. 7.

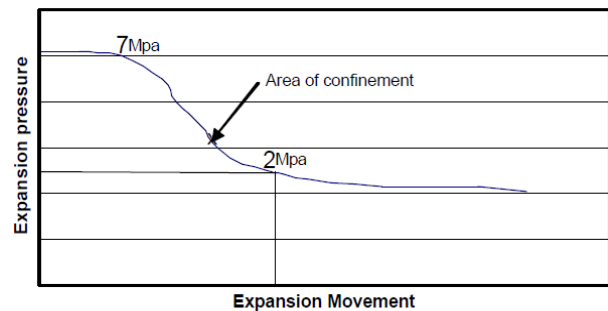
Various researchers, including Carse (1992), had shown that the rate of ASR reduced as internal pressure increased. One of the primary goals, therefore, was to develop an FRP jacket that would not simply act as a barrier to inhibit the ingress of chlorides, moisture and oxygen, but would provide sufficient confinement to allow a buildup in internal pressure to slow the ASR reaction. A practical operating pressure of 2MPa was adopted for purposes of design of a confinement system (Fig. 3). As discussed above, the FRP jackets that were in use at the time could not provide an impervious moisture barrier nor could they resist a confining pressure of 2 MPa (300 psi).

Figure 3 - Confinement pressure versus expansion (from McGuffin 2003)

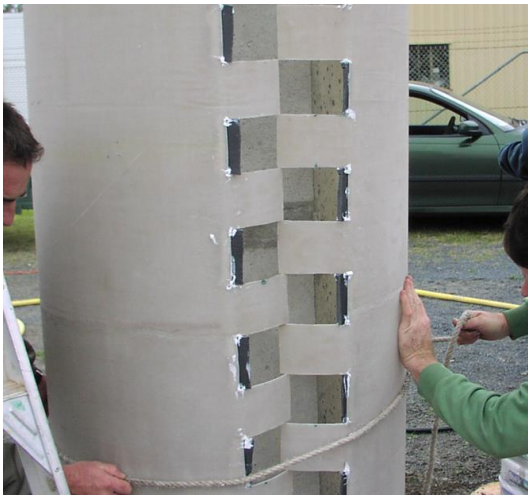
A prototype FRP jacket was subsequently designed and tested. At the time, it was considered that underwater-curing epoxies were not sufficiently advanced to meet the project objectives, and a mechanical jointing system was preferred. The prototype was designed with a finger joint system, with the fins being turned in to be anchored in the hardened grout subsequently placed in the annulus between the pile and jacket (Fig. 4).

Testing of the prototype was partially successful, proving the concept, but requiring further development to progress to a commercial product (McGuffin et al. 2003).

Figure 4 - 2003 Prototype FRP Jacket

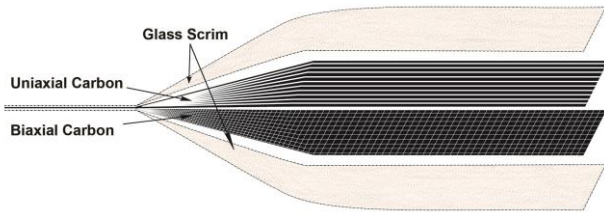
The new PileMedic® laminates are constructed with specially-designed equipment. Sheets of carbon or glass fabric up to 60 inches (1.5 m) wide are saturated with resin and passed through a press that applies uniform heat and pressure to produce the laminate (Figs. 5 and 6). The laminates offer three major advantages compared to other FRP laminates. First, by using a combination of unidirectional and/or biaxial fabrics, the laminate may provide strength in both longitudinal and transverse directions; this is a tremendous advantage that opens the door to strengthening of columns for both bending and confinement. Secondly, they are very thin; with a typical thickness

Figure 5 - PileMedic laminates are manufactured with multiple layers of uni- or multi-directional fabric

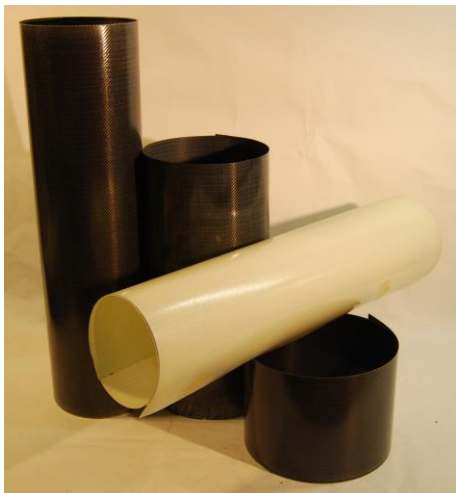
of 0.025 inches (0.66 mm), they can be easily bent into any shape circle with a diameter of 12 inches (300 mm) or smaller (Fig. 6). Lastly, the number and pattern of the layers of fabrics can be adjusted to produce an endless array of customized products that can significantly save construction time and money.

Figure 6 - PileMedic laminates made with carbon or glass fabric

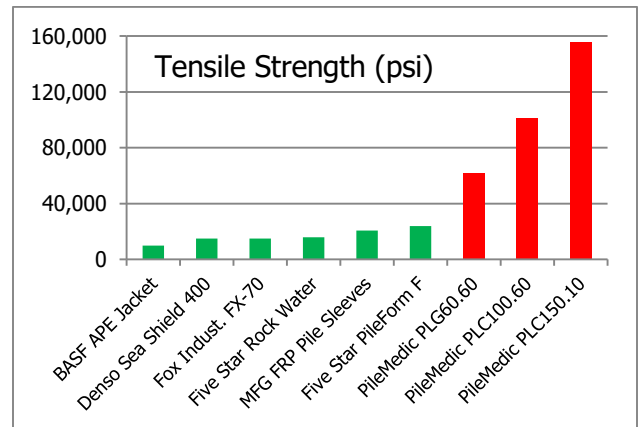
The tensile strength of PileMedic® laminates ranges between 62 to 156 ksi (427-1080 MPa). The thickness of the laminates ranges from 0.01 to 0.03 inches (0.25 to 0.76 mm). It is noted that the development of an equipment to produce such uniformly thin and wide laminates is not a trivial matter and has been a major part of this product development.

Figure 7 - Comparison of tensile strength (psi) for PileMedic and common fiberglass jackets

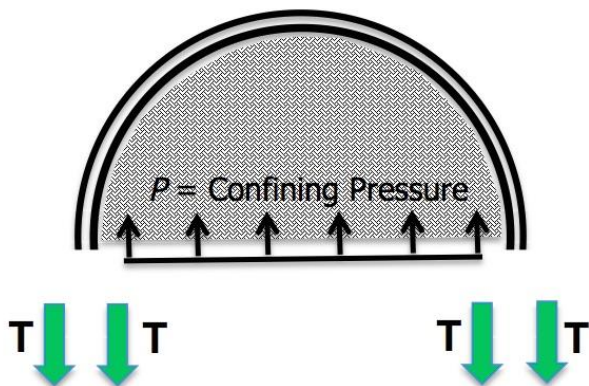
When the objective of the jacket is to provide confinement for the column or pile, the design is explained with the aid of the free body diagram shown in Fig. 8. Assuming an element of the column with unit height, let us assume that the diameter of the jacket that encompasses the pile and the grout in the annular space is 25 inches (635 mm). If the jacket is made by wrapping two layers of PileMedic® PLC150.10 laminates, each one inch width of this laminate has a breaking strength of $T = 4050$ pounds (18 kN). The confining pressure, p , acting on the pile is the reaction of the sum of the 4 tension forces shown in Fig. 8, such that:

$$4T = p \times \text{Jacket Diameter, or}$$

$$p = 4T / \text{Diameter} = 4 \times 4050 / 25 = 648 \text{ psi (4.38 MPa)}$$

Figure 8 - Free body diagram for calculation of confining pressure

As demonstrated, the laminates provide significant confining pressure for the pile. This confining pressure increases the compressive strength of the original pile and the newly placed grout. The amount of this confining pressure can be changed by using

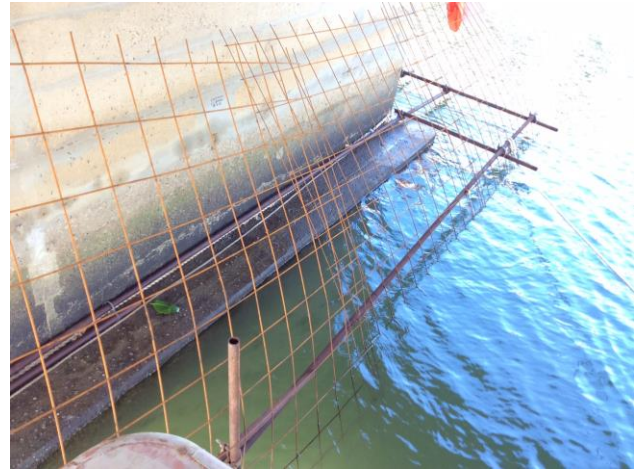
A total of four piers each having 10 submerged piles were repaired on this project. The bridge site on Barron River is known for its crocodiles, bull sharks, jellyfish and the like. For safety of the diving crew, a steel cage was positioned around each group of pier (Fig. 9).

Figure 9 - Steel cage around each pier to protect the diving crew from crocodiles and bull sharks

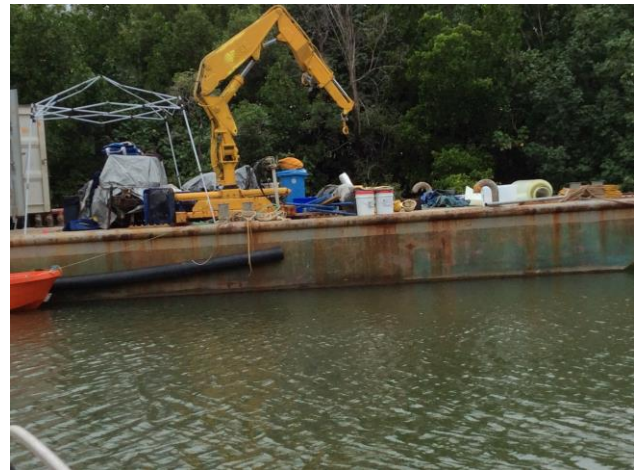
A barge was used to provide a flat working platform and a staging area for the materials and equipment (Fig. 10). The barge also included a small crane for loading of the materials such as the resin and grout.

Figure 10 - Barge used as working platform

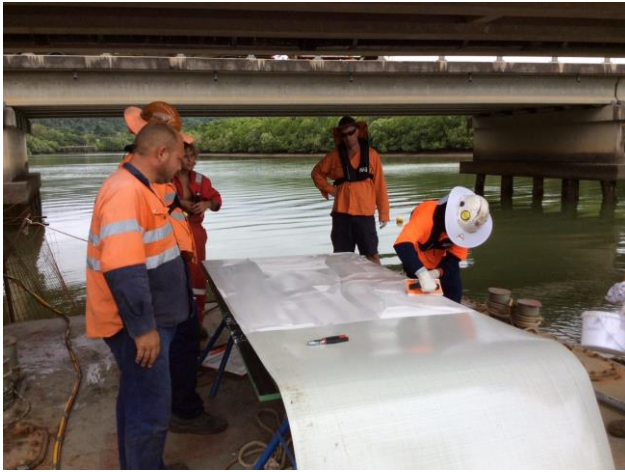
The circumference of such a jacket is 78.5 inches (2m). So, the 4-ft (1.2m) wide laminates were cut in lengths of $2 \times 78.5 + 8 = 165$ inches (4200mm) in the field. The laminate is placed flat on a table (Fig. 11). A two-part epoxy resin paste is supplied as a part of this system. This resin cures underwater and

Figure 11 - Cutting of laminate to size and application of epoxy paste

The laminate will be wrapped around the pile to create a two-ply shell. In doing so, the portion of the laminate that is adjacent to the shell does not have to be coated with epoxy. But the second ply and the 8 inch extension, must be coated. In this case, a length of $78.5+8=86.5$ inches (2200mm) of the laminate had to be coated with epoxy. The two-component epoxy has a consistency similar to tooth paste and can be applied using a notched trowel to achieve a uniform thickness of 30-40 mil (0.75-1 mm).

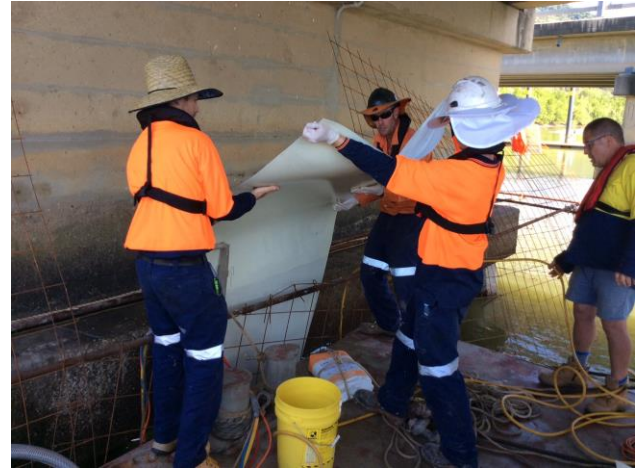
Next, the coated laminate is picked up and passed over the steel cage to the diving crew (Fig. 12). In spite of their size, the lightweight jackets are fairly easy to handle once they are submerged. Spacers such as short pieces of 2 inch (50mm) diameter PVC pipe can be attached to the pile surface to define the required annular space for grout. The crew wraps the laminate around the pile over the spacers. The epoxy paste serves as a lubricant and allows easy adjustment of the size of the jacket. Ratchet straps can be wrapped around the shell to maintain its shape and dimension while the epoxy cures.

The first 4-ft (1.2m) tall jacket was installed at the base of each pile and extended 18 inches (450 mm) below the mud line. The next jacket was applied with a 4-inch (100 mm) overlap along the height of the pile. An epoxy paste is applied to this overlapping region. The process continued until a jacket of desired height was created. The diving crew consisted of 4 workers: 2 divers performing the

Figure 12 - Laminate being passed to the diving crew for installation

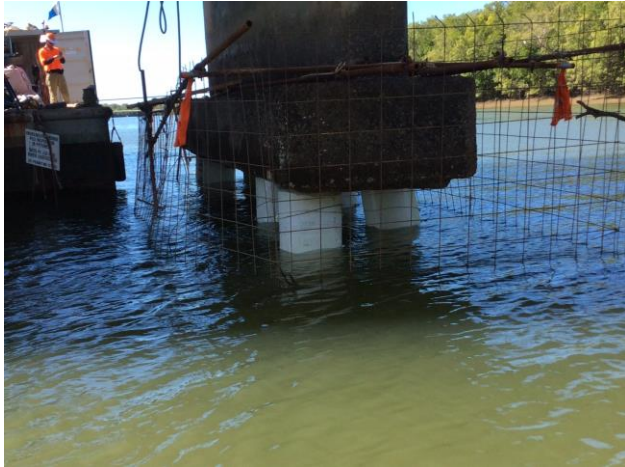
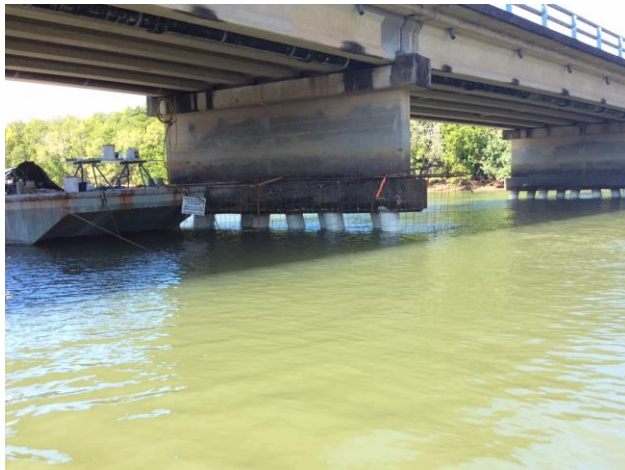
Once the jacket was installed, the annular space was filled with a cementitious underwater grout using the tremie placement method. A shear mixer and pump were utilized for this application. As the grout is placed, its hydrostatic pressure pushes the two layers of the laminate against each other for a perfect bond. Moreover, the heat of hydration of the grout can also assist with the faster curing of the epoxy paste. In the following day the ratchet straps will be removed and the repair is complete. Figure 13 shows the completed project after all 40 piles were successfully repaired.

Figure 13 - Views of the completed project
