# Evolution of FRP Products for Concrete Repair

Mo Ehsani, PhD, PE, SE, F.ACI  
President, QuakeWrap, Inc.  
[Mo@QuakeWrap.com](mailto:Mo@QuakeWrap.com) (520)250-7020

July 2024

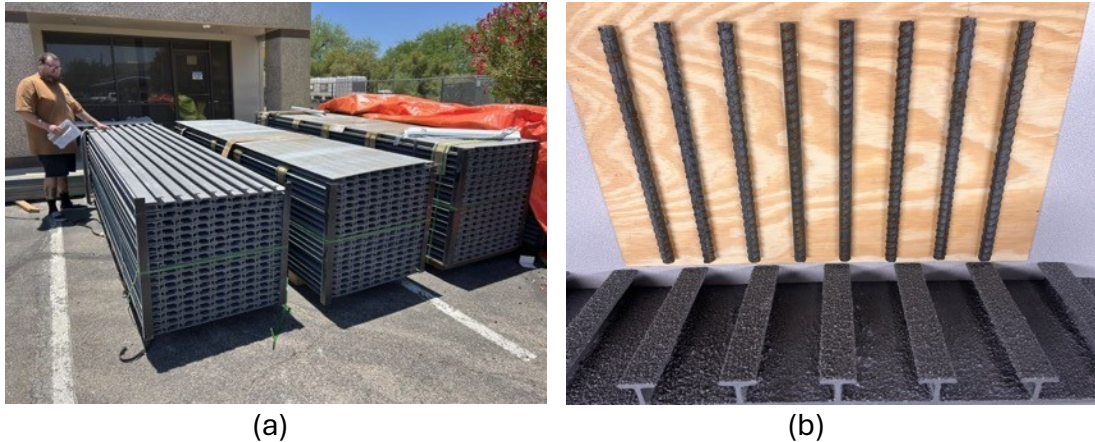
Fig. 2. T-panels: (a) 3-ft wide x 12 or 18-ft long; (b) close view of grit coated surface and equivalency to steel reinforcing bars.

The patent-pending panels, named [SPiRe®+](#), will be hereafter referred to as T-panels. The panels are 3-ft (910mm) wide and can be cut to any length in the field (Fig. 2a). They are constructed with glass fabric using a pultrusion process. The exterior face of the panels is flat and smooth. The interior face has protruding T profiles. That face is also grit coated for improved bonding to concrete. Together, the flat panel and the T profiles act as reinforcing elements for strengthening any beam, slab or wall (Fig. 2b). The panel wall thickness is 0.2 in. (5mm).

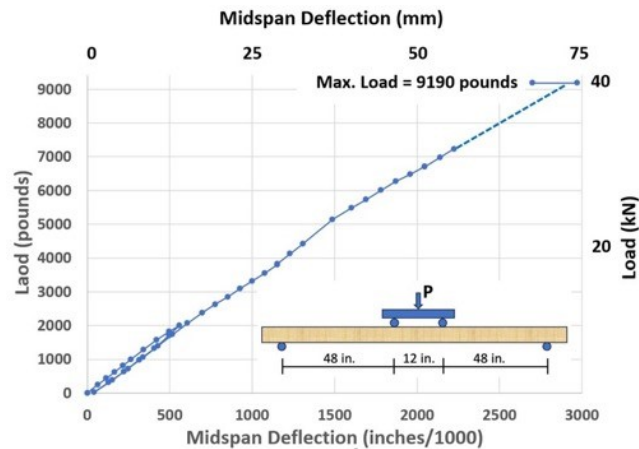
Fig. 4. Load vs. midspan deflection of the beam constructed with T-panel

and fluid (Fig. 3b). The beam was subjected to a 4-point bending and the load vs. midspan deflection results are shown in Fig. 4.

The only reinforcement in the beam specimen was provided by the two T-profiles and the flat plate of the T-panel (Fig. 3c). A large number of fine flexural cracks formed along the length of the beam, indicating good bond between the T-panel and the concrete due to the grit-coated surface. The specimen failed at a load of 9190 pounds (41 kN); which corresponds to a flexural moment of 220.5 k-in. (24.9 kNm). In comparison, if this 4-in. (100mm) thick beam were constructed with steel reinforcement, it would require #6 Grade 60 steel bars at a spacing of 3 ½ in. (or 20mm  $\phi$ , 500MPa @120mm) to provide the same flexural capacity. Fig 2b shows this equivalent steel area; it is evident that the strength provided by these panels exceeds the reinforcement required for most projects.

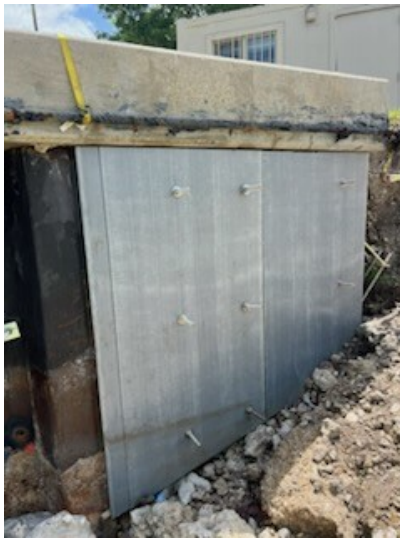
Fig. 6. Repair of corroded steel sheet piles in Weston, FL, June 2024

A similar application for repair of a severely corroded steel seawall is currently in progress in the city of [Weston, FL](#) (Fig. 6). These are parts of two pump stations where excess flood water is pumped from a retention pond into a canal. In some cases, the holes in the walls were as large as 1 square foot ( $0.1 \text{ m}^2$ ) which would allow significant loss of soil through the wall. In a few areas the walls were surrounded by water on both sides. These were sandwiched between two sets of T-panels, one on each side of the wall. Another

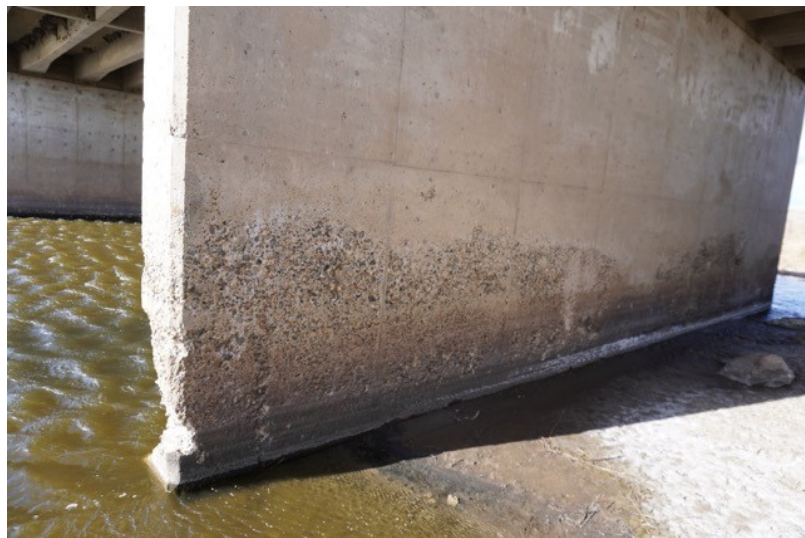
Fig. 7. Concrete pier wall in a bridge in North Dakota scheduled to be repaired in August 2024.

**Repair of Bridge Pier Walls** – Pier walls in river crossings often get damaged by abrasion, erosion and corrosion. Repairing concrete below waterline is a challenging task. In its first application of this type, T-panels are being used to repair the pier wall shown in Fig. 7 in [Buffalo Creek Bridge](#) in North Dakota. The panels will be connected by anchor bolts to the wall from the riverbed to an elevation 9 feet (2.74 m) above the mudline. These panels will cover both sides and the front and rear ends of the wall, creating a watertight form that will be filled with concrete. The panels will serve as formwork and reinforcing bars and will provide waterproofing for the repaired wall.

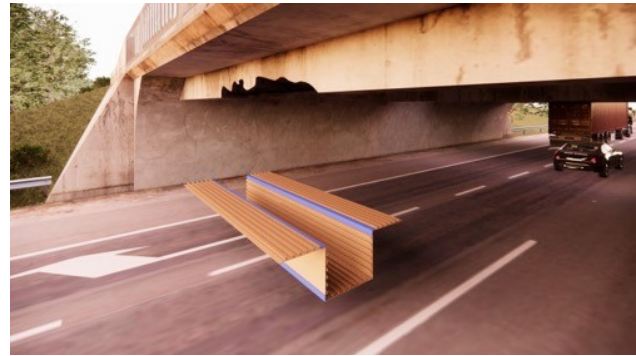
Fig. 8. Concrete beams and slabs can be repaired in a few hours with T-panels

**Repair of Beams and Slabs** - Corrosion of reinforcing bars in slabs and girders in buildings, bridges and ports results in loss of load-carrying capacity in these structures. Repairs can be very time consuming with significant effort required to prepare the surface and patch it by troweling concrete or spraying shotcrete. In some structures, such as bridges, these long repair times cause delays in traffic and road closures. As shown in Fig. 8, these panels can be cut and connected using L-shaped angles along the corners

to create a shell of desired shape and size. If necessary, additional non-corroding GFRP bars can also be added to these panels through the special spacers shown in the drawing. These panels can be lifted in place and secured with bolts to the host structure before concrete is pumped into the annular space through provided grout ports. Such repairs can be completed in hours instead of weeks, saving significant time and cost for the project. The panels serve as the formwork, reinforcing bars and provide permanent protection for the host structure against moisture, salt spray, and corrosion.

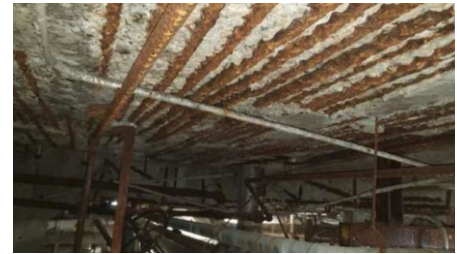
Fig. 9. Severely corroded slab in an industrial plant

Similar conditions exist in mines and industrial plants as shown in Fig. 9. The slab in this plant was severely corroded due to the presence of chemicals and fumes in the plant. Access to the underside of the slab at such height and at the presence of existing pipes and attachments is very limited, making conventional repairs with patching of concrete impractical. The SPiRe®+ panels can be lifted from below and secured with a few bolts to the underside of the slab. The annular space is filled with grout or concrete.
