# Repair of timber piles in rail bridges – A Canadian perspective

**Presented at IABMAS Conference, Copenhagen Denmark, June 2024**

**ABSTRACT:** Timber piles are used in many railroad and secondary highway bridges throughout North America. Many of these structures are reaching the end of their design life and the piles are showing signs of deterioration. These structures are often located in remote sites where limited access favors repair techniques that require minimal equipment. This paper describes two such techniques that have been successfully used in Canada to repair and extend the operation life of those aging structures.

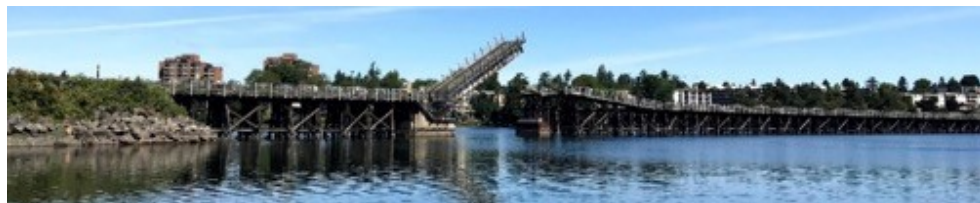
Figure 3. Selkirk Trestle elevation and view from southeast.

The trestle is comprised of 61 timber bents, typically spaced at 4.5m and generally constructed with 6 piles each, and a 37m long steel Scherzer Rolling Lift Bridge commonly referred to as "the bascule". The overall structure length is 302 m. Detailed records of historic repairs are not available for the existing structure. It is known that ~1/3 of the piles were replaced in 1957 and it is probable that the remaining piles have also been replaced at some point in the 100+ year history of the structure. The bridge is located NW of Victoria BC, with the coordinates of [48.439343, -123.382491](#).

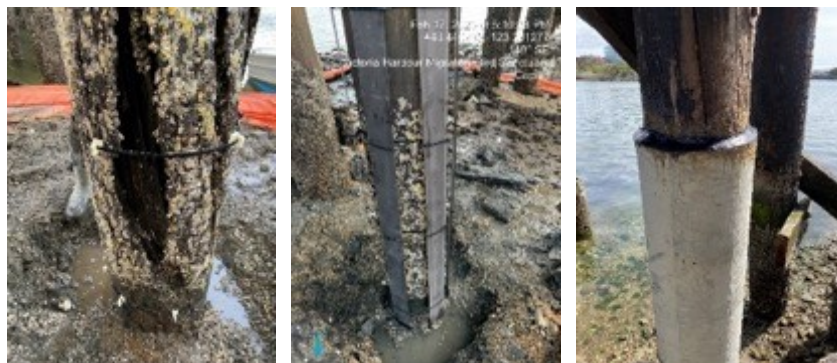
Figure 4. Progressive repair steps using the PileMedic® system.

marine contractor, Salish Seas Industrial Services (SSIS), was engaged to complete the repairs. Four 100mm (4 in.) wide carbon laminate strips with tensile strength of 2825 MPa (410 ksi) were placed around the pile in the damaged zone (Figures 2 and 4). PileMedic® laminate was wrapped around the pile and created a seamless shell that was filled with a low viscosity high compressive strength resin. This resin bonds the carbon strip, timber pile and the PileMedic® shell together to resist all imposed loads. The low viscosity resin also flows through all cracks and fills the voids formed by the marine borers, increasing the axial capacity of the pile. The carbon strips and the PileMedic® shell provide significant flexural capacity for the repaired pile.

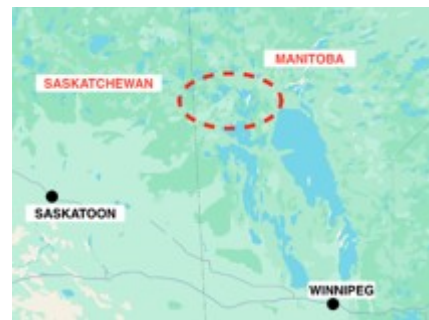
Figure 5. Vicinity map where 135 piles were repaired in 2023.

The 135 piles repaired in 2023 were located on 8 bridges; they were scattered in the circled area shown in Figure 5 throughout northern Manitoba which experiences very cold temperatures and snowfall. The bridges had piles that varied in diameter between 400 to 500mm (16 to 20 in.). The repairs were completed over the period of April through late November 2023.

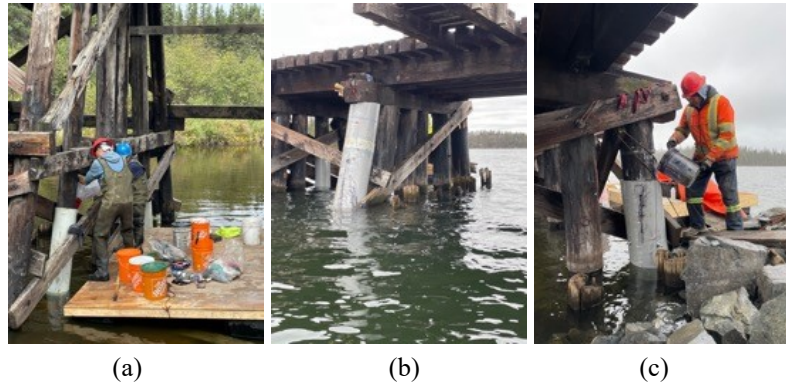
Figure 7. Installing the laminates to create a (a) partial or (b) full height repair of a pile; (c) placement of low viscosity resin in the annular space.

Each laminate covers a length of 1200mm (4 ft) along the pile (Figure 7a). Additional laminates can be installed overlapping the previous one by 100mm (4 in.) to cover the desired height (Figure 7b). Once the required length of the pile is wrapped in the PileMedic® shell, the high strength low viscosity resin is mixed and gravity fed into the annular space (Figure 7c). This will fill all the cracks and voids in the pile and it will bond the shell to the pile.

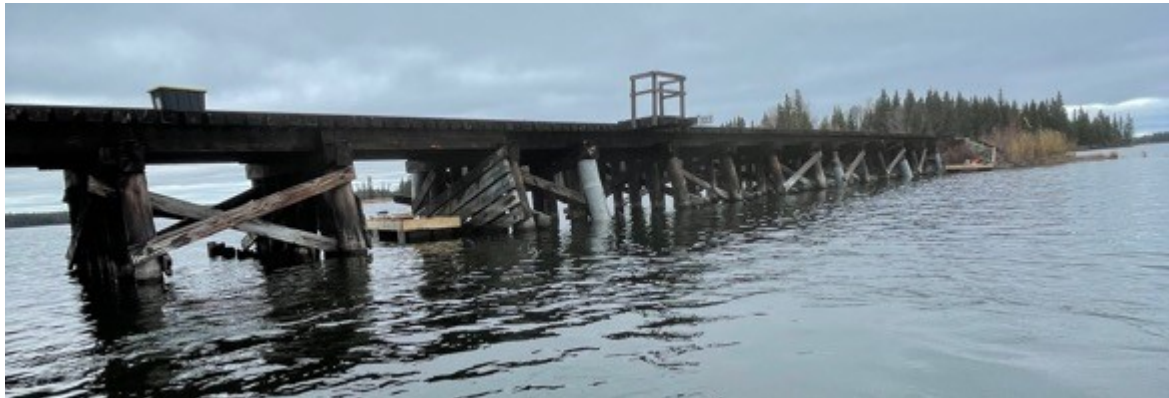
Figure 9. One of the rail bridge sites where dozens of piles were repaired.
