Emergency repair of an RC bridge column with fractured bars using externally bonded prefabricated thin CFRP laminates and CFRP strips

An emergency repair technique for a reinforced concrete (RC) bridge column that had buckled and fractured longitudinal bars was developed and assessed through an experimental study. The repair technique involved removing loose concrete, casting grout, cutting a trench around the base of the column in the footing, embedding carbon fiber reinforced polymer (CFRP) strips for flexural reinforcement, building a jacket from a prefabricated thin CFRP laminate, lowering the jacket into the trench bonding the CFRP composites to the column and the footing with pressurized epoxy, and restoring the strength of footing with externally bonded CFRP sheets. The repaired column was tested to failure under constant axial load and cyclic lateral load resulting in combined flexure, shear, and torsional moment loading. Test results showed that the repair method was successful in restoring the seismic performance of the column in terms of lateral strength and deformation capacity.

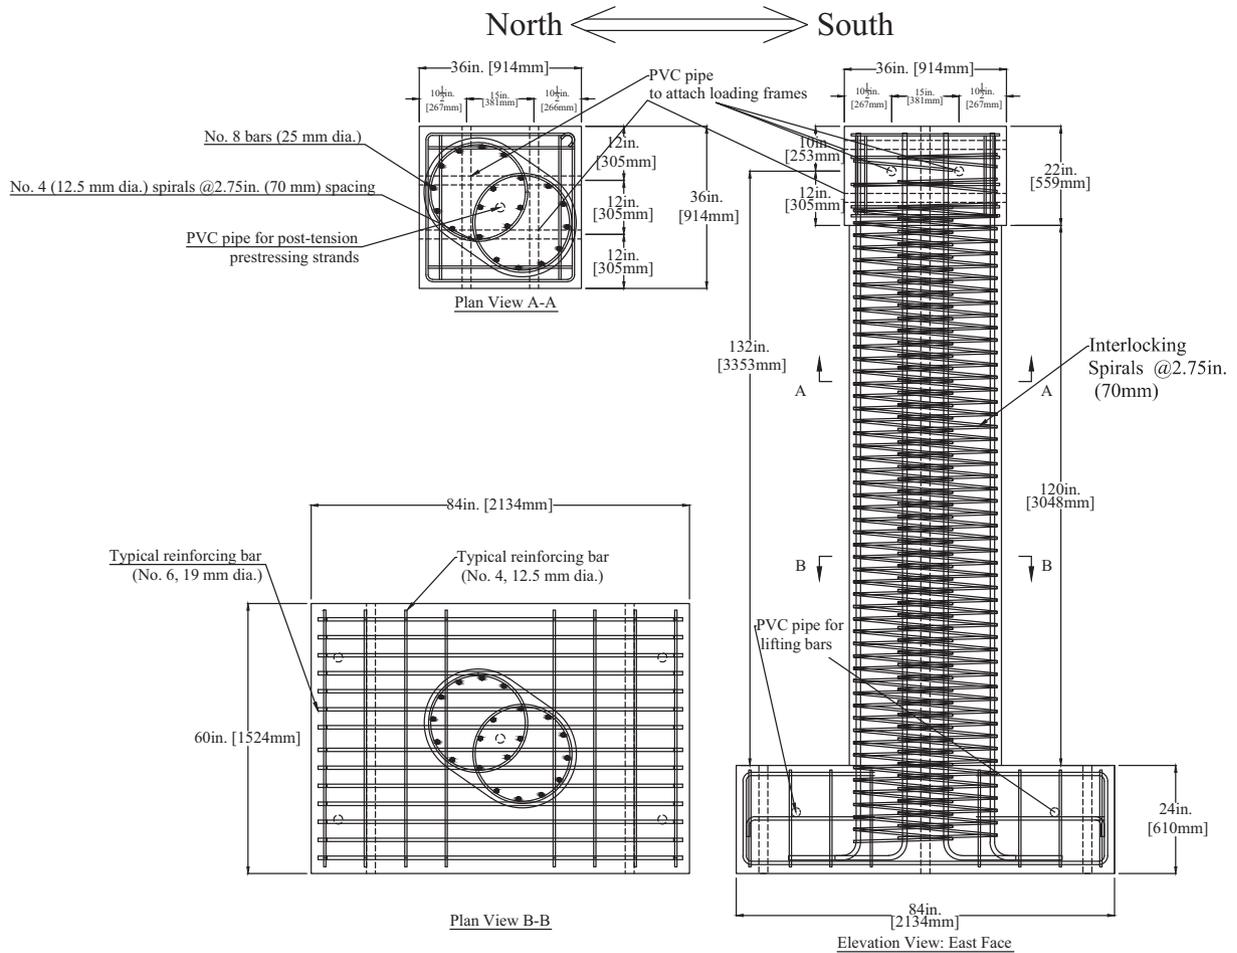
Fig. 1. Geometry and reinforcement details of Calt-3.

In a previous study, a 1/2-scale RC bridge column specimen was tested to failure under constant axial load and cyclic lateral loading [24]. In this paper, the original column is referred to as Calt-3. The column geometry and reinforcement details are shown in Fig. 1. The column had an oval-shaped cross section of 24 in. \times 36 in. (610 mm \times 915 mm), and the clear concrete cover to the spiral reinforcement was 1 in. (25 mm). The total height of the specimen was 166 in. (4.2 m) with an effective height of 132 in. (3.35 m) measured from the top of footing to the centerline of applied load,

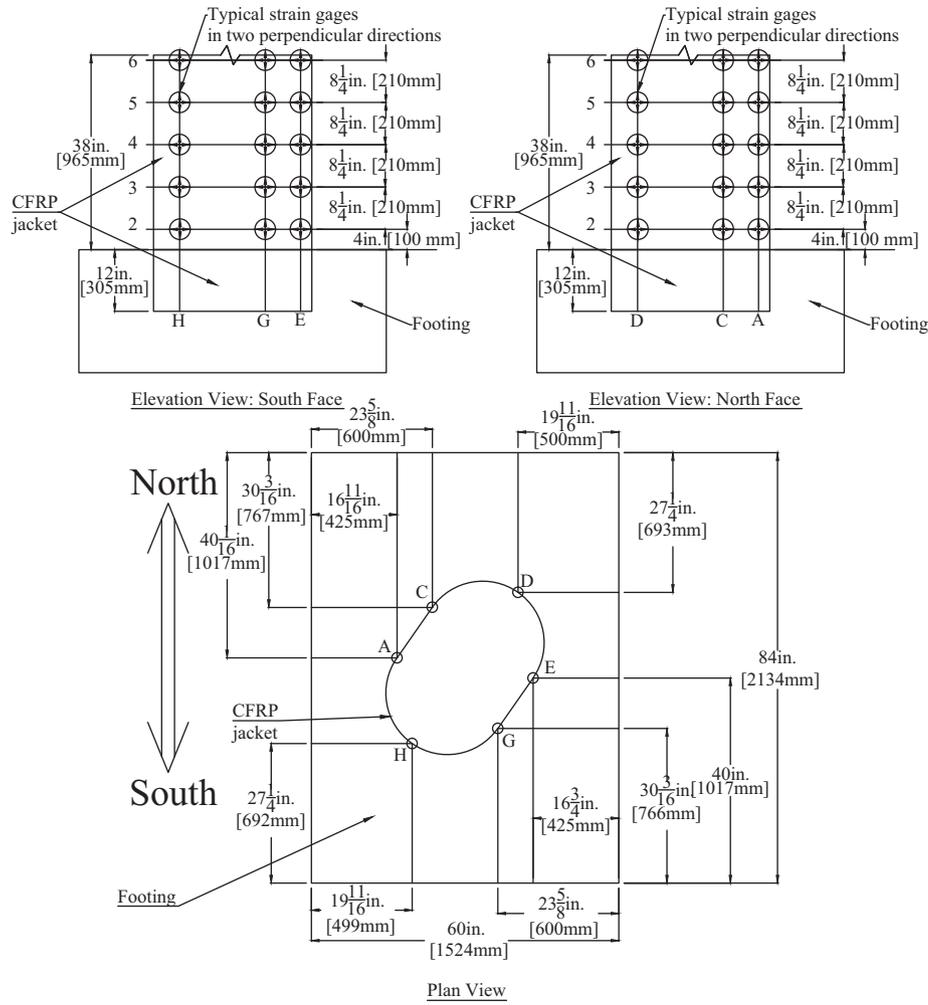
Fig. 8. Strain gage layout on CFRP jacket for R-Calt-3.

The maximum measured tensile strain in the longitudinal fibers of the CFRP jacket was at location "H" of the cross-section (defined in Fig. 8) at a height of 4 in. (100 mm) above the top of the footing. The maximum value was measured at a drift ratio of -2% and was close to 0.008, which is 56% of the rupture strain in that direction (0.0142 provided by the manufacturer, refer to Table 3). The

maximum measured compressive strain in the longitudinal fibers of the CFRP jacket was 0.008 at a drift ratio of +5% at a location of “H” at a height of 12.25 in. (310 mm) from the top of the footing. The measured strain values indicate no rupture of CFRP in the region instrumented with strain gages, which was consistent with the observation during testing that rupture of CFRP occurred within a region no higher than 2 in. (50 mm) from the top of the footing.

Strains measured in the transverse fibers of the CFRP jacket were mainly tensile strains. The maximum tensile strain was measured at location “E” (defined in Fig. 8) at a drift ratio of +5% at a height of 4 in. (100 mm) above the top of the footing. The measured value was between 0.008 and 0.01, which was close to the rupture strain of the CFRP jacket in that direction (0.0085 provided by the manufacturer, Table 3).

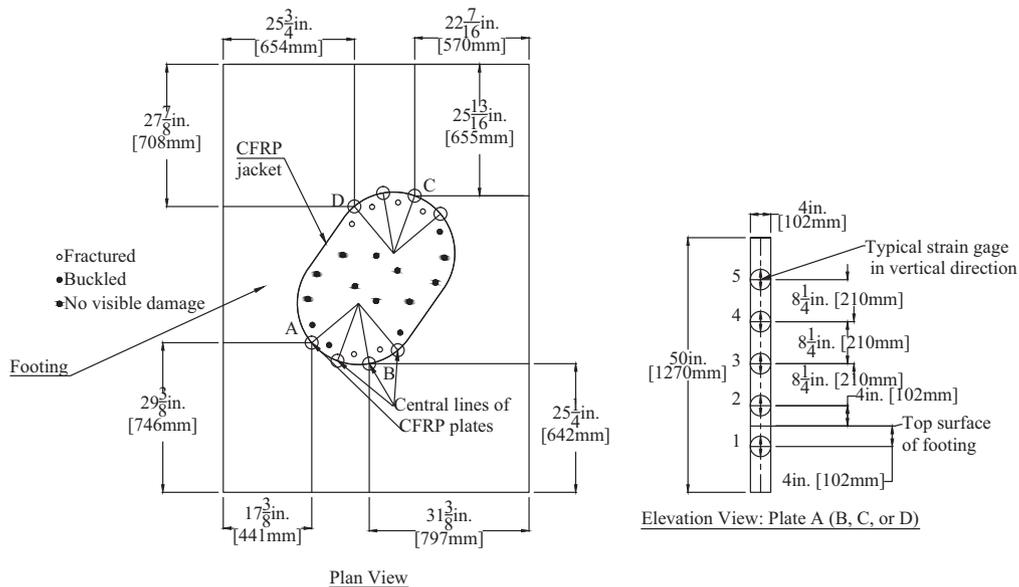
Fig. 9. Strain gage layout on CFRP strips for R-Calt-3.

The maximum tensile strain in the CFRP strips was measured at location “B” (defined in Fig. 9) at a drift ratio of +3% at a height of 4 in. (100 mm) above the top of footing. The maximum measured strain was 0.006, which was 35% of the rupture strain provided by the manufacturer (refer to Table 1). The strain gages at this location malfunctioned at higher drift ratios, and no additional data could be recorded. However, it should be noted that the strains in the CFRP strips at the column-footing joint might be higher than that at the 4 in. (100 mm) high location because the plates ruptured at the base of the column as discussed in Section 5.1. The maximum measured compressive strain in the CFRP strips was 0.006 at a drift ratio of +3% at location “C”. Strain measurements from gages mounted 4 in. (100 mm) below top of footing indicated that the strain penetrated into the footing with a maximum tensile strain of 0.003 and maximum compressive strain of 0.005 measured at location “B”.

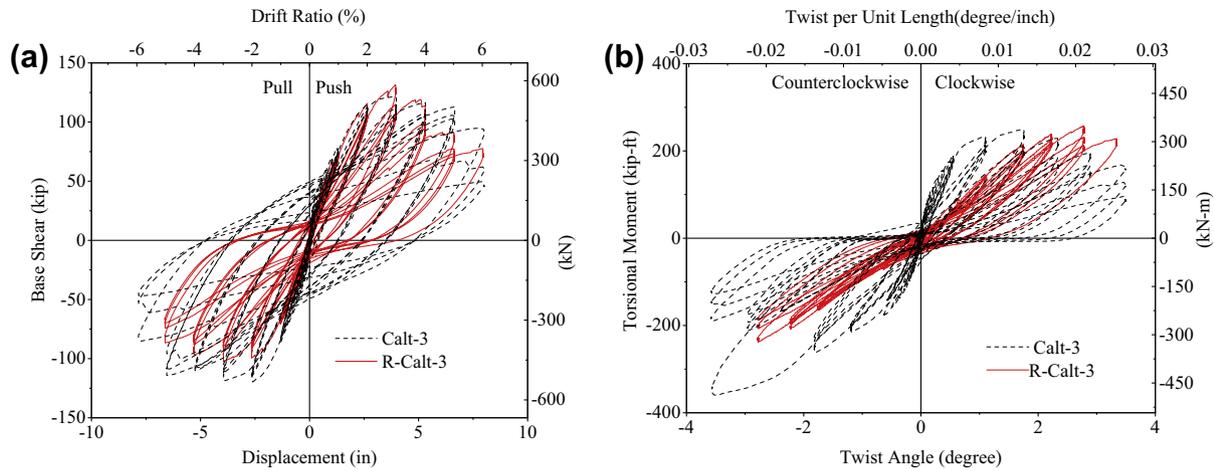
Fig. 12. Load–displacement hysteresis responses of Calt-3 and R-Calt-3. (a) Base shear vs. displacement. (b) Torsional moment vs. twist angle.

The base shear-lateral displacement hysteresis for R-Calt-3 and Calt-3 are compared in Fig. 12(a), where “push” was defined as positive and “pull” as negative. The hysteretic behavior of R-Calt-3 was asymmetric with higher maximum base shear in the push direction than in the pull direction. This may be due to

the fact that the rupture of CFRP jacket of R-Calt-3 in the positive cycle reduced the load capacity in the subsequent negative cycle. It should be noted that the higher maximum lateral displacement

applied in the push direction was due to the fact that the actuators had a larger stroke capacity in the push direction than in the pull direction. The maximum positive base shear of R-Calt-3 was larger

Fig. 12(b) shows the hysteresis of torsional moment and twist, where clockwise torsion is defined as positive and counterclockwise torsion as negative. Degradation of the torsional strength of R-Calt-3 was observed at an angle of 2.5 degrees corresponding to a twist per unit length of 0.02 degrees/in. in the positive direction, while no degradation of the torsional strength of R-Calt-3 was observed in the negative direction. Torsional moment and twist envelopes of R-Calt-3 and Calt-3 are compared in Fig. 13(b). The initial torsional stiffness of R-Calt-3 was much lower than that of Calt-3. This may be due to relative movement (slip) between the CFRP jacket and the column due to the low modulus of the epoxy filled in between them. Elasto-plastically idealized torsional moment and twist curves are shown in Fig. 13(b), from which critical values were calculated and summarized in Table 6. The equivalent yield torque of R-Calt-3 was 97% of that of Calt-3, while the equivalent elastic torsional stiffness and torsional ductility ratio of R-Calt-3 was only 36% and 28% of that of Calt-3, respectively. This indicates that the repair method was successful in restoring the torsional strength; however, it did not restore the torsional stiffness and ductility.

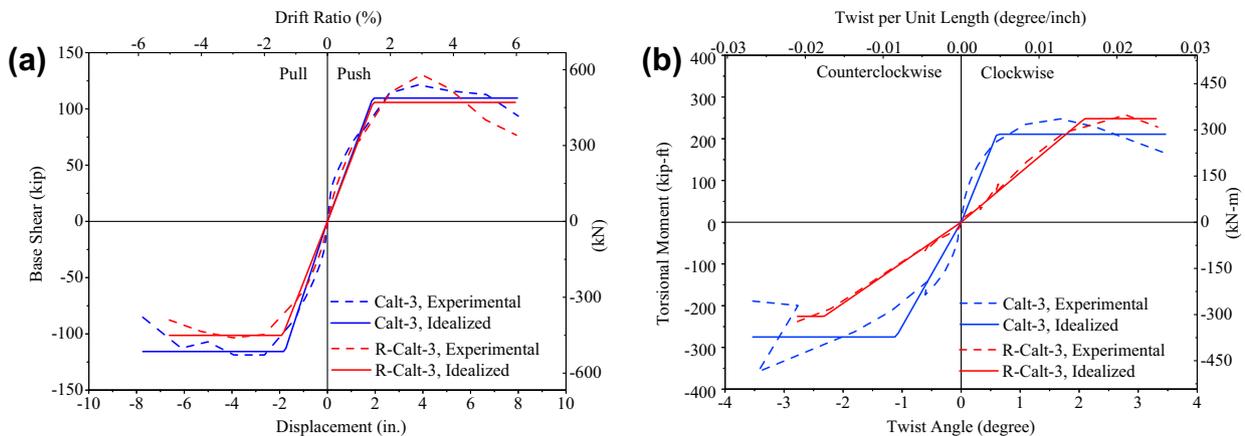
Fig. 13. Experimental and idealized load–deformation envelopes of Calt-3 and R-Calt-3. (a) Base shear vs. displacement. (b) Torsional moment vs. twist angle.

Base shear and lateral displacement envelopes for R-Calt-3 and Calt-3 are compared in Fig. 13(a). The initial lateral stiffness of R-Calt-3 was lower than that of Calt-3 in both directions. This

may have been due to slippage of the CFRP jacket relative to the substrate since the adhesive layer was as thick as 1 in. (22 mm) in places and had a much lower stiffness than both the CFRP and concrete. Table 5 summarizes the maximum base shear in both directions. Idealized envelopes representing an elasto-plastic curve for Calt-3 and R-Calt-3 are also compared in Fig. 13(a). The bilinear envelopes were idealized by setting the initial slope to pass through the first yield point recorded during testing of Calt-3 and adjusting the plastic portion to equate the areas under the measured and idealized curves. Table 6 summarizes the critical values obtained from the idealized envelopes. In Table 6, the equivalent yield base shear (or torsional moment) is the average value of yield base shears (or torsional moments) in both directions. The equivalent lateral (or torsional) stiffness is the average value of the stiffness calculated in both directions. The equivalent lateral (or torsional) ductility ratio is the average value in the both directions. As shown in Table 6, the equivalent yielding lateral force, the equivalent elastic lateral stiffness, and the equivalent lateral ductility ratio of R-Calt-3 was approximately 92%, 95%, and 98% of that of Calt-3, respectively. This indicates that the repair method was successful in restoring the lateral behavior of the column.

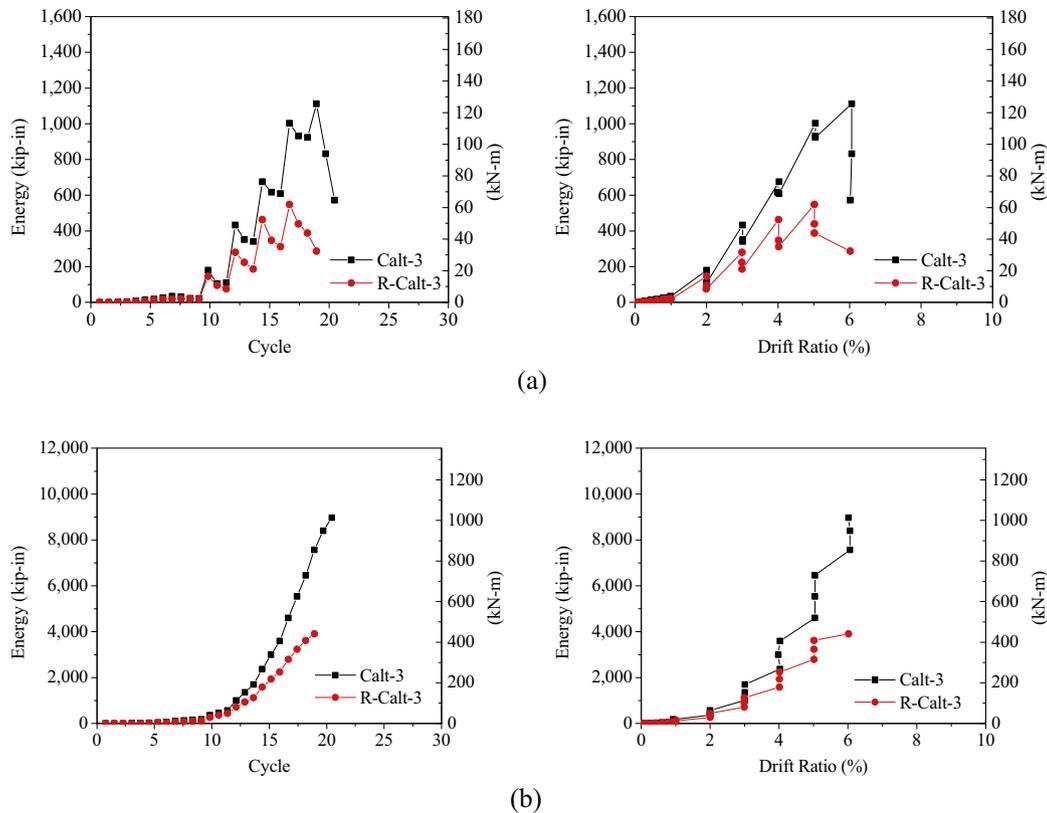
Fig. 14. Energy dissipation per cycle and cumulative energy dissipation of Calt-3 and R-Calt-3. (a) Energy dissipation per cycle. (b) Cumulative energy dissipation.

The energy dissipation for both the repaired and original columns is shown in Fig. 14(a). The energy dissipation per cycle of R-Calt-3 was lower than that of the Calt-3. Also, the energy dissipation of R-Calt-3 at different drift ratios was lower than that of Calt-3. Cumulative energy dissipation is compared between the original and repaired columns in Fig. 14(b). The repaired column showed smaller cumulative energy dissipation at end of each load cycle than the original column. This is attributed to the brittleness of the CFRP reinforcement and the significant amount of plastic deformation that had already occurred in the internal steel reinforcement during the original test. The cumulative energy dissipation at different drift ratios of R-Calt-3 was also lower than that of Calt-3.
