Repair of Wood Piles Using Prefabricated Fiber-Reinforced Polymer Composite Shells

Roberto Lopez-Anido, M.ASCE¹; Antonis P. Michael, S.M.ASCE²; Thomas C. Sandford, M.ASCE³; and Barry Goodell⁴

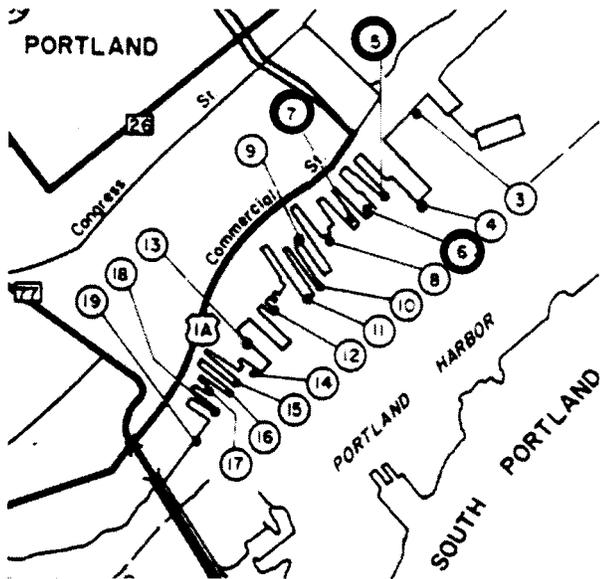
Fig. 1. Piers inspected in Portland Harbor, adapted from Maine DOT (1986)

A harbor on the Northeast coast of the United States, a region where wood piles traditionally have been used, was selected to conduct a case study. The condition of structural wood piles repaired using various methods in Portland Harbor piers was determined by visual inspection in May 2000. The objective of the inspection was to assess methods currently used to repair damaged wood piles. Wood pile repair methods in three piers—Portland Pier (7), Custom House Wharf (6), and Maine Wharf (5)—were inspected during low tide, as depicted in Fig. 1. The Portland Pier had a timber-retaining wall with solid fill, wood piles, and a wood deck supporting a parking lot (Maine DOT 1986). The Custom House Wharf had an earth-filled pier structure with wooden timber and a steel crib bulkhead, wood piles, and an asphalt-paved wood deck; several marine-related businesses were operating on the pier (Maine DOT 1986). The Maine Wharf pier had wood piles with a concrete deck (Maine DOT 1986).

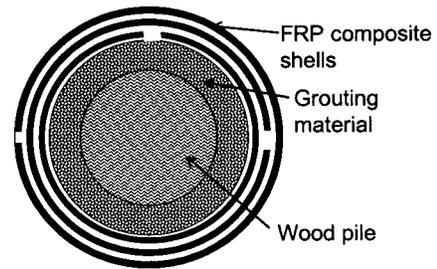
Fig. 5. Cross section of wood pile repaired with fiber-reinforced polymer composite shells

The wood pile repair method proposed in this paper utilizes an FRP composite encasement or shield that encapsulates and splices the deteriorated portion of the pile. The encasement was developed based on experience with appropriate technologies in the structural FRP composites field (Kshirsagar et al. 2000; Lopez-Anido and Karbhari 2000; Lopez-Anido et al. 2000; Lopez-Anido and Xu 2002) combined with the needs for wood pile protection and strengthening observed in the field inspection, survey, and literature review. The shield is made of bonded thin and flexible FRP composite prefabricated cylindrical shells that deliver the required strength to repair damaged wood piles. The shells are fabricated in a quality-controlled composites manufacturing facility. The cylindrical shells have a slit or opening along their length, which enables them to be opened and placed around the deteriorated wood pile. Since it is advantageous to encase the pile with a series of overlapping shells, the minimum number of FRP composite shells required is two; however, additional shells can be added, depending on the structural restoration needs. The slit in each cylindrical shell is staggered to avoid lines of weakness through the entire shield (Fig. 5).

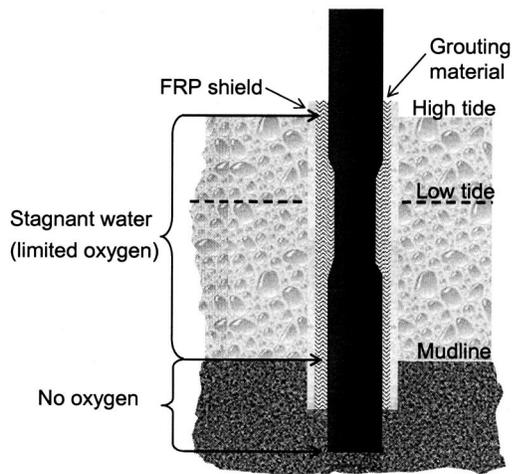
In the proposed repair method, the space between the FRP composite shield and the wood pile is filled with a grouting material that does not provide a structural bond with the wood pile, but rather provides interlocking (friction) between the wood pile and the FRP composite shells. Since the grout is not expected to completely seal the wood core, seawater saturates the pile, creating a layer of stagnant water, potentially limiting the oxygen supply. Assuming a lack of oxygen, marine borers already inside the wood pile would be expected to die and new borers would be prevented from attacking the wood pile. A schematic of the proposed repair system is depicted in Fig. 6.

Fig. 6. Schematic of wood pile repair with fiber-reinforced polymer composite shells

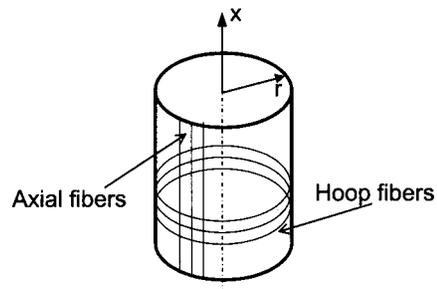
The proposed fiber architecture for the FRP composite shell consists of three layers of unidirectional continuous fabric reinforcement in the longitudinal direction (0°), one layer of unidirectional continuous fabric reinforcement in the hoop direction (90°), and two outer CSM layers (Fig. 7). The intent is to fabricate the final FRP composite shield from these shells in place on the pile using adhesive to bond the shells together. This is done because the individual shells have the required compliance to be opened wide enough along the seam to fit around the wood pile. The elastic nature of the shell would then allow it to return to its original fabrication dimensions. This design also allows the seams to be oriented so that overlapping of seams does not occur.

Fig. 7. Fiber reinforcement of fiber-reinforced polymer composite shell

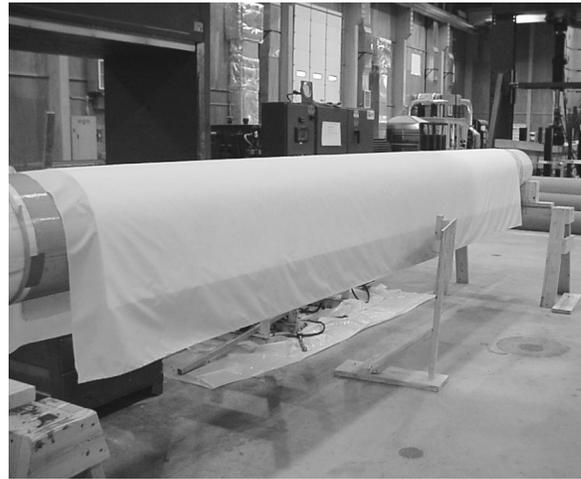
Fig. 8. Dry fabrics and peel ply on PVC mold

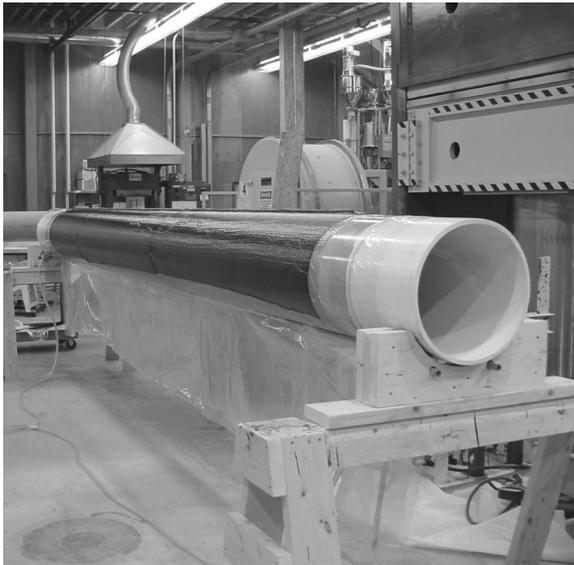
Fig. 9. Tube vacuum bag placed over system

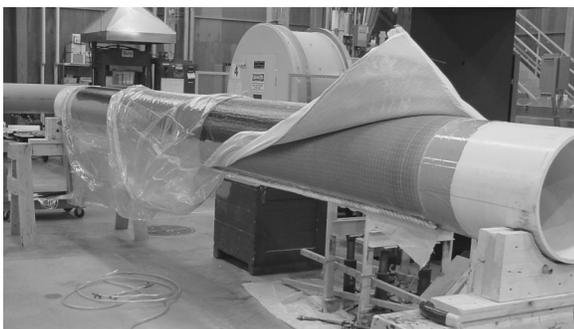
To overcome the fabrication problems encountered, a variation of the VARTM process, the licensed Seemann Composites Resin Infusion Process (SCRIMP) (TPI 2001), was selected for fabricating the FRP composite cylindrical shells with the longitudinal slit. A PVC pipe rated for 900 kPa internal pressure was used as a mold or tool. The fabric reinforcement was placed on the cylindrical mold dry (Fig. 8), and then the fabric reinforcement was sealed with a tubular vacuum bag (Fig. 9). Vacuum pressure of -102 kPa was applied with a vacuum pump and resin was infused through a resin pot. The pressure differential between the atmosphere and the applied vacuum allowed infusion of the resin into the fabric reinforcement layup. Once the resin completely impregnated the fiber reinforcement, the vacuum pressure was reduced to -51 kPa until the resin gelled. The vacuum pressure debulked (compacted) the dry fiber reinforcement. After the resin gelled, vacuum pressure was removed and the part was allowed to cure. A cured, partially exposed cylindrical shell is shown in Fig. 10. The FRP composite shell was then removed by pulling open the longitudinal slit.

Fig. 10. Demolding of cured fiber-reinforced polymer composite shell

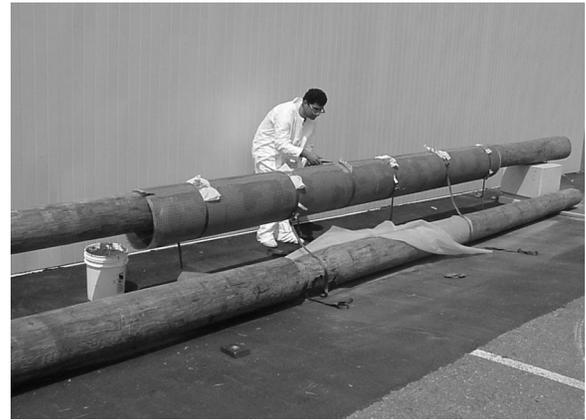
The feasibility of the repair method was demonstrated in the laboratory by fabricating FRP composite shells and restoring “damaged” wood pile prototypes (Fig. 11). Marine borer damage was simulated by reducing the cross-sectional area of the pile. The space between the wood core and the FRP composite shells was filled with a grouting system. Two different grouting materials were used: (1) portland cement-based (inorganic) structural grout (Fig. 12), and (2) polyurethane-based (organic) nonstructural grout with shear connectors that transfer loads from the wood pile to the FRP composite shells (Fig. 13). Laboratory prototypes were fabricated for two types of experiments: (1) pushout tests by compression loading to characterize the interface response (wood/grout/shear connector/FRP composite) (Lopez-Anido et al. 2004a); and (2) full-size bending tests to characterize the overall structural response (Lopez-Anido et al. 2003).

Fig. 11. Application of fiber-reinforced polymer composite shells to predamaged wood pile

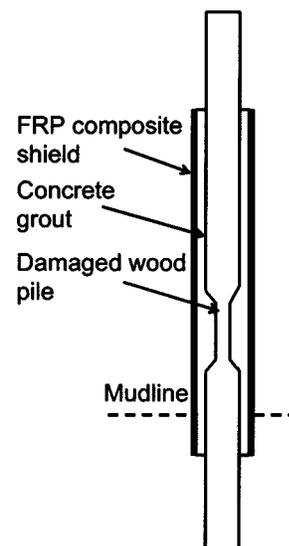
Fig. 12. Fiber-reinforced polymer composite repair system with cement-based grout

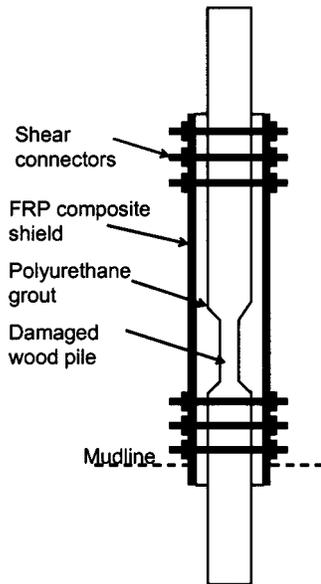
Fig. 13. Fiber-reinforced polymer composite repair system with shear connectors and polyurethane grout
