TxDOT Project 0-6731

Repair Systems for Deteriorated Bridge Piles

Technical Memorandum #4a

Task 4a: Full-scale laboratory tests of repaired piles

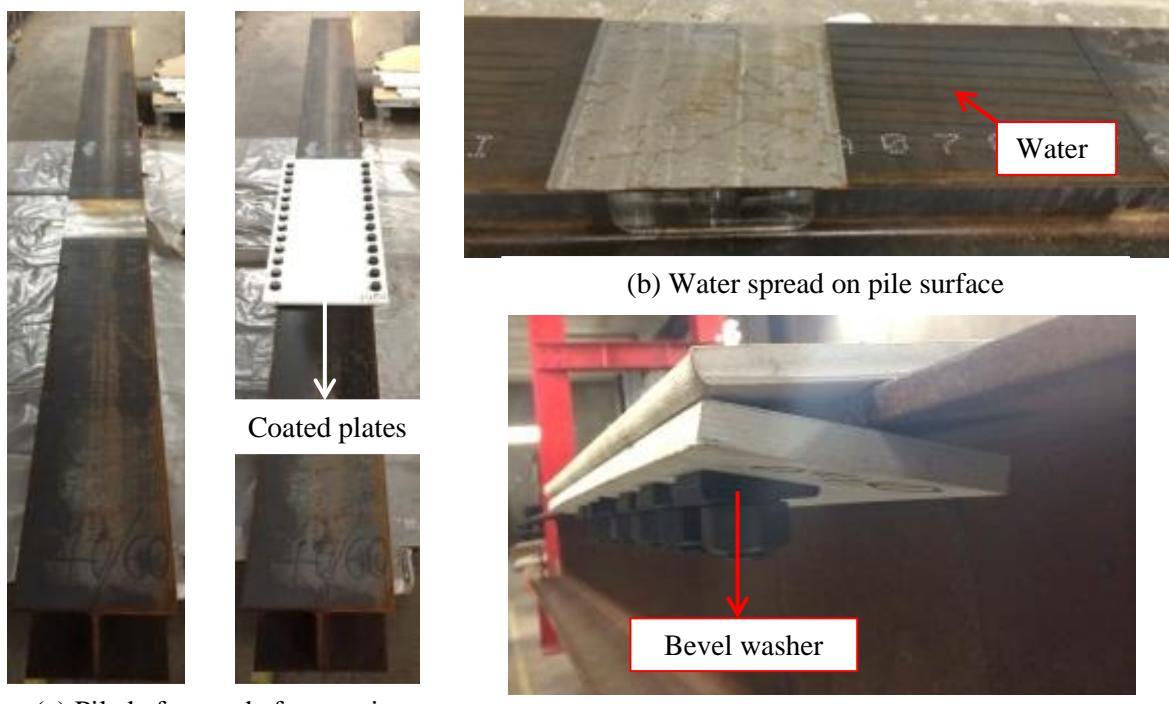
Figure 4: Fabrication of Steel-based Repair System

Figure 4(a) shows one of the piles that were repaired using the steel-based system. The new steel plates were coated with two layers of coatings (Technical memorandum #2) to be protected against corrosion and provide adequate coefficient of friction between the repair plates and the existing pile. The first layer, a solvent-based, inorganic ethyl silicate, zinc-rich coating, was directly applied onto the freshly sandblasted surfaces of the steel plates,; the second layer, a non-zinc containing, Class B-rated, polyamide epoxy coating, provides the necessary coefficient of friction. Before assembling the plates, water was spread on the surfaces of the flanges, as shown in Figure 4(b) to simulate the coefficient of friction in an underwater application. The bolts were tightened to 28kips using a calibrated torque wrench following the TxDOT bolting specification (TxDOT Metric Special Provisions to Item 447-Structural bolting, 2004). Bevel washers were used, as shown in Figure 4(c) to minimize the bending of the bolts for all specimens except 40/60-S.

(a) Pile before and after repair

(c) Bevel washers

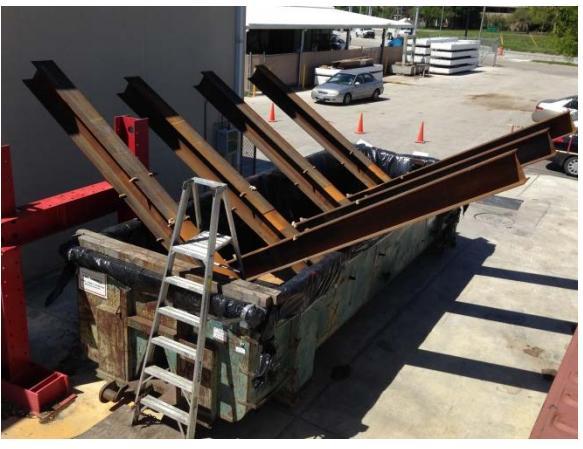
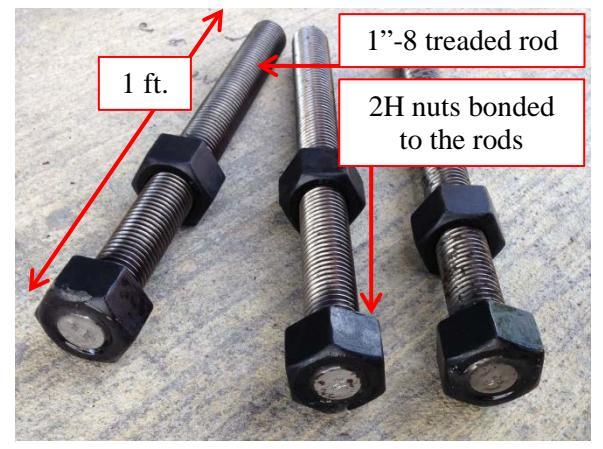
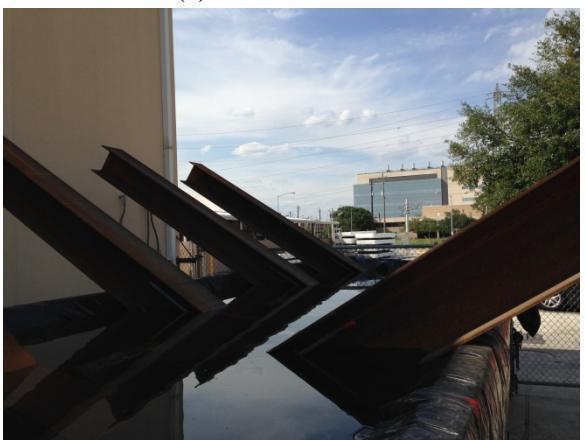
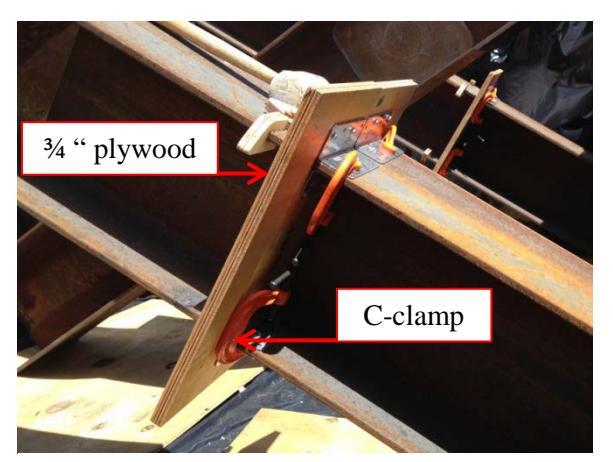
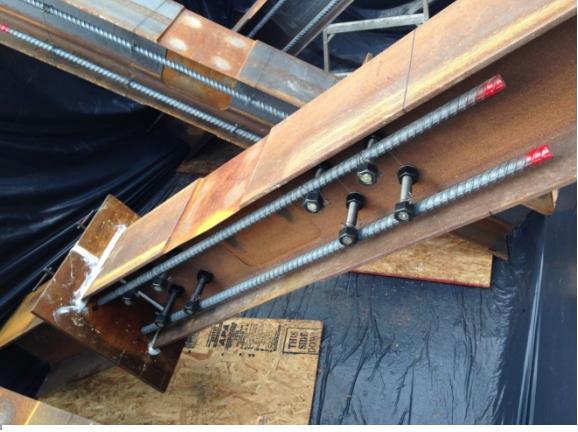
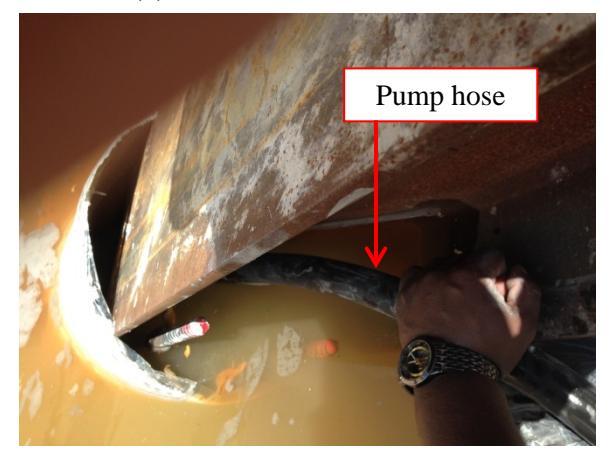
Figure 12: Implementation of the FRP-based Repair System

Figure 12 shows the details of the underwater repair process for the FRP-based repair systems. The repairs were conducted in a 5-1/2 ft. deep steel tank to simulate as closely as possibly an on-site repair application. The repairs were conducted in five steps as illustrated in Figure 12 and summarized below:

- 1. Preparation and installation of the end-caps
- 2. Preparation and installation of the rebars and anchors
- 3. Submerging the corroded piles in water
- 4. Installation of the FRP jackets
- 5. Casting grout

(a) Placing the piles in the repair tank

(c) headed-stud anchors

(e) submerging the piles in water

(b) end-cap detail

(d) rebars and anchors installation

(f) casting grout

To simulate the underwater repair process, all 7 piles in each group were placed into a 22'x8'x5.5' tank. The piles rested on the edge of the tank in an inclined configuration to ensure that the milled region was submerged in water after filling the tanks as shown in Figure 12(a) and (e). The tanks were filled with potable municipal water after installing the end caps, rebars, and anchors but before the jacket installation. This was done to simplify the

Figure 12 (d) shows the installed rebars and anchors. Longitudinal rebars were installed for the 40/20-F1/R, 40/20-F2/R, 40/60-F1/R, 40/60-F2/R, 80/60-F1/R, 80/60-F2/R, 80/60-F1/RA, 80/60/V-F1/RA, 80/60/V-F1/RA, 80/60/V-F2/RA, 80/60/3-F1/RA, and 80/60/3-F2/RA piles. The #6 and #8 rebars were held in place using tie wires that were wrapped around the rebars, piles, and anchors. The anchors consisted of 12" long, 1" diameter threaded rods (UNC thread) with double heavy nuts that were used to snug tighten the anchors to the web of the piles and to provide a head similar to that of a headed anchor. Figure 12(c) shows the partially assembled anchors. Anchors were installed on the six piles with the most severe loss of section, i.e.80/60-F1/RA, 80/60-F2/RA, 80/60/V-F1/RA, 80/60/V-F1/RA, 08/60/V-F2/RA, 80/60/3-F1/RA, and 80/60/3-F2/RA. Eight holes, four above and four below the milled region, were drilled in the web of each pile using a magnetic drill. In an underwater application this can be achieved using a pneumatic drill.

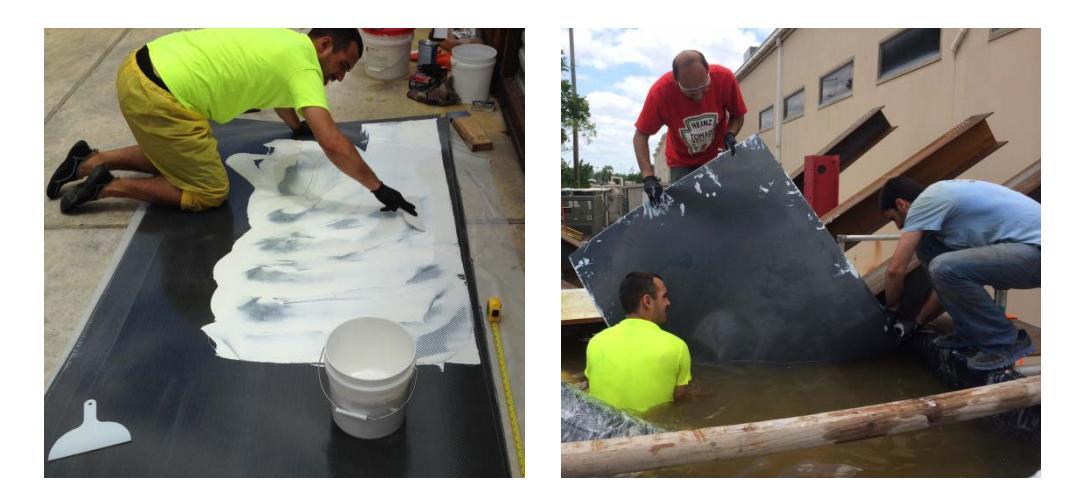
Figure 13: Installing FRP Jacket for F1 FRP-based Repair System

Before installing the FRP jackets, the repair tank was filled with water to submerge the milled region of the piles. Figure 13 shows the process of installing the F1 type FRP jackets. The FRP laminate for the F1 repair system was pre-cut to the desired length and shipped to the laboratory by the manufacturer. The laminate was hand sanded with 60 grit sand paper to roughen the surface and wiped clean with a piece cotton cloth. As shown in Figure 13, after applying the underwater-curing epoxy to the surface of the laminate, the laminate was wrapped around the pile and pressed against the end-cap. A 10 ft. long laminate was wrapped completely around each pile twice (providing a jacket with two layers of CFRP) with a minimum of 8-in of overlap length at the end of the wrap. For the piles with a 1 ft. long corroded region a 4-ft. long repair was implemented resulting in load development lengths of 1.5 ft. above and below the corroded regions. For the pile with a 3 ft. long corroded region, two 4-ft. wide laminae were provided with an 18-in overlap located at the center of the milled region resulting in a total repair length of 6.5 ft. This resulted in load development lengths of 1.75 ft. above and below the corroded regions. The installation of the jackets on seven piles was completed in one day by one trained representative from the manufacturer and two untrained graduate student assistants. The jacket installations were achieved using hand tools and minimal power tools and did not require any heavy equipment.

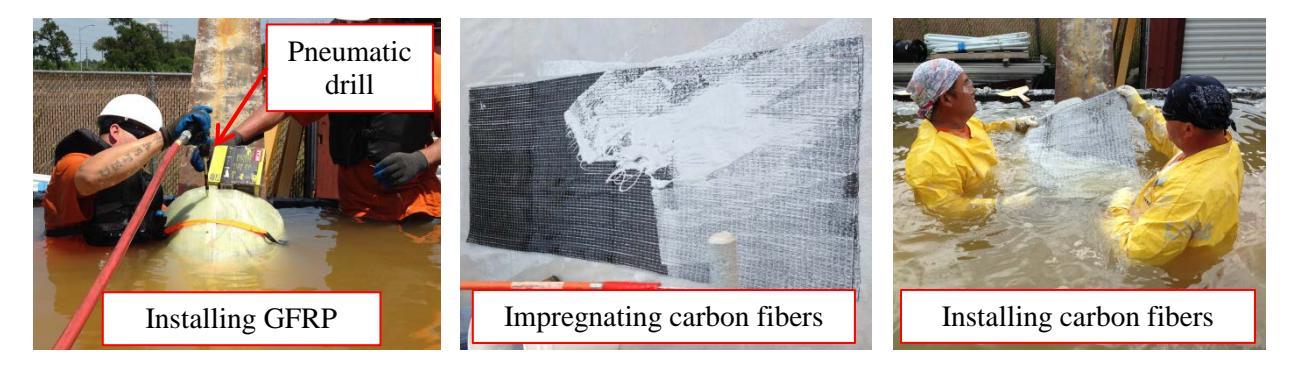
Figure 14: Installing FRP Jacket for F2 FRP-based Repair System

Figure 14 shows the steps for installing the F2 FRP jackets. The F2 FRP jackets consisted of 2 plies. The first ply was a pre-fabricated unidirectional GFRP cylinder with the primary fibers oriented in the hoop direction of the jacket. The jacket, which had a nominal diameter of 18 in., had an unbonded vertical seam that ran the entire length of the jacket which allowed it to be easily installed around the pile. The 12 in wide overlapping seam was sealed using self-tapping screws spaced at 6 in. on center and an underwater curing epoxy adhesive. The second ply was a wet lay-up unidirectional CFRP that was installed with the structural fibers oriented in the hoop direction. The lengths of the jackets were 4 ft. and 6.5 ft. for the piles with 1 ft. and 3 ft. corroded regions respectively. Installation of the jackets on all seven piles was completed in three days by three trained representatives who were sent by the manufacturer. The jacket installation was completed using basic hand and power tools and did not require any heavy equipment.

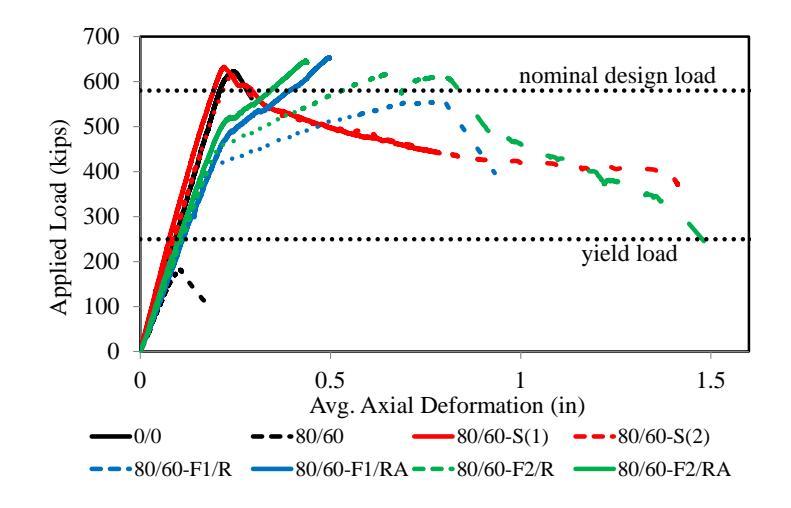
Figure 24: Load-deformation Response of the Piles 80/60 Repaired with Three Different Systems

Figure 23 and Figure 24 illustrate the failure mode and axial load-deformation relationships, respectively, of the 80/60 group of piles. The behavior is compared to that of the corroded and uncorroded control piles. Table 8 summarizes the measured axial peak loads, elastic stiffnesses, and failure modes of all of the tested piles.

Pile	Axial Peak Load	Stiffness	Failure Mode
	[kips]	[kips/in]	
0/0	623	2776	FB^{a}
80/60	182	2001	FLB^{b}/WLB^{c}
80/60-S(1)	632	3271	FLB/WLB
$80/60-S(2)^d$	615	2798	FLB/WLB
80/60-F1/R	556	2286	FRP Rupture
80/60-F2/R	617	2294	FRP Rupture
80/60-F1/RA	653	2182	No Failure ^d
80/60-F2/RA	646	2408	No Failure ^d
