Assessment and Evaluation of Timber Piles Used in Nebraska for Retrofit and Rating

Sponsored By
Nebraska Department of Roads

April, 2014

1. Report No.	2. Government Accession No.	3. Recipient's Catalog No.	
4. Title and Subtitle Assessment and Evaluation of Timber Piles Used in Nebraska for Retrofit and Rating		5. Report Date April. 2014

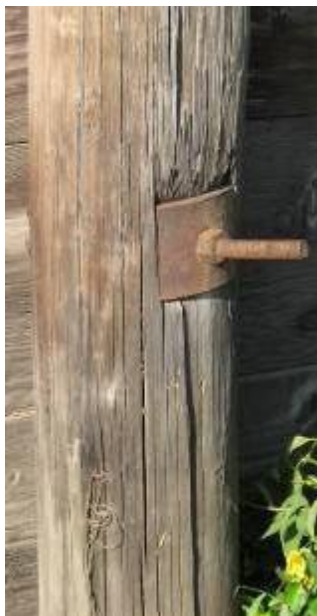
(a) Mechanical Damage

Physical damages are caused by different factors and cause the deterioration of exterior treated wood cover. Damage of exterior protective cover provides biological mechanism access to interior untreated wood resulting in decay of the interior wood. Different types of physical damages are shown in Figure 2.1. The most common type of physical damage is caused by impact of objects floating in water. Physical damage is also caused by overloading due to heavy loads, failure of adjacent piles, and over-tightening of the fasteners. Fire can destroy and cause failure of timber pile bridges in a matter of hours. Partially burned timber pile can carry load depending on the remaining unburned cross section of the pile.

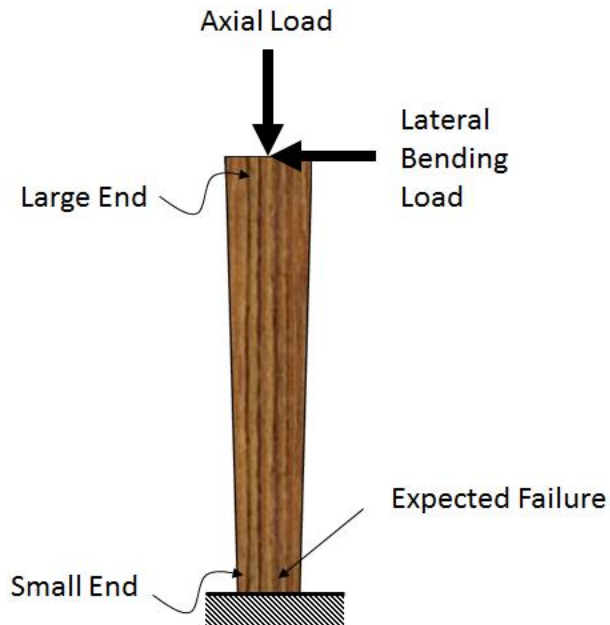
rotation free at the large end. With the large end of pile free to rotate and the small end fixed, the failure is expected in the pile section near the small fixed end of the pile as shown in Figure 5.4. However as discussed earlier, due to heterogeneous timber material, non-uniform specimens, and accompanied loading eccentricities, it is difficult predict precise location of the failure.

Figure 5.4: Expected failure at the small fixed end of the pile
