Investigation of Steel-Stringer Bridges: Superstructures and Substructures, Volume II

Final Report
October 2007

Sponsored by
the Iowa Highway Research Board (Project TR-522)
and the Iowa Department of Transportation (CTRE Project 04-184).

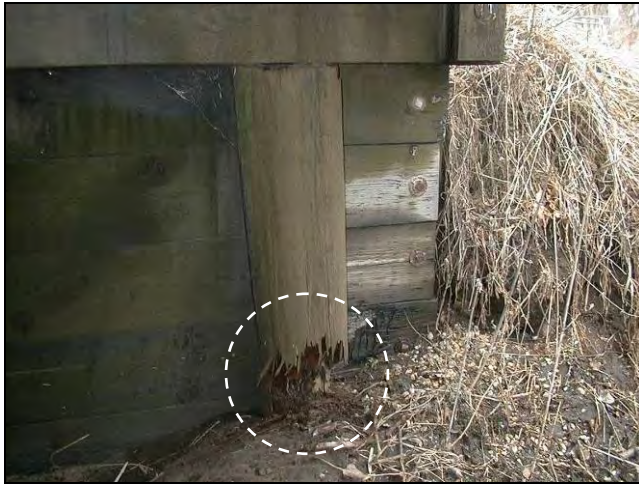
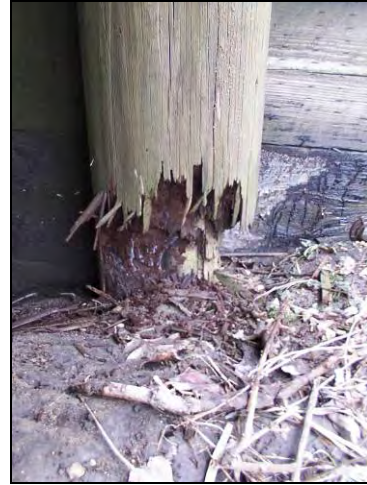
(a) Reduction of pile cross section (Bridge No. 13-42-06 Buchanan County – February 16 2005)

Figure 4.1. Timber pile biological deterioration

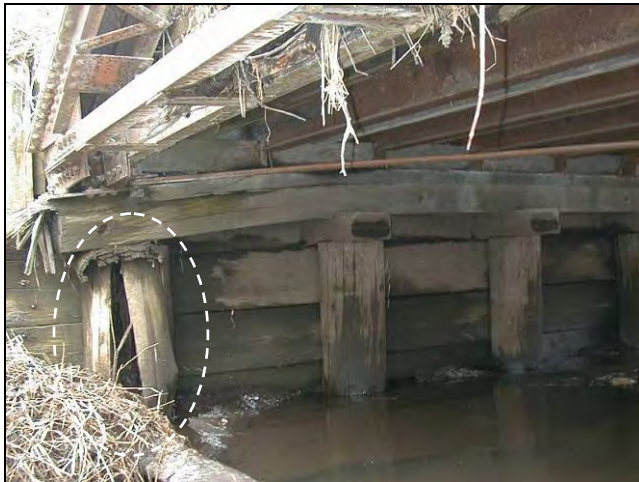
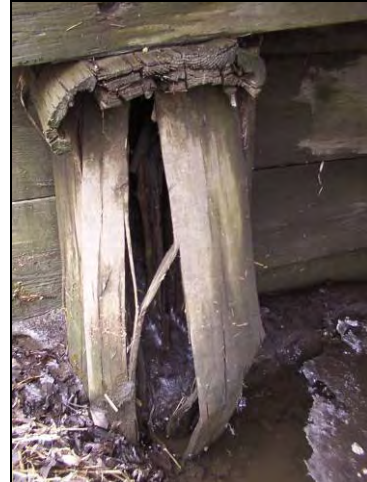
(b) Complete deterioration of pile section (Bridge No. 27-42-00 Buchanan County – February 16 2005)

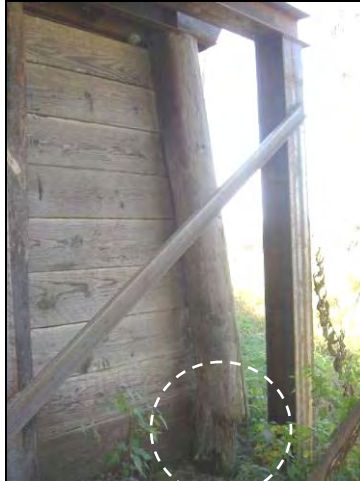
(a) Separation of pile section (Bridge No. 23-70-00 Mahaska County – July 8 2005)

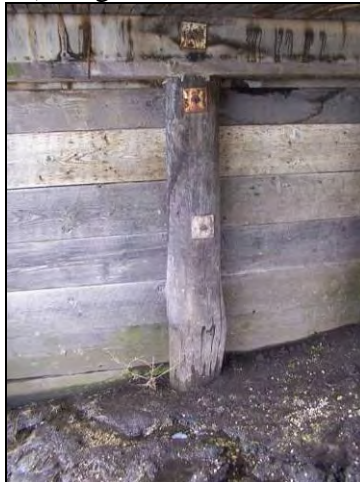
(b) Bulging of timber fibers (Bridge No. 35-87-00 Buchanan County – February 15 2005)

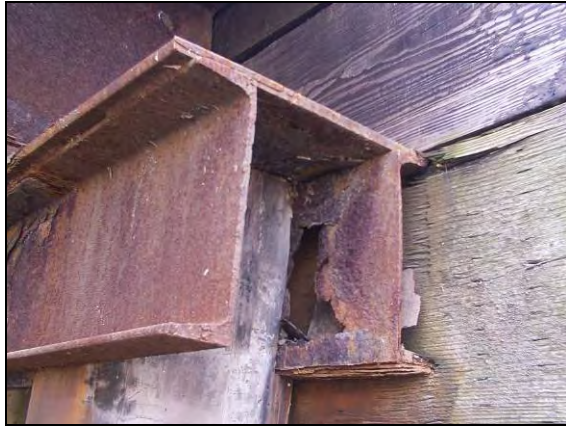
Another observed form of substructure degradation was deterioration of pile caps. A corroded steel cap is presented in Figure 4.7a, while a biologically deteriorated timber cap is shown in Figure 4.7b. Deteriorated pile caps can result in poor load-bearing characteristics and overloading of adjacent piles.

(a) Corroded steel
(Bridge No. 1045 Black Hawk County
– April 2 2005)

Figure 4.7. Deterioration of pile cap

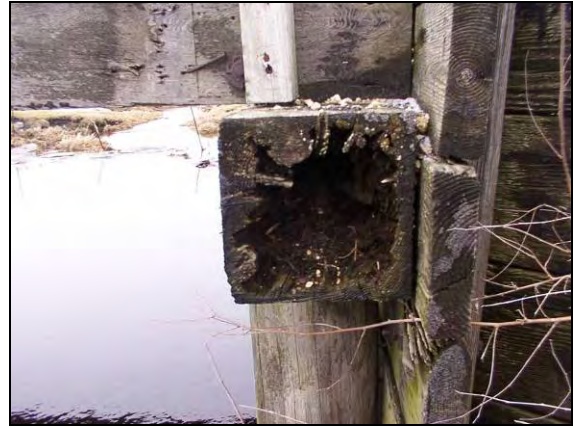
(b) Biologically degraded timber cap
(Bridge No. 15-00-62 Buchanan County
– February 15 2005)

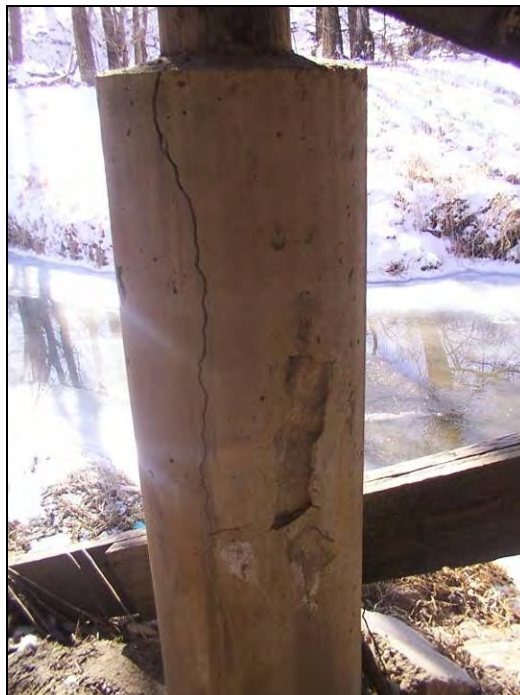
As mentioned in the pile maintenance section, concrete casing, which can be used to restore timber, concrete or steel piles, is typically used when the pile cross sectional area is reduced by 10 to 50%. At one bridge, the center piers were encased with concrete as shown in Figure 4.8. Inspection at this site showed that longitudinal cracks and concrete spalling were present in all concrete casings, which may have resulted from corrosion of reinforcement and freeze-thaw degradation (See Figure 4.9). Another maintenance practice observed is the addition of a new pile adjacent to a defective pile. In the case of progressive deterioration at one pile, a new pile (timber or steel) is driven next to the faulty pile as shown in Figure 4.10. The final maintenance practice observed is the complete replacement of the existing abutment system, which mainly occurred when advanced deterioration is widespread in more than one pile threatening the integrity of the bridge.

Figure 4.9. Spalling and cracking of concrete casing (Bridge No. 149 Boone County – February 11 2005)

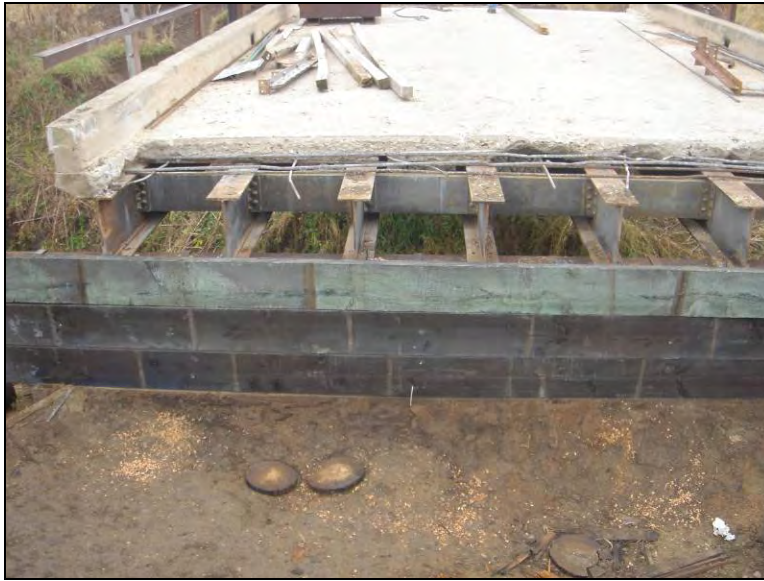
In one bridge in Tama County, IA, complete replacement of an existing timber abutment with a new timber abutment system was documented. Replacement was conducted because of severe deterioration at both the north and south abutments. Several deterioration problems were identified at the north abutment such as brooming of the pile section due to overloading, soft section near the ground level with high moisture content, and hollow pile section caused by biological decay (See Figure 4.11). To drive new piles, a section of the concrete deck was removed and about 20 ft of the gravel road near the backwall was excavated (Figure 4.12). Four temporary timber piles (two on each side) were driven adjacent to the sides of the bridge and steel beams were placed on top of them under the existing girder to support the bridge as the

Figure 4.12. A section from the concrete deck is removed for driving timber piles (Bridge No. 31-72-50 Tama County – September 8 2005)

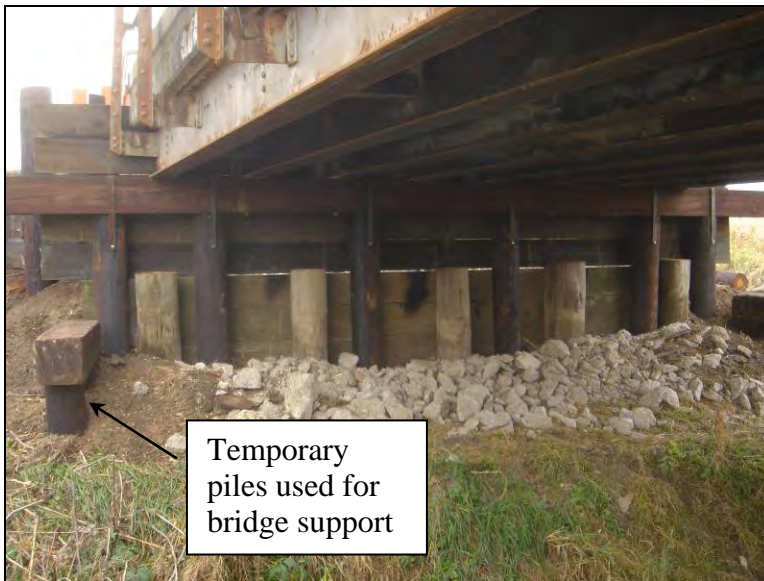
deteriorated piles were cut short. The new timber piles were driven next to the existing ones and a new timber pile cap was placed under the girders and connected to the new piles. The supporting beams were removed and the old and temporary piles were left in place (Figure 4.13). Leaving the deteriorated piles in place diverts the biological decay away from the new piles, however, it is still recommended to treat the causes of biological decay if the new piles are timber. As an alternative, steel piles can be used for maintenance as shown in Figure 4.14.

Figure 4.13. New timber abutment system constructed at the north side (Bridge No. 31-72-50 Tama County – September 8 2005)

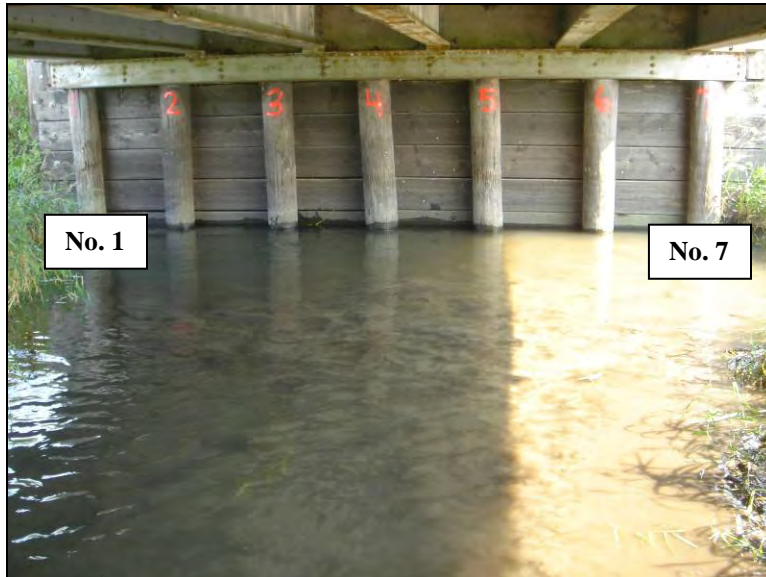
Figure 7.3. Piles denoted by numbers 1 through 7 at the north abutment (Bridge No. 7710 Boone County – July 1 2005)

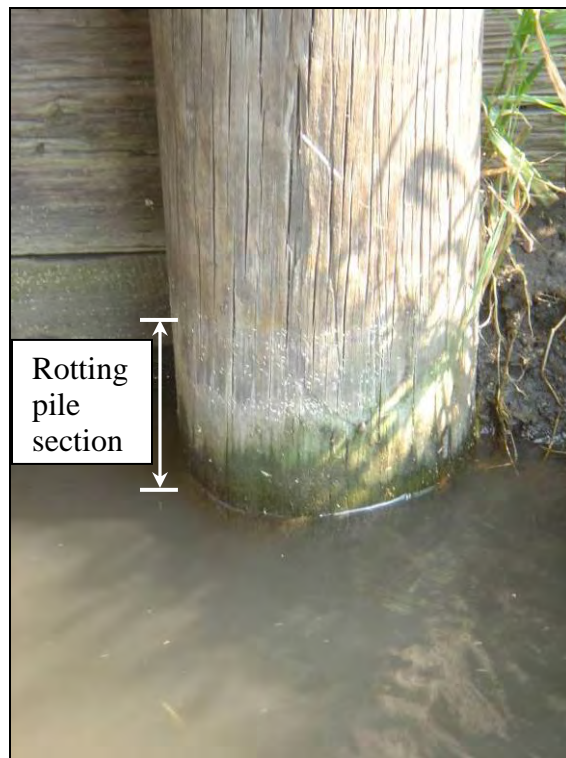
Figure 7.7. Soft section at pile No. 7 above the water level (Bridge No. 7710 Boone County – July 1 2005)

In the third test conducted, load was applied at the east edge of the bridge. The strains and the locations of the applied loads are shown in Figure 7.12. The highest strains were measured in pile no. 6. One interpretation of the high strains is the transfer of axial load from the adjacent pile no. 7 due to the soft pile section observed at the water level (Refer to Figure 7.7). The strain transducer attached to pile no. 7 (denoted by 1-7) measured positive strain values. As shown in Figure 7.13, the pile cap is not aligned over the centerline of pile no. 7 and is partially resting on the backwall. This may have produced eccentric axial loads, which may lead to pile bending and hence positive strains in the upper portion of the pile. The same observation was noted when the abutment was previously loaded at the centerline of the bridge. All strains measured in pile no. 1 were positive. This indicates that pile no. 1 was subjected to tension due to a net uplift force on the west edge of the pile cap.

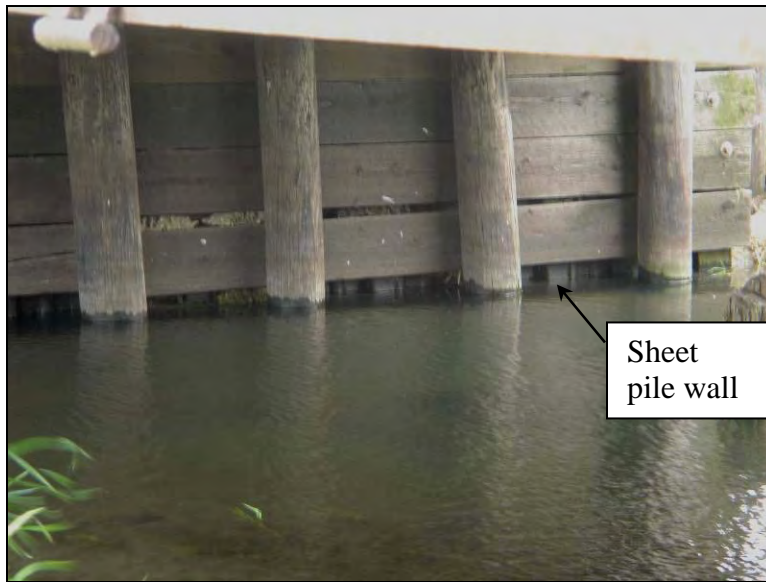
Each abutment is comprised of seven timber piles about 7 inches in diameter, a timber backwall, and a double c-channel cap (See Figure 7.2). The average exposed length of the piles above the water table was about 50 inches. The pile length below ground level is unknown since no bridge plans were available. The piles at the north abutment were denoted as no. 1 located at the northwest edge of the bridge, through no. 7 as shown in Figure 7.3. The dimensions of the north abutment are shown in Figure 7.4. A schematic diagram of the abutment, shown in Figure 7.5, indicates that the bridge does not have a conventional stub-abutment detail; the girder ends are integrally connected to a concrete diaphragm, which rests directly on top of the pile cap. This integral connection complicates the substructure analysis due to the difficulty in quantitatively, isolating, and understanding its effect on load distribution through the substructure components. Inspection of the north abutment revealed decay at pile no. 1 about 32 inches above the water level (See Figure 7.6). Also, a soft pile section right above the water table was observed at pile no. 7 as shown in Figure 7.7. The soft section may be a result of high levels of moisture due to the variation of the water table, which in turn triggers biological activity. Excessive scour occurred near the south abutment undermining the timber backwall. This led to exposure and erosion of the backfill material creating a void behind the backwall. In 1993, as shown in Figure 7.8, a sheet pile wall was driven behind the south abutment to prevent further erosion; the erosion-induced void was filled with concrete.

Figure 7.8. Sheet pile wall driven behind the south abutment to prevent backfill erosion (Bridge No. 7710 Boone County – June 1 2005)

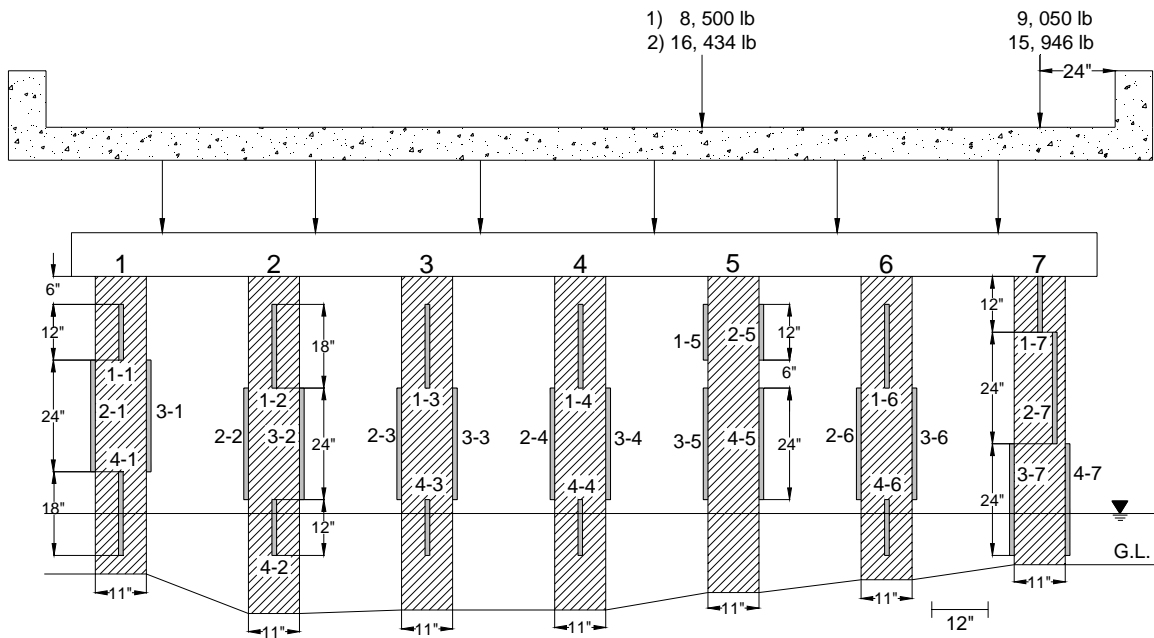
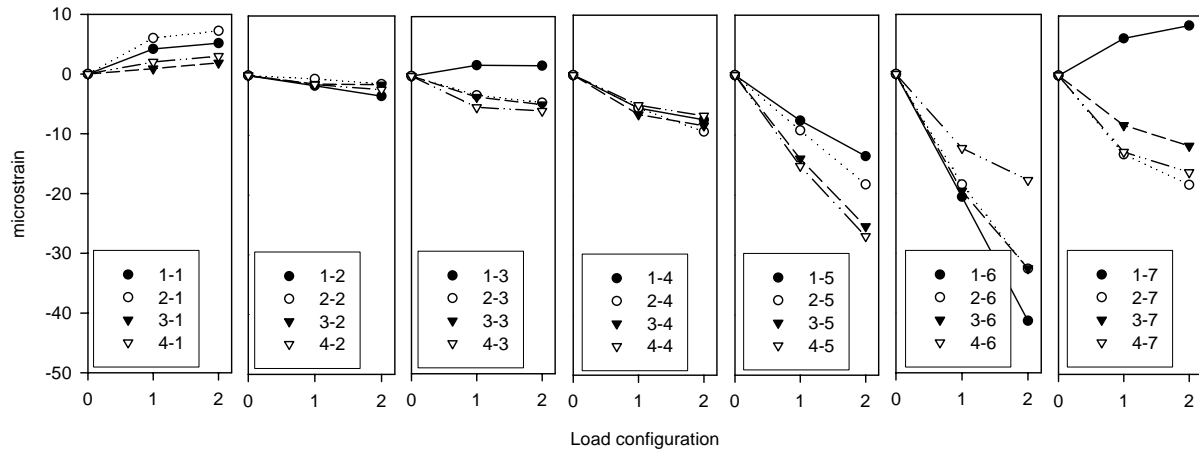
Figure 7.12. Pile strains at the north abutment – East edge (Bridge No. 7710 – Boone County)

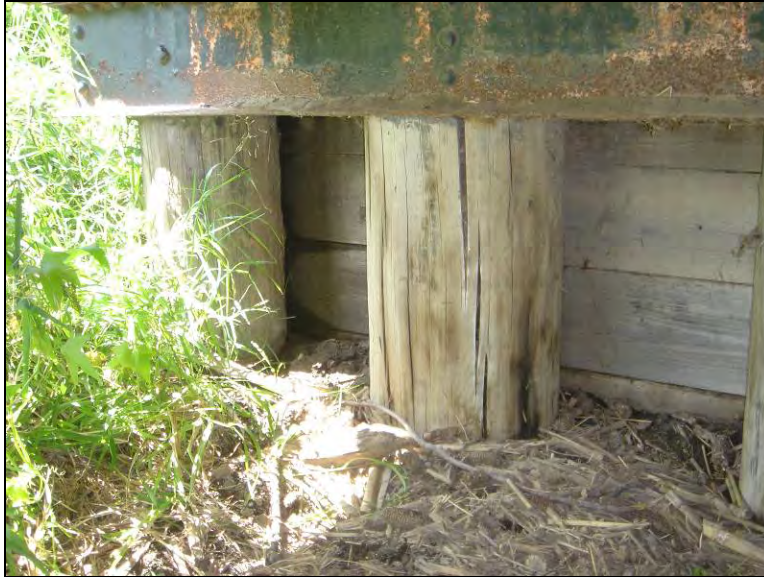
According to maintenance records, the substructure was inspected in spring of 1998. Pile no. 2 (added at a later date) and pile no. 4 at the north abutment were identified as having about 50% section loss. Prior to 1998, substructure rating varied between good and satisfactory. The bridge was inspected again by a consultant in December 2003. The bridge substructure was given a poor condition rating with seven piles undergoing decay. These piles, however, were not identified in the inspection report.

Visual inspection revealed that both abutments showed signs deterioration. At the north abutment, hammer sounding and probing indicated that pile no. 2 had a hollow core. Considerable pile cracking was also noted (See Figure 8.6). Also, advanced biological deterioration was observed at pile no. 4; the intact pile diameter was about 3 inches as shown in Figure 8.7. The intact pile was surrounded by timber powder, which was reddish brown in color, possibly caused by brown-rot fungi. At the south abutment, high moisture content was observed at the ground level resulting in a rotted section in piles nos. 1 and 4 (See Figure 8.8).

Figure 8.6. Hammer sounding and probing revealed a hollow core at pile no. 2 at the north abutment (Bridge No. 243470 Marshall County – June 22 2005)

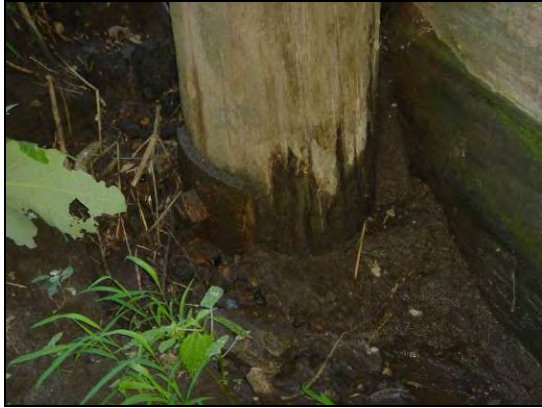
(a) Pile no. 1

Figure 8.8. Rotting pile sections at the south abutment caused by high moisture content near the ground level (Bridge No. 243470 Marshall County – July 22 2005)

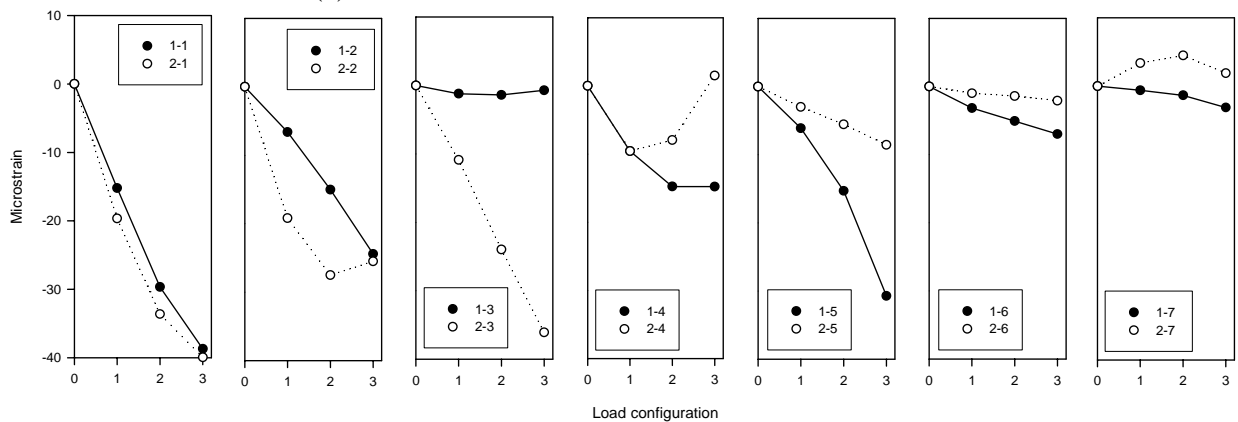
(b) Pile strains

Figure 8.11. Static load test at the west edge (Bridge No. 243470 – Marshall County)

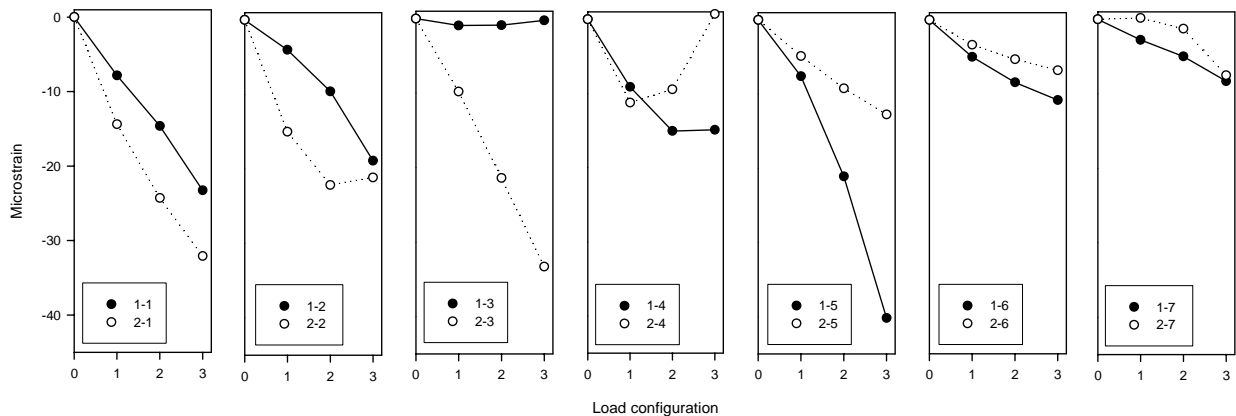
The second load test was carried out by aligning the truck wheel on the centerline of the bridge deck. Location of the applied loads and the pile strains are shown in Figure 8.12. Similar to the previous load test, pile nos. 1, 3 and 5 had the highest strains. Also, the deteriorated pile nos. 2 and 4 demonstrated behavior similar to the previous test where the strains increased initially to a maximum value after which they decreased. The maximum strain value recorded for pile no. 2 was about -27 microstrains. Strain transducer 1-4 increased to a value of -12 microstrains at load configuration 1 and then decreased with increasing load. Strain transducer 2-4 reached a maximum strain value of -14 microstrains at load configuration 2 and remained constant with increasing load. The results from the west edge and the centerline load tests illustrate that strain transducer 1-3 experienced essentially no strain.

(b) Pile strains

Figure 8.12. Static load test at the centerline (Bridge No. 243470 – Marshall County)

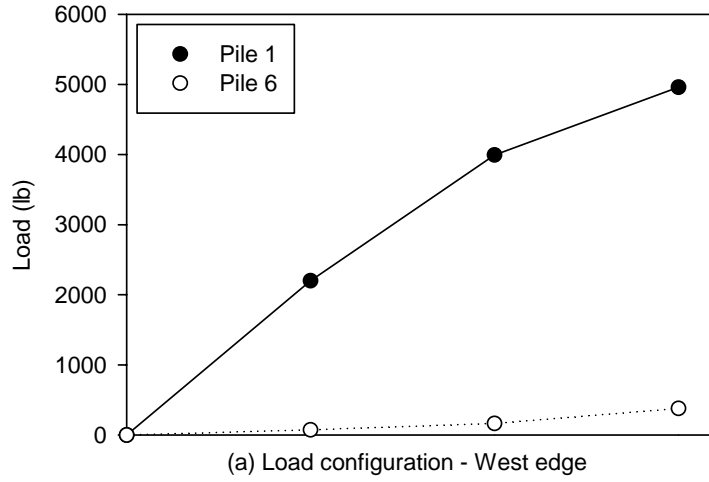
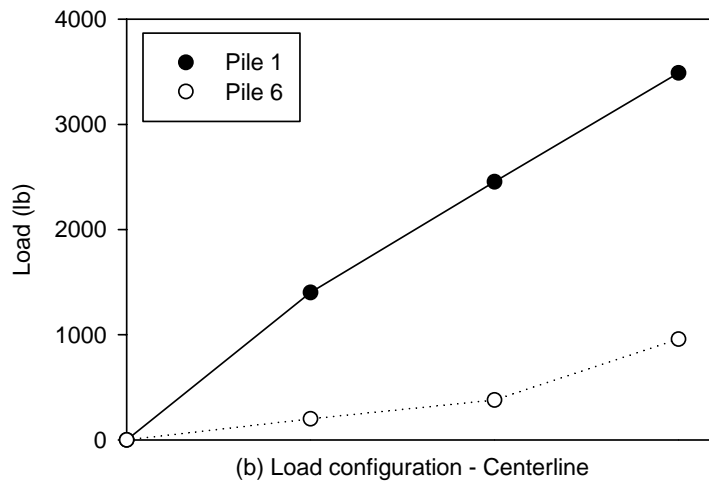
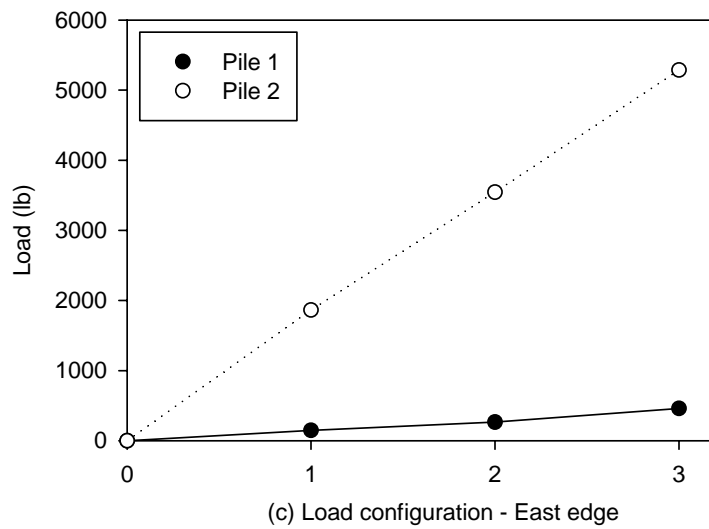
Using E determined by conducting axial compression tests, the loads carried by pile nos. 1 and 6 were determined. Table 8.2 summarizes the calculated loads carried by each pile. The results show that the percent load carried by pile no. 1 during the west edge test was about 13% for load configurations 1 and 2 and about 14% for load configuration 3. The load carried by pile no. 6, however, was about 0.4, 0.5 and 1.1% for load configurations 1, 2, and 3, respectively. It was noted that for load configuration 3, where the highest axial load was applied, the percent load carried by the piles increased compared to previous load configurations. This can be explained by load transfer from adjacent deteriorated piles as their maximum load carrying capacity was reached. The loads carried by the piles during the centerline and east edge tests are also shown in Table 8.2. Figure 8.14 is a graphical representation of the loads carried by pile nos. 1 and 6.

Figure 8.14. Calculated load carried by pile nos. 1 and 6 at the north abutment (Bridge No. 243470 – Marshall County)

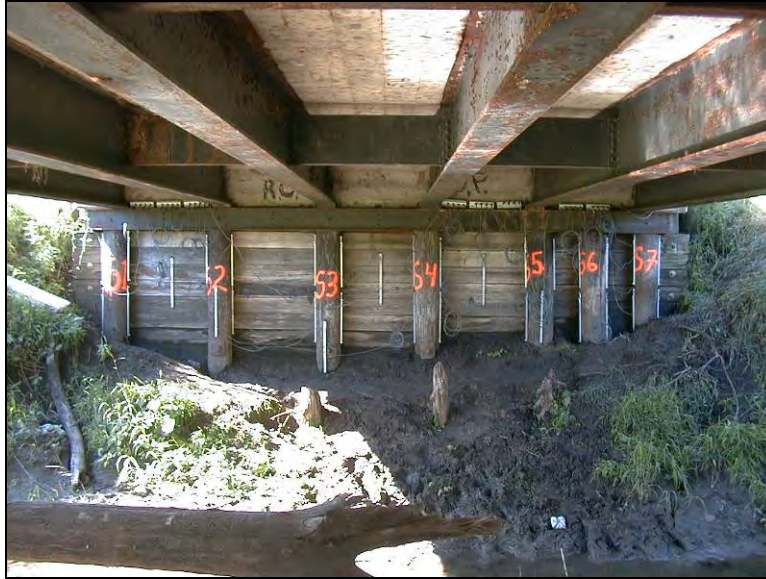
Figure 8.15. Additional strain transducers, with a 24 inch gage length, were attached to the timber backwall. At pile no. 3, a fifth strain transducer, with a 24 inch gage length, was attached so that it crossed the tie back rod to study the influence of lateral restraint on strains induced by axial and horizontal loads (See Figure 8.16). The first load test on the south abutment was conducted at the west edge. Figure 8.17a shows the location of the applied axial load, while Figure 8.17b and c show the piles and backwall strains, respectively. Pile nos. 5, 6, and 7 had the maximum strains. The strains decreased with increasing distance from the applied loads. At pile no. 1, the strain transducer denoted by 1-1 measured positive strains, while the opposing strain transducer 2-1 measured negative strains. This may be due to pile bending in the upper portion of the pile about the weak axis (bending plane perpendicular to the backwall) causing tension on the outer side of the pile and compression on the inner side. Strain transducers 3-1 and 4-1, which were attached near the ground level, measured essentially zero strain. At pile no. 3, strain transducer 4-3, which was crossing the tie back rod, experience essentially zero strain. The lateral constraint caused by the tie back rod may have alleviated the axial compression and/or bending at this location.

**Figure 8.15. South abutment instrumented with strain transducers (Bridge No. 243470
Marshall County – July 27 2005)**

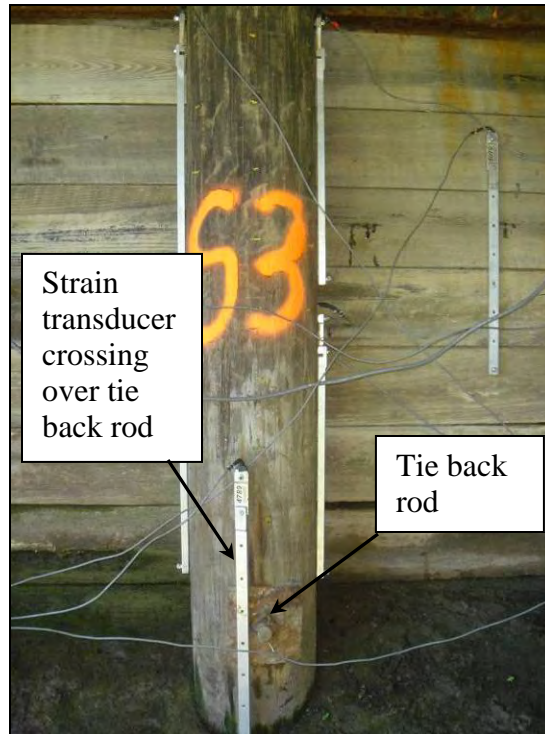
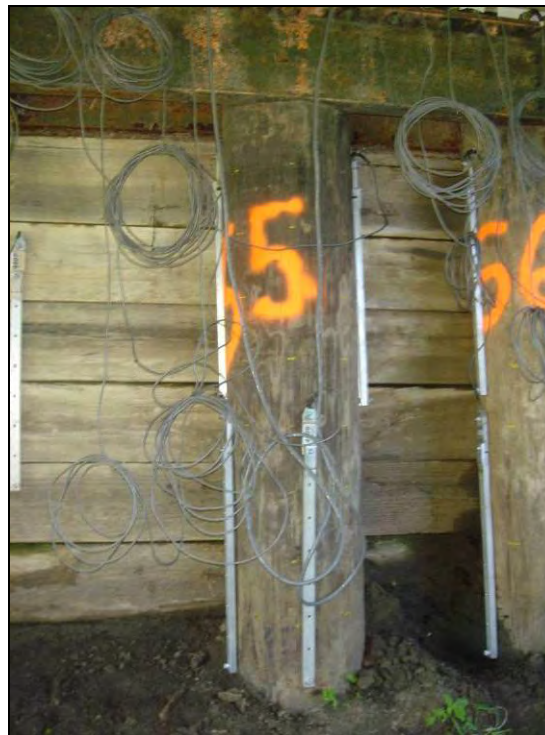
(a) Pile no. 3 at the south abutment

(b) Pile no. 5 at the south abutment

Figure 8.16. Strain transducers crossing over the tie back rod (Bridge No. 243470 Marshall County – July 27 2005)

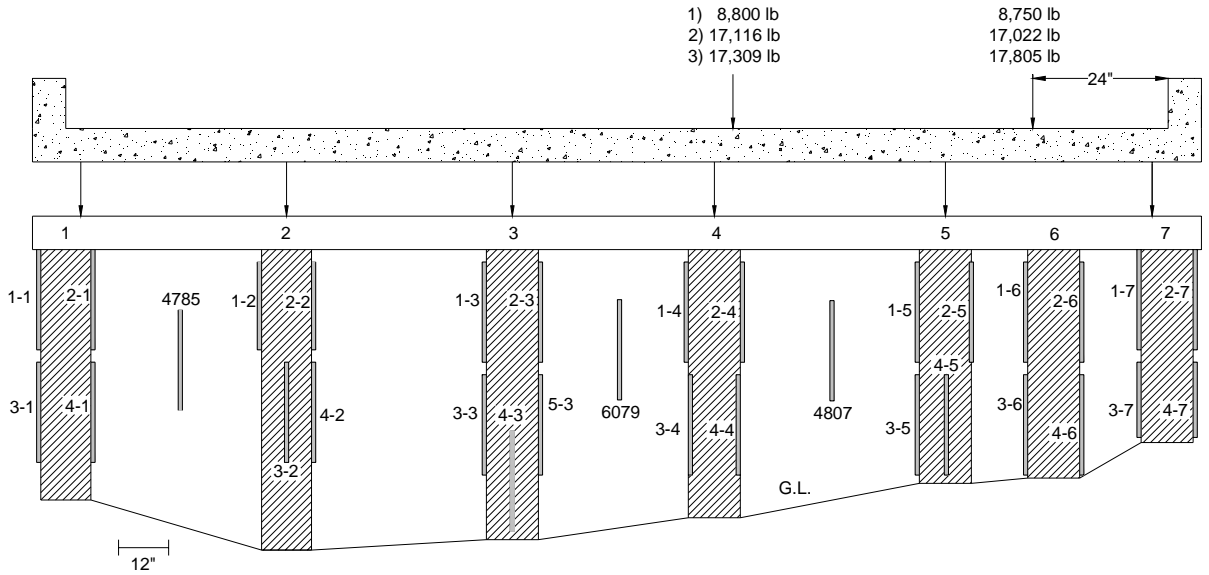
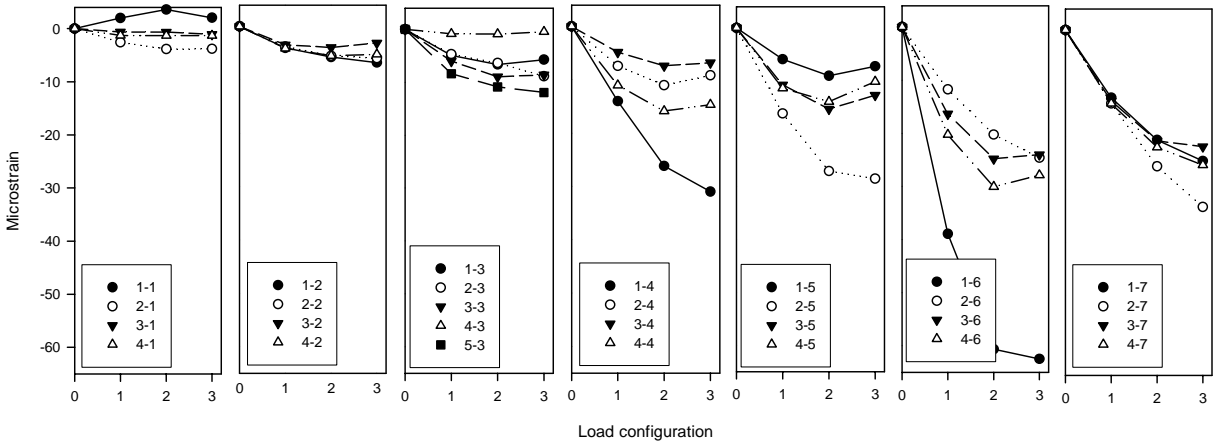
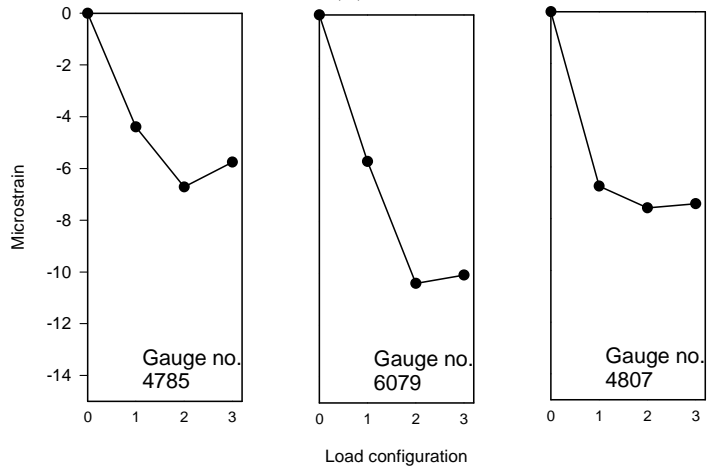
Figure 8.17. Static load test at the west edge (Bridge No. 243470 – Marshall County)

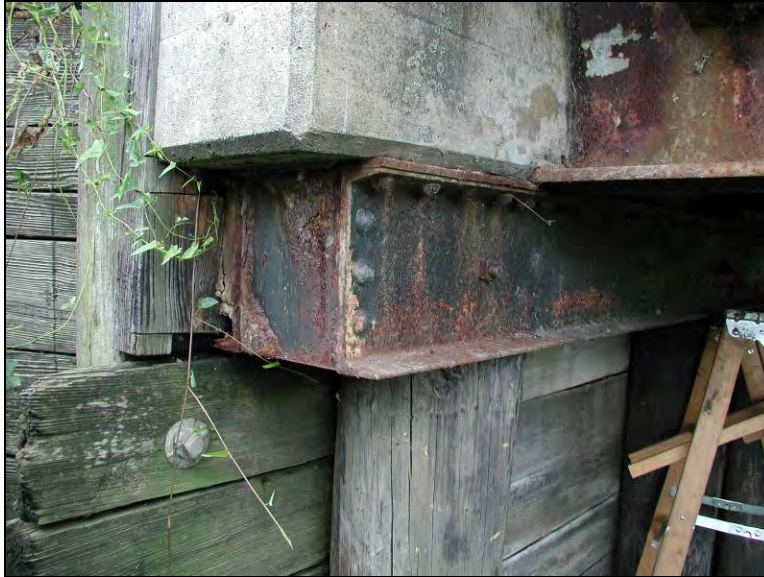
Similar to the pile strains, the backwall strains were higher directly under the live load and decreased with increasing distance from the load location. Figure 8.18 shows the pile cap partially resting on the top of the timber backwall; therefore, the measured negative strains may be a result of axial compression of the backwall.

Figure 8.18. Pile cap partially resting on the timber backwall (Bridge No. 243470 – Marshall County – July 28 2005)

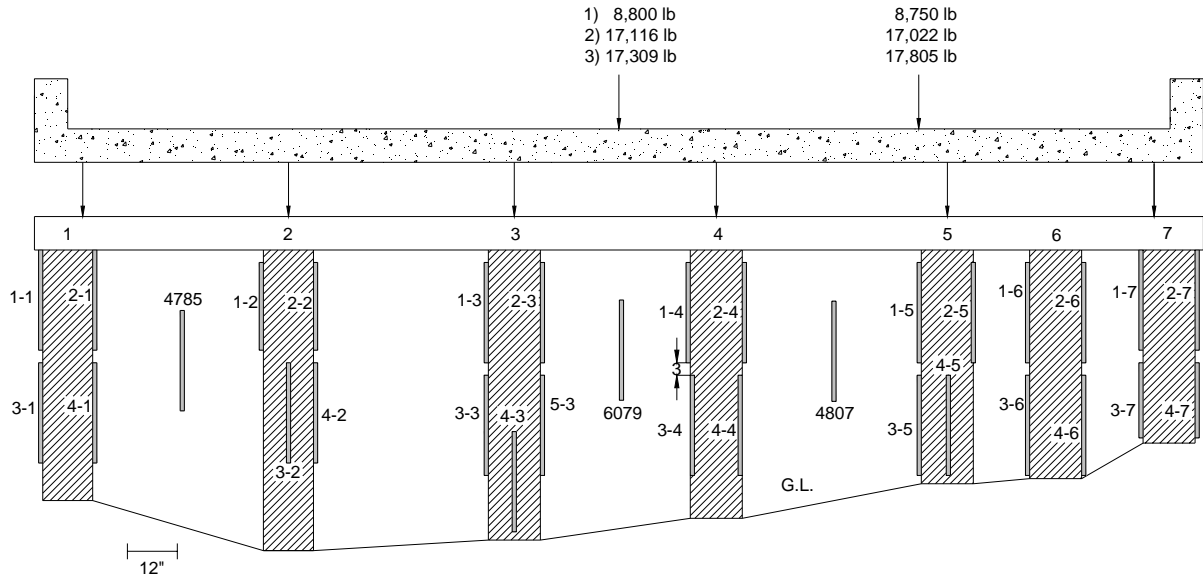
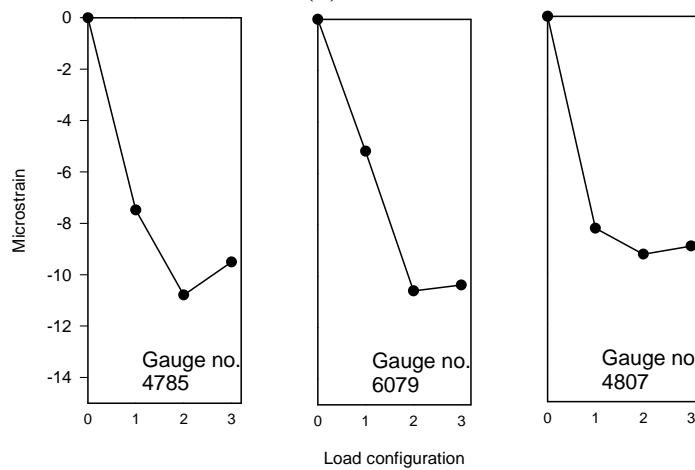
The second load test at the south abutment was completed with the loads at the centerline of the bridge deck. The locations of the applied loads, recorded pile strains, and backwall strains are shown in Figure 8.19. The strains were greatest in pile nos. 4 through 6, and decreased with increasing distance from the applied load. Similar to the previous test, the strain transducer bridging over the tie back rod (transducer 4-3) measured low strains compared to the other strain transducers attached to pile no. 3.

The backwall strains, which were more uniformly distributed compared to the previous test (See Figure 8.19c), were negative during the third load configuration due to the partial bearing of the pile cap on the backwall.

Figure 8.19. Static load test at the centerline (Bridge No. 243470 – Marshall County)

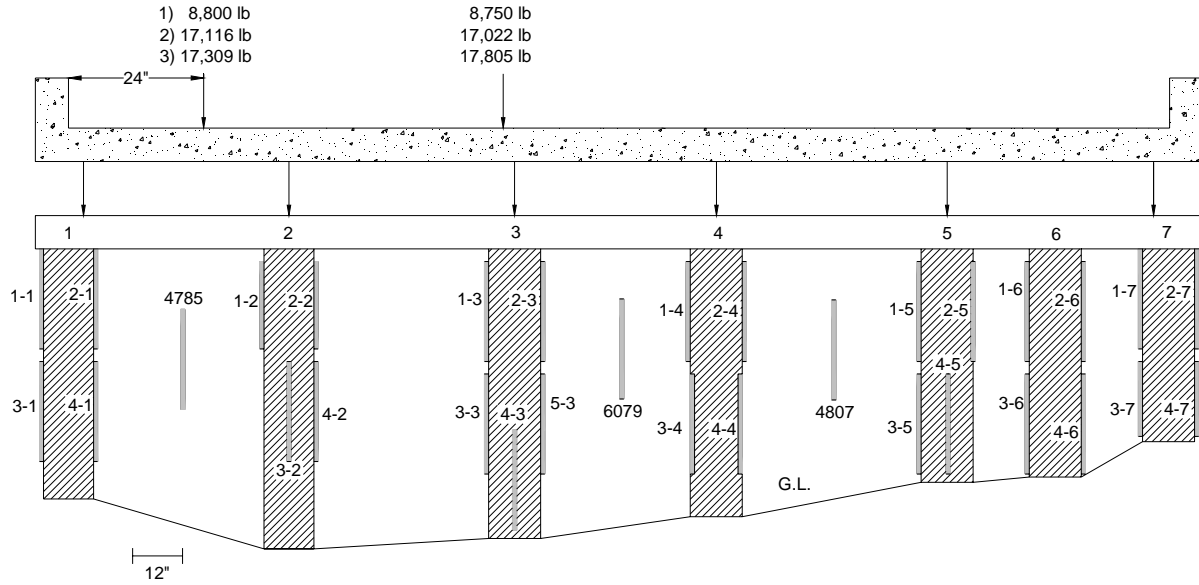
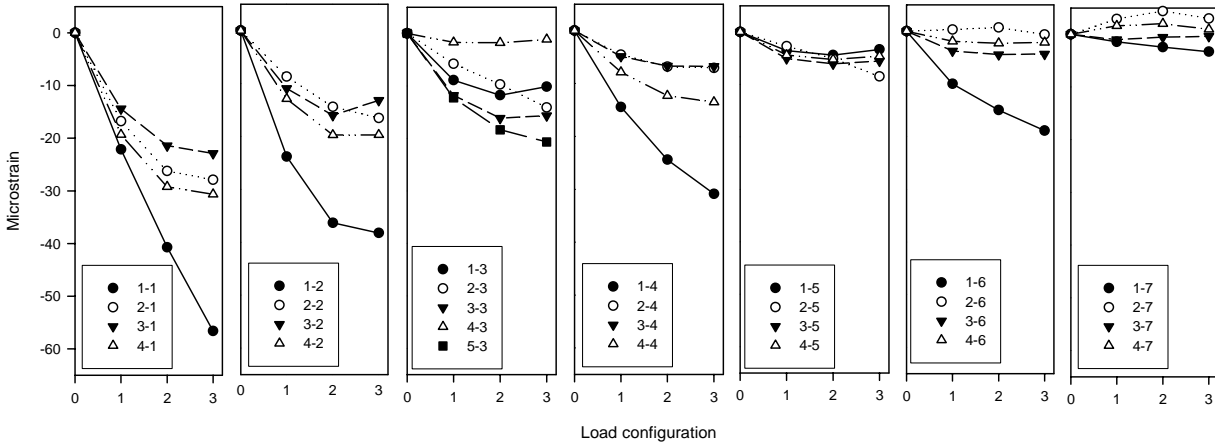
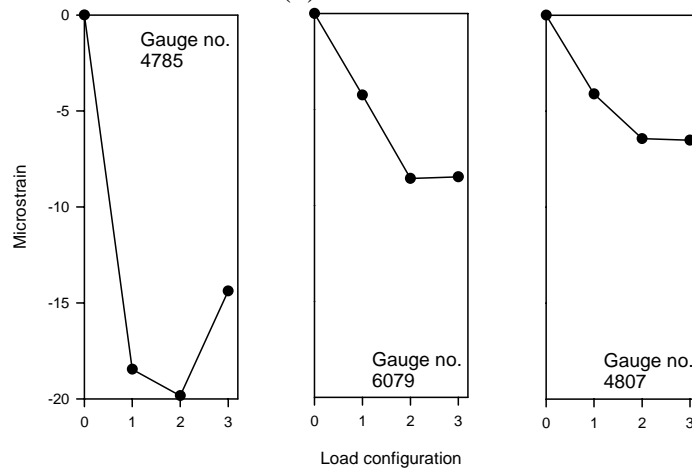
The third test was carried out with the loads positioned at the east edge. The location of the applied axial loads, pile strains, and backwall strains are shown in Figure 8.20. The highest measured strains were directly under the applied load (i.e. pile nos. 1, 2, and 3), and decreased with increasing distance from the location of the applied load. The strain transducer attached over the tie back rod at pile no. 3 indicated negligible strain values. At pile no. 7, strain transducers 2-7 and 4-7, which were connected to the outer side of the pile, recorded positive strain values. The opposing strain transducers 1-7 and 3-7 recorded negative strains.

The strains measured in the backwall showed a non-uniform distribution. Strains were higher at the east side of the bridge directly under the live load and decreased with increasing distance from the load location.

Figure 8.20. Static load test at the east edge (Bridge No. 243470 – Marshall County)

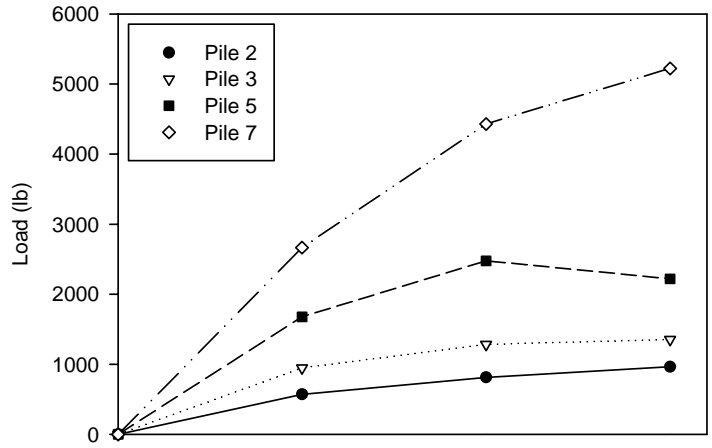
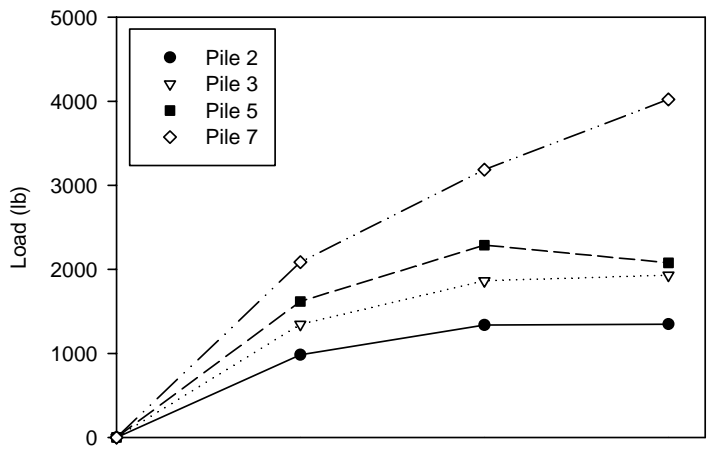
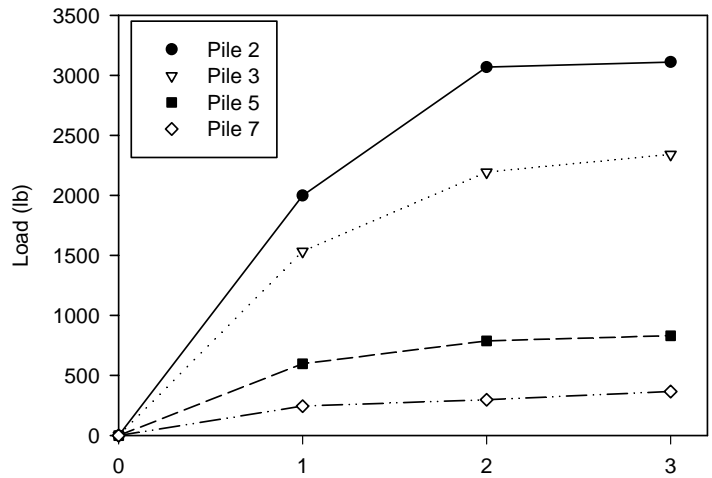
The loads carried by pile nos. 2, 3, 5, and 7 in the south abutment were calculated using their measured E and strain values. Table 8.3 summarizes the calculated loads and the percentage relative to the total applied load. When the load was at the west edge, the percent load resisted by pile No. 7 varied from 13 to 15%, which is comparable to the load carried by pile no. 1 in the north abutment. When the load was at the opposite side of the bridge, the percent load carried by pile 7 ranged from 1 to 1.4%. Loading the bridge at the centerline appears to distribute the load more evenly between piles. Pile no. 2 carried about 10% of the load when the load was positioned directly over it. This is also comparable to pile no. 6 in the north abutment where the carried load ranged from 11 to 15%. The load carried by all four piles was about 30% of the total load. Loads carried by the south abutment piles are presented in Figure 8.21.

Figure 8.21. Calculated load carried by south abutment piles (Bridge No. 243470 – Marshall County)

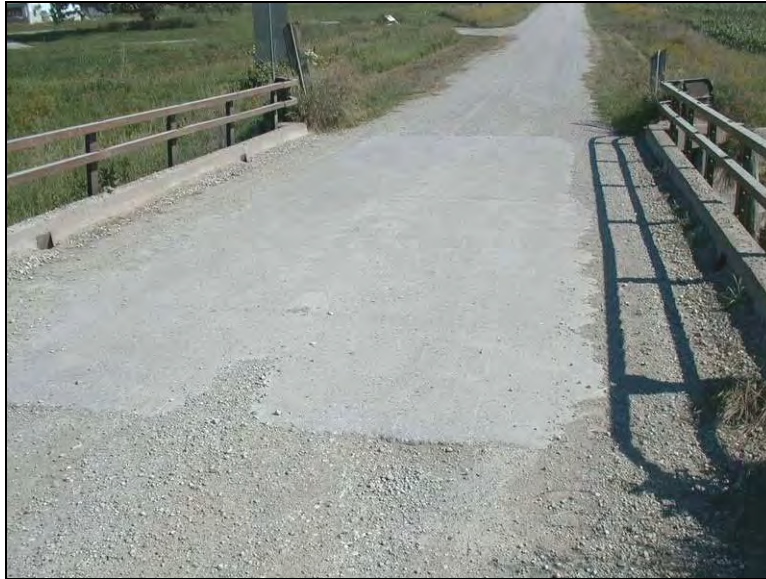
This bridge is located in Mahaska County on Rutledge Avenue near Oskaloosa, Iowa. The bridge, which is a single span, is about 33.3 ft long and 17.5 ft wide (See Figure 9.1). The superstructure, which has a 0° skew, has a concrete deck, which is supported on five steel girders. No plans were available for this bridge.

Figure 9.1. Bridge No. 237350 – Looking north (October 25 2005)

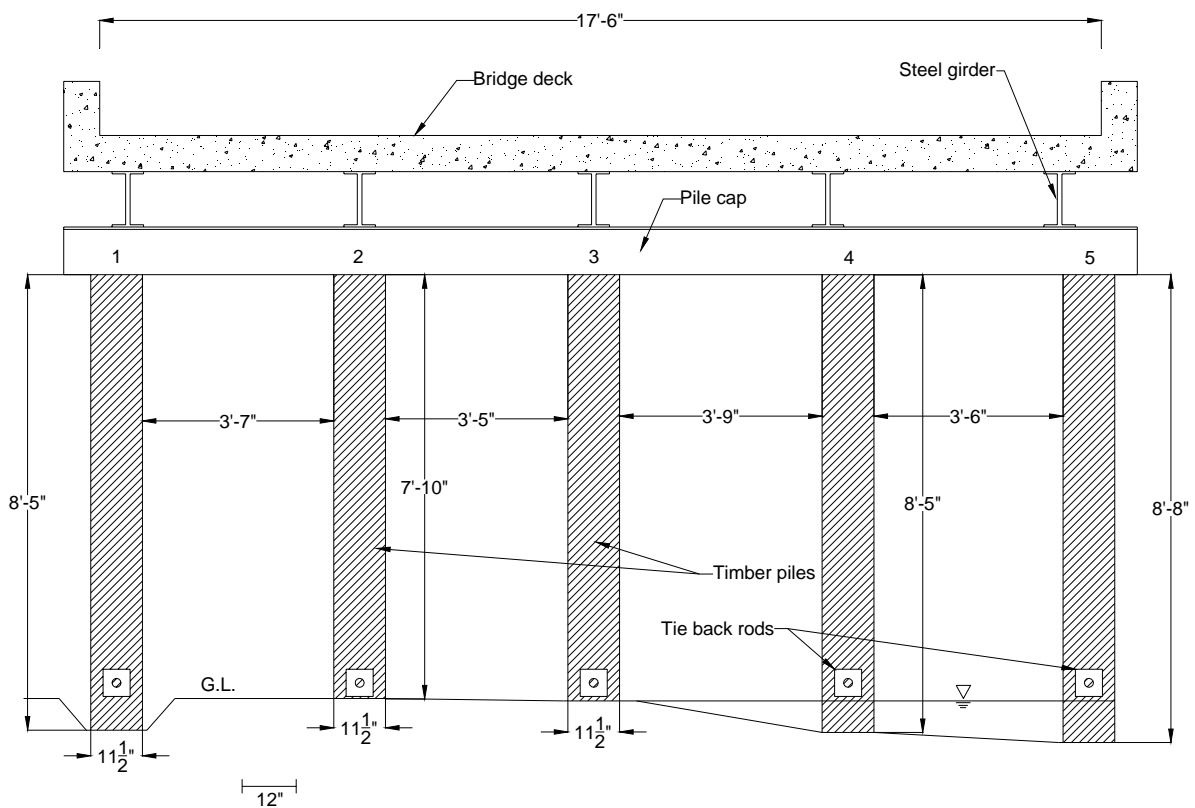
Figure 9.3. Schematic diagram of the north abutment (Bridge No. 237350 – Mahaska County)

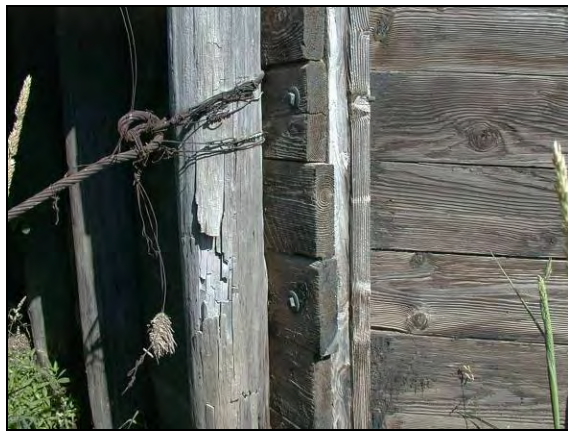
(a) UV degradation

Figure 9.5. Deterioration observed at pile No. 5 (Bridge No. 237350 Mahaska County – October 25 2005)

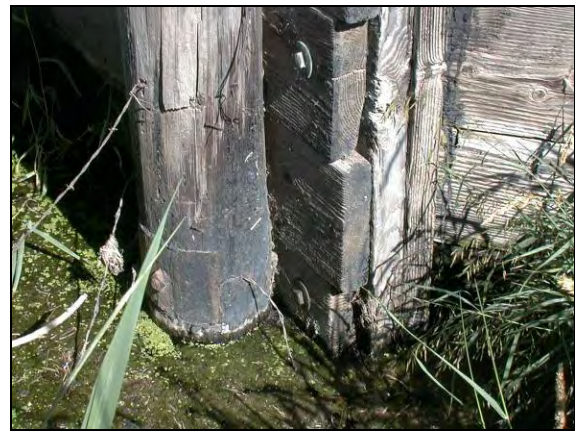
Each abutment is supported on five timber piles in front of a timber backwall with two timber piles at each wingwall. The pile cap is comprised of two double c-channel steel sections. The average exposed pile length and pile spacing at the north abutment are 98 inches and 46 inches, respectively (See Figure 9.2). A schematic of the north abutment illustrating the exposed pile lengths, location of girders, pile spacing, and tie back rod elevations is shown in Figure 9.3. The tie back rods are located at a depth of about 94 inches from the pile heads. Since no plans are available for this bridge, the pile lengths and the length of the tie back rods are unknown. Pile no. 1 at the northwest corner of the bridge showed signs of biological deterioration near the ground level as shown in Figure 9.4. Pile no. 5 at the northeast corner of the bridge showed signs of UV degradation as evidenced by the broken wood fibers on the pile surface; this pile also had a soft section near the water level (See Figure 9.5).

(b) Soft section near the water level
