Investigation of Steel-Stringer Bridges: Superstructures and Substructures, Volume II

Final Report
October 2007

Sponsored by
the Iowa Highway Research Board (Project TR-522)
and the Iowa Department of Transportation (CTRE Project 04-184).

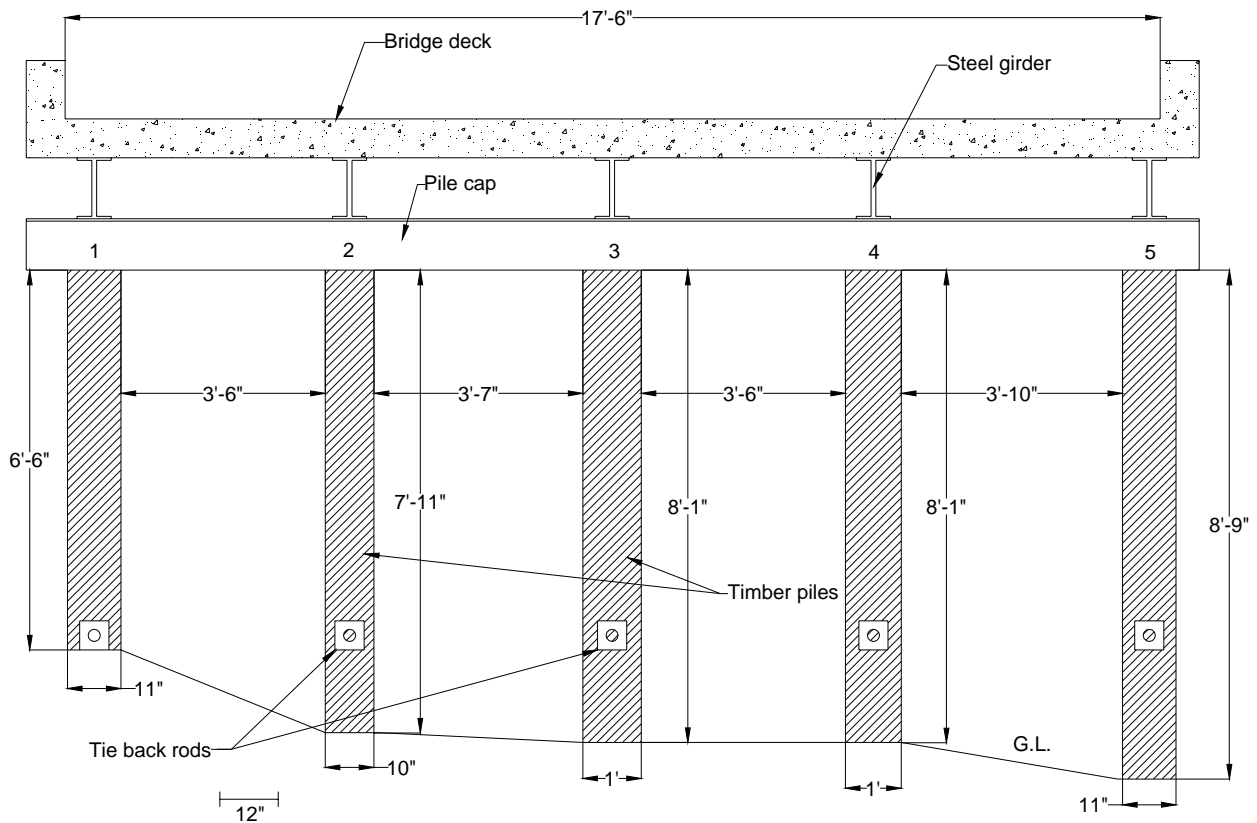
The south abutment, shown in Figure 9.6, has an average exposed pile length of about 94 inches and an average pile spacing of 49 inches. The tie back rods are about 6.5 ft from the pile heads. Figure 9.7 is a schematic diagram of the south abutment illustrating the exposed pile lengths and spacing. Visual observation revealed brooming in pile no. 2 near the ground level as shown in Figure 9.8. For pile no. 5, rotting near the ground level was observed (See Figure 9.9).

Figure 9.7. Schematic diagram of the south abutment (Bridge No. 237350 – Mahaska County)

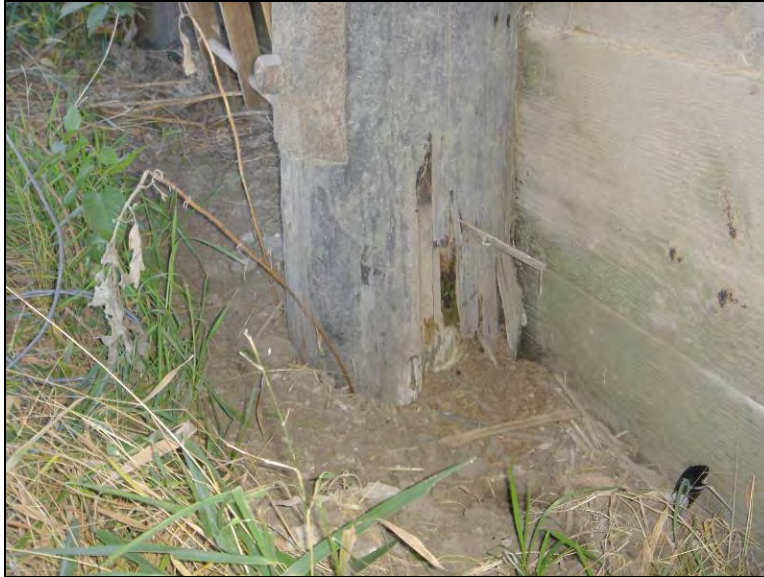
Figure 9.8. Brooming of pile No. 2 near the ground level (Bridge No. 237350 Mahaska County – October 25 2005)

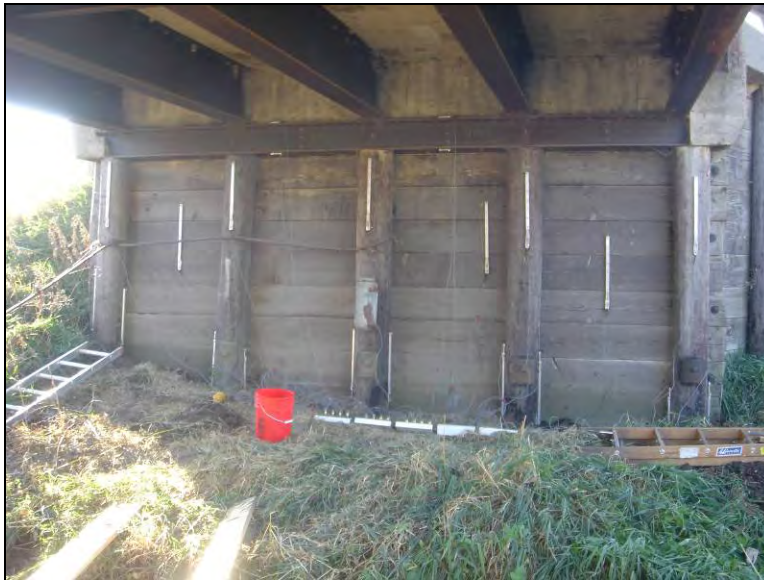
(b) South abutment

Figure 9.10. Substructure instrumentation (Bridge No. 237350 Mahaska County – October 28 2005)

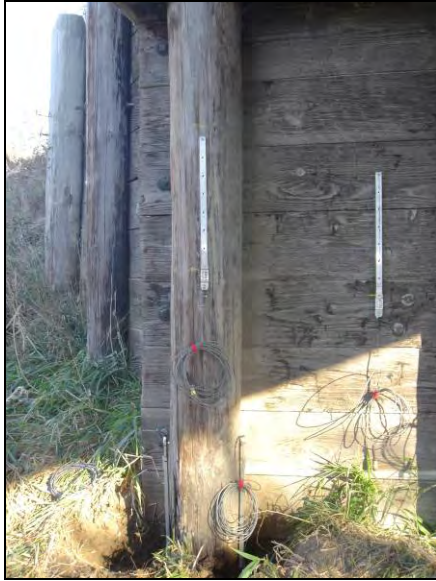
(a) Pile no. 1 at the north abutment

Figure 9.11. Soil excavated around piles to allow for strain transducer installation across deteriorated regions (Bridge No. 237350 Mahaska County – October 28 2005)

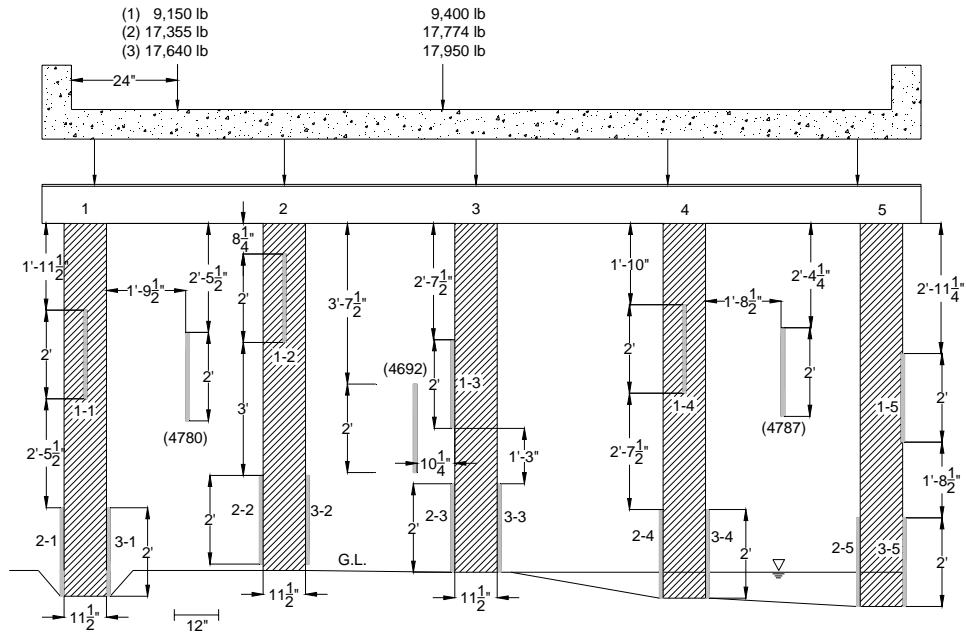
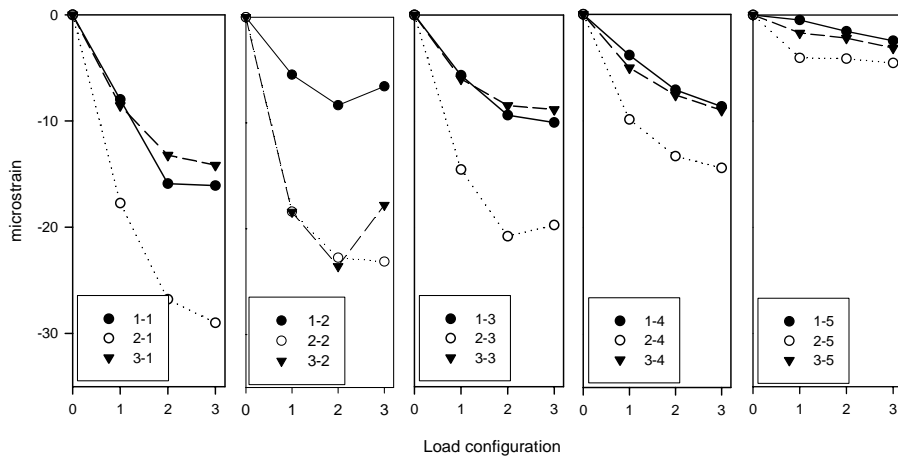
The first load test was performed with the load at the west edge of the bridge. The load was offset about 2 ft from the curb. Figure 9.12 shows the location and magnitude of the loads, pile strains, and backwall strains. The highest strain measured was in pile no. 1 and was about -29 microstrains during load configuration 3. The measured strain decreased with increasing distance from the location of the applied loads. Strain transducer 2-1, which was attached to a biologically deteriorated section, indicated a higher strain measurement when compared to other strain measurements in pile no. 1.

The backwall strains were highest near the applied load, and decreased with increasing distance from the location of the loads. For load configurations 2 and 3, the recorded strain decreased due to reduction in axial load. Negative strains were recorded at load configuration 3 because of the partial bearing of the pile cap on the backwall (See Figure 9.13).

Figure 9.12. Static load test at the west edge (Bridge No. 237350 – Mahaska County)

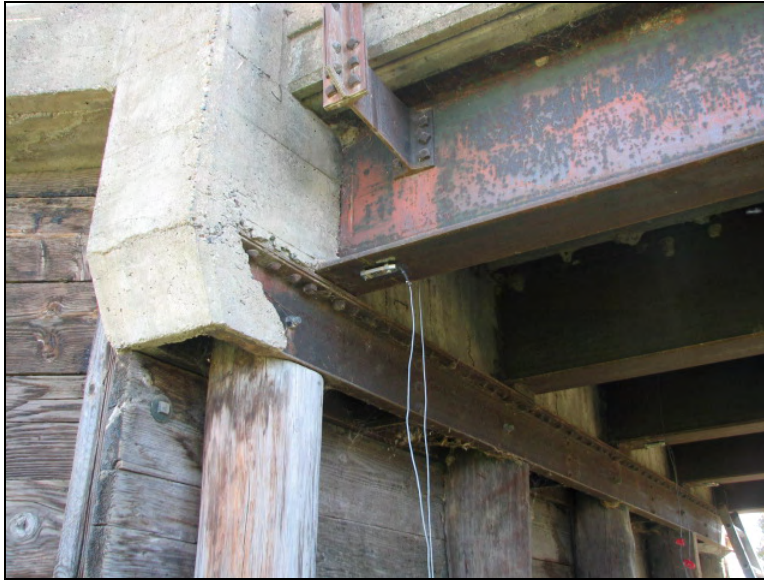
Figure 9.13. Pile cap partially resting on the timber backwall (Bridge No. 237350 Mahaska County – October 28 2005)

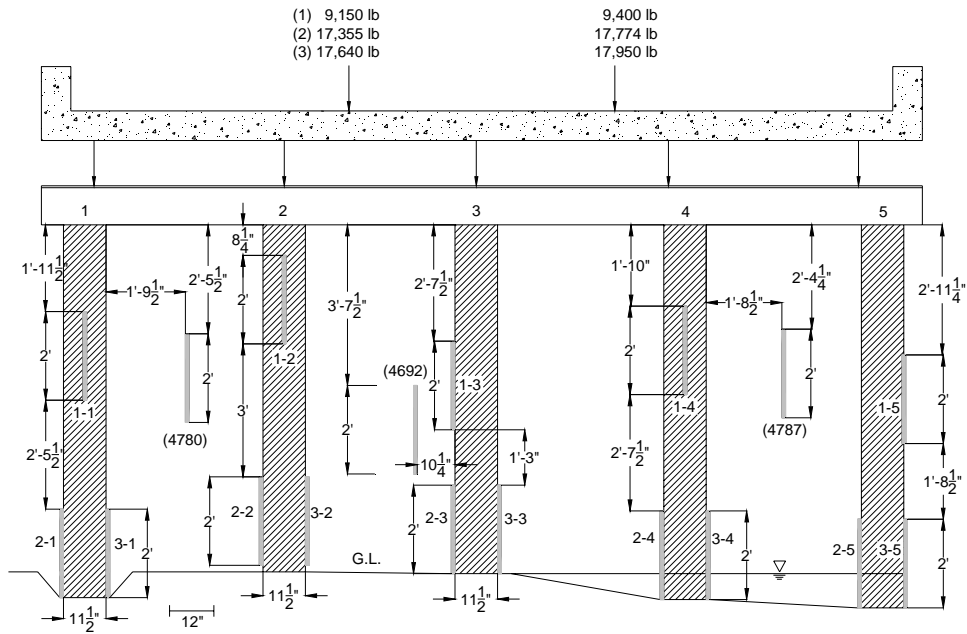
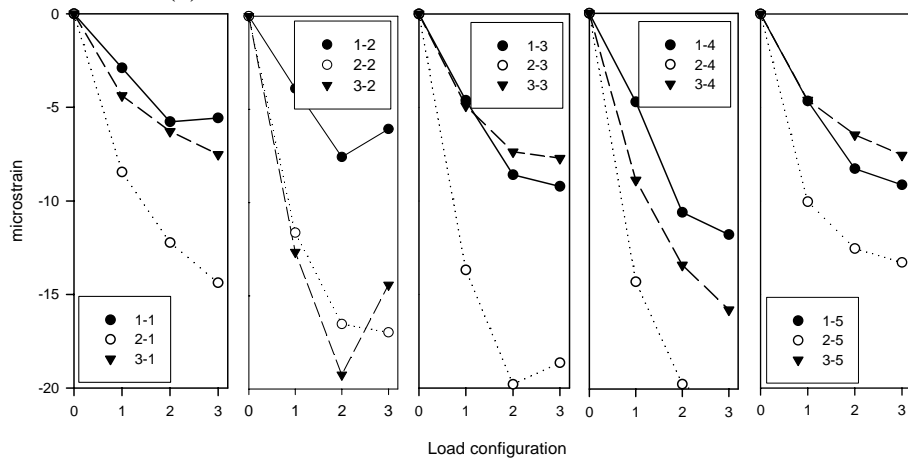
The second load test was performed with the load in the centerline lane. The location and magnitude of the applied axial loads, pile strains, and backwall strains are shown in Figure 9.14. The recorded strains were highest in pile nos. 2, 3, and 4 and decreased with increasing distance from the location of the applied load. The highest strain occurred in pile no. 4 and was about -20 microstrains in load configuration 3. Strain transducer 2-1 continued to show higher strain compared to other strains measured in pile no. 1. Similarly, the backwall strains were highest directly under the applied load (i.e. between pile nos. 2 and 3). In load configuration 1, the highest strain measured was about -21 microstrains between pile nos. 2 and 3.

Figure 9.14. Static load test at the centerline (Bridge No. 237350 – Mahaska County)

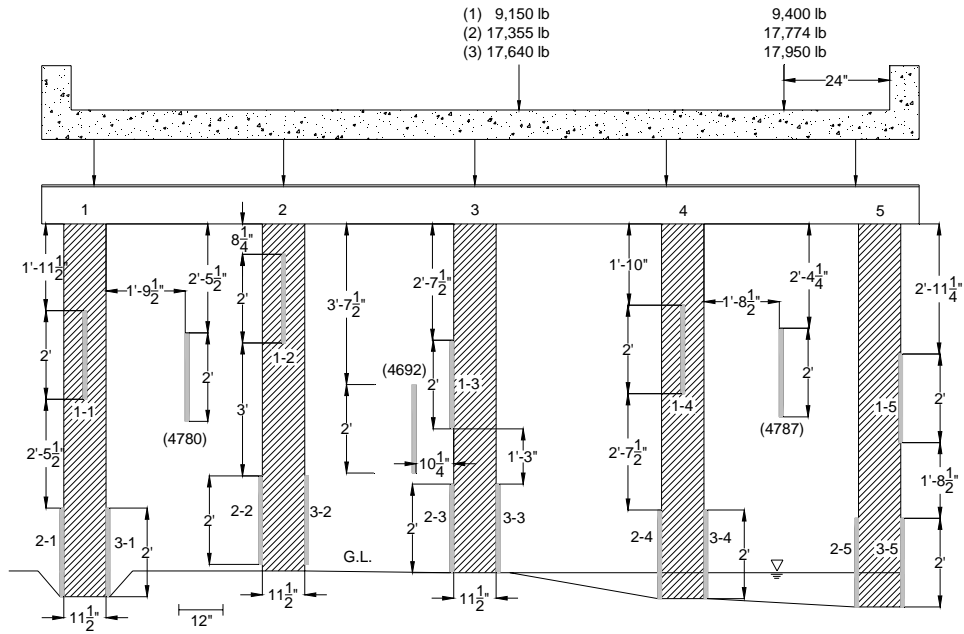
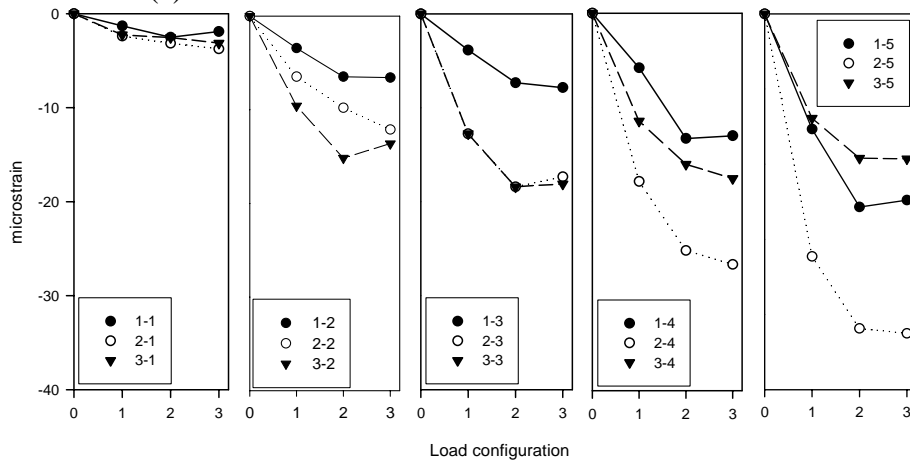
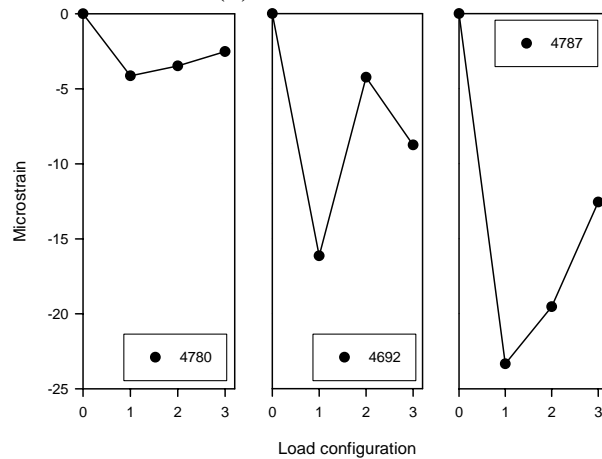
The third load test was performed with the load at the east edge of the bridge. The load was offset about 2 ft from the curb. The location and magnitude of the applied axial loads, piles strains, and backwall strains are shown in Figure 9.15. The highest strain was measured in pile no. 5 and was about -21 microstrains in load configuration 3. The measured strain decreased with increasing distance from the location of the applied loads. The backwall strains were highest near the applied load (i.e. between pile nos. 4 and 5), and decreased with increasing distance from the location of the axial loads. In load configuration 1, the highest strain measured was about -23 microstrains.

Figure 9.15. Static load test at the east edge (Bridge No. 237350 – Mahaska County)

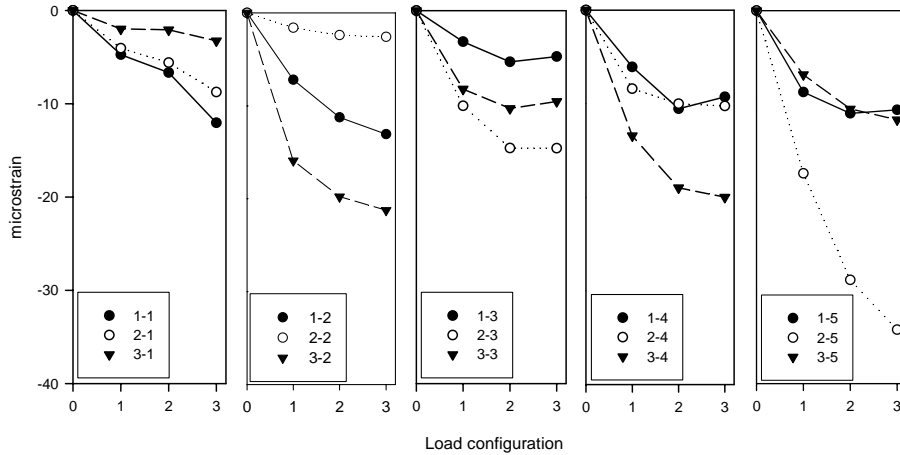
(b) Pile strains

At the south abutment, the first static load test was performed with the load at the west edge of the bridge. The load was offset about 2 ft from the curb. The location and magnitude of the applied axial loads, piles strains, and backwall strains are presented in Figure 9.16. The highest strain was measured in pile no. 5 and was about -34 microstrains at load configuration 3. The measured strain decreased with increasing distance from the location of the applied loads. Strain transducers 3-2 and 2-5, which were attached to soft sections near the ground level, displayed higher strains compared to other strain measurements in pile nos. 2 and 5.

The highest backwall strain was between pile nos. 3 and 4 directly under the applied load and was about -20 microstrains. Backwall strains decreased with increasing distance from the location of the axial loads. In load configurations 2 and 3, the backwall showed positive strain values.

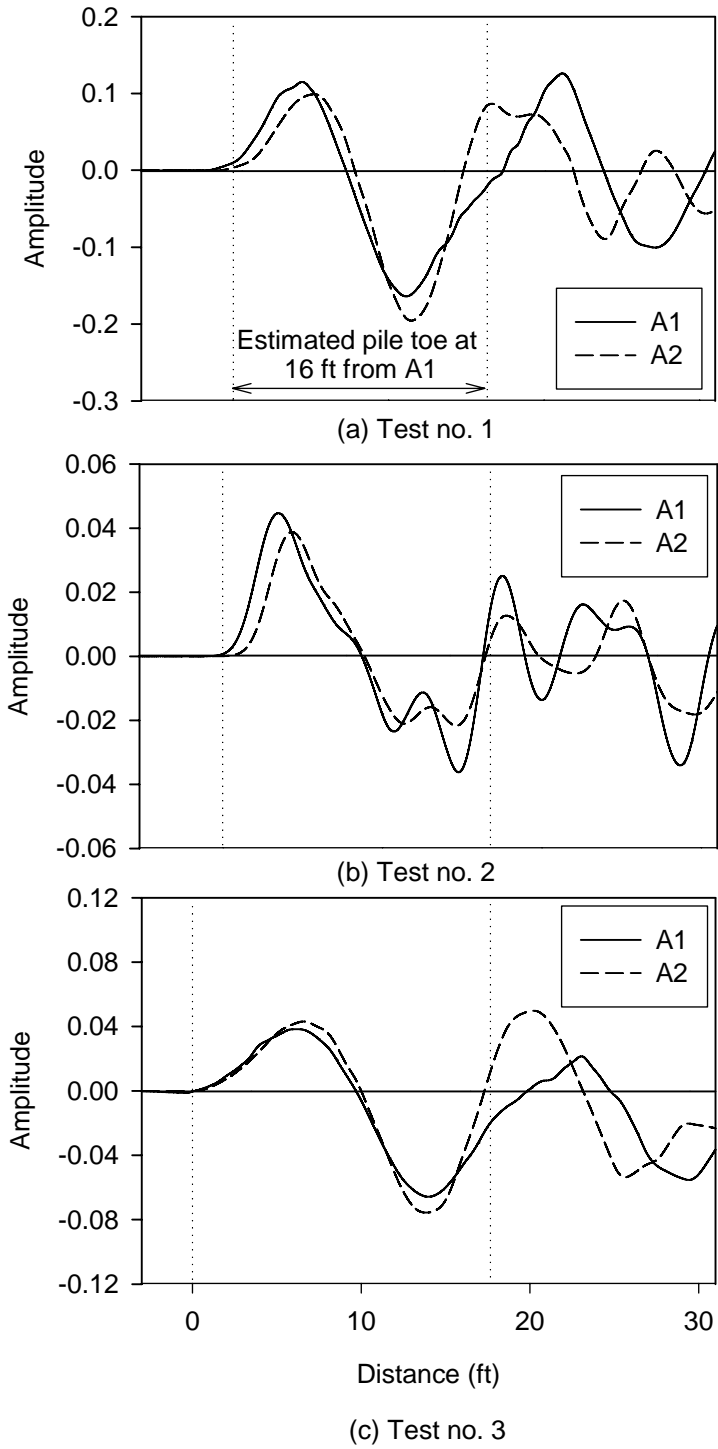
Figure 9.26. Results of PIT on pile no. 2 at the north abutment (Bridge No. 237350 – Mahaska County)

Abutment	Pile No.	Distance between A1 and A2 (ft)	Comments
North	2	2	Possible pile toe or defect at 21 ft (16 ft below A1 + 4.7 ft)
	2	5	
	3	3	Possible pile toe or defect at 20 ft (15 ft below A1 + 4.7 ft)
	3	2	
	3	5	
South	2	2	The defect at about 8 ft from the pile head makes the input pulse wide and prevents from seeing beyond this point
	2	4.5	
	3	2.5	The defect at about 7 ft from the pile head makes the input pulse wide and prevents from seeing beyond this point
	3	4.5	
	5	2	
5	5	The defect at about 7 ft from the pile head makes the input pulse wide and prevents from seeing beyond this point

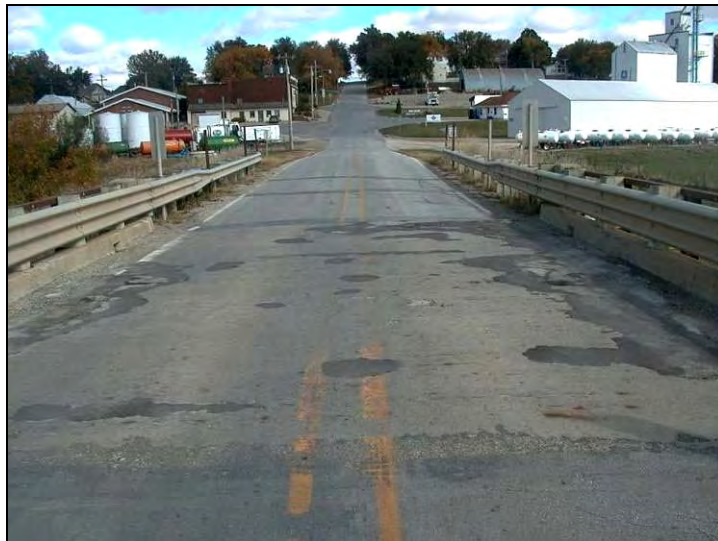
Figure 10.2. Concrete deck patched with asphalt (Bridge No. 094680 Carroll County – May 16 2006)

The fourth bridge tested was in Carroll County, Iowa. The bridge, which was 33.5 ft long, 22 ft wide, and has a 0° skew, was located on 245th St. south of Halbur, Iowa crossing a creek (See Figure 10.1). The superstructure consisted of a non-composite concrete deck supported by a four girder system. Due to deterioration in the concrete deck, as may be seen in Figure 10.2, there were numerous asphalt patches.

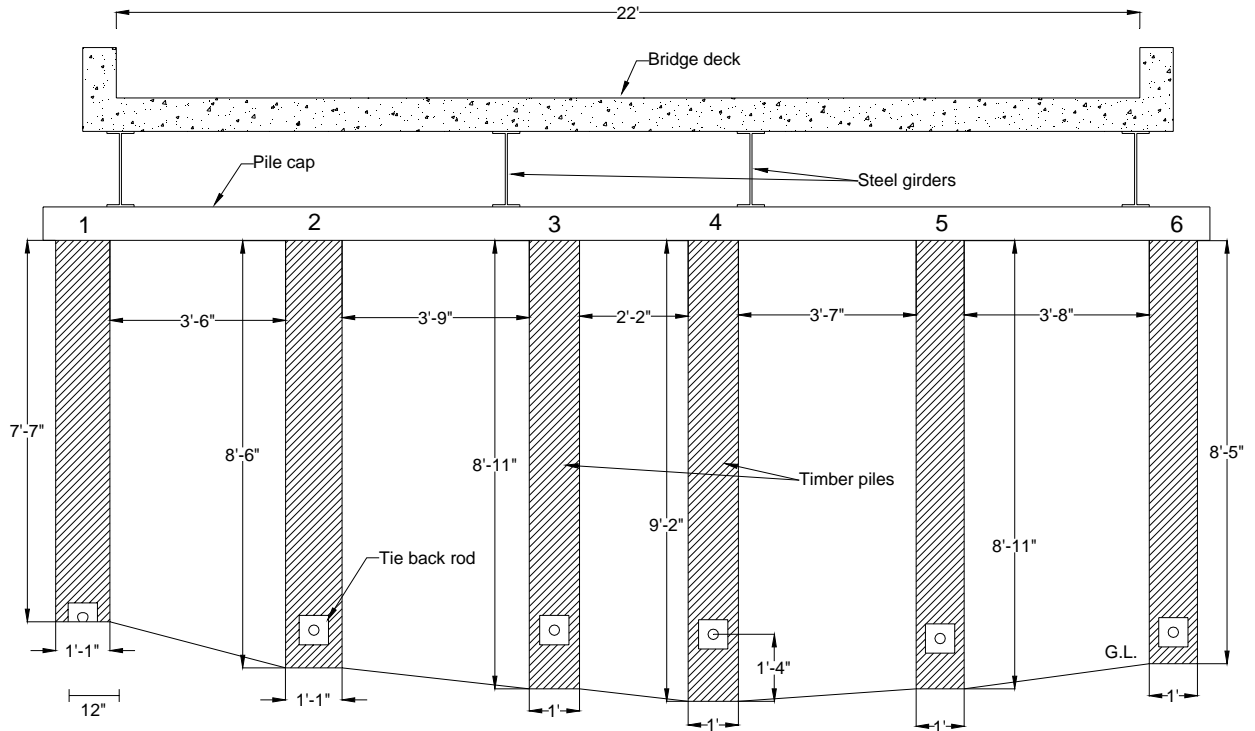
Figure 10.6. A schematic diagram of the north abutment (Bridge No. 094680 – Carroll County)

The average exposed pile length and pile spacing at the north abutment were about 8.6 ft and 3.8 ft, respectively. The tie back rods were located about 7.3 ft from the pile heads. The pile diameters varied between 12 and 13 inches (See Figure 10.5 and Figure 10.6). At the south abutment, the average exposed length and the pile spacing are about 10 ft and 4 ft, respectively. The tie back rods are about 7.8 ft from the pile heads, and the pile diameters vary between 10 and 11 inches (See Figure 10.7 and Figure 10.8). According to the construction plans for this bridge, the total lengths of the piles supporting the abutments are 40 ft, whereas the lengths of the wingwall piles are 25 ft for the pile closest to the abutment and 20 ft for the other two piles. As shown in Figure 10.9a, the tie back rods extend a distance of about 15 ft behind the backwall. The soil profile, shown in Figure 10.9b, was determined by drilling a test hole near the south abutment. The upper 14.5 ft comprise of soft to medium stiff loam, and the underlying soils comprise of a mixture of sand and gravel. The bottom 4 ft comprise of medium stiff clay. The water table was at a depth of 9 ft from the test hole elevation.

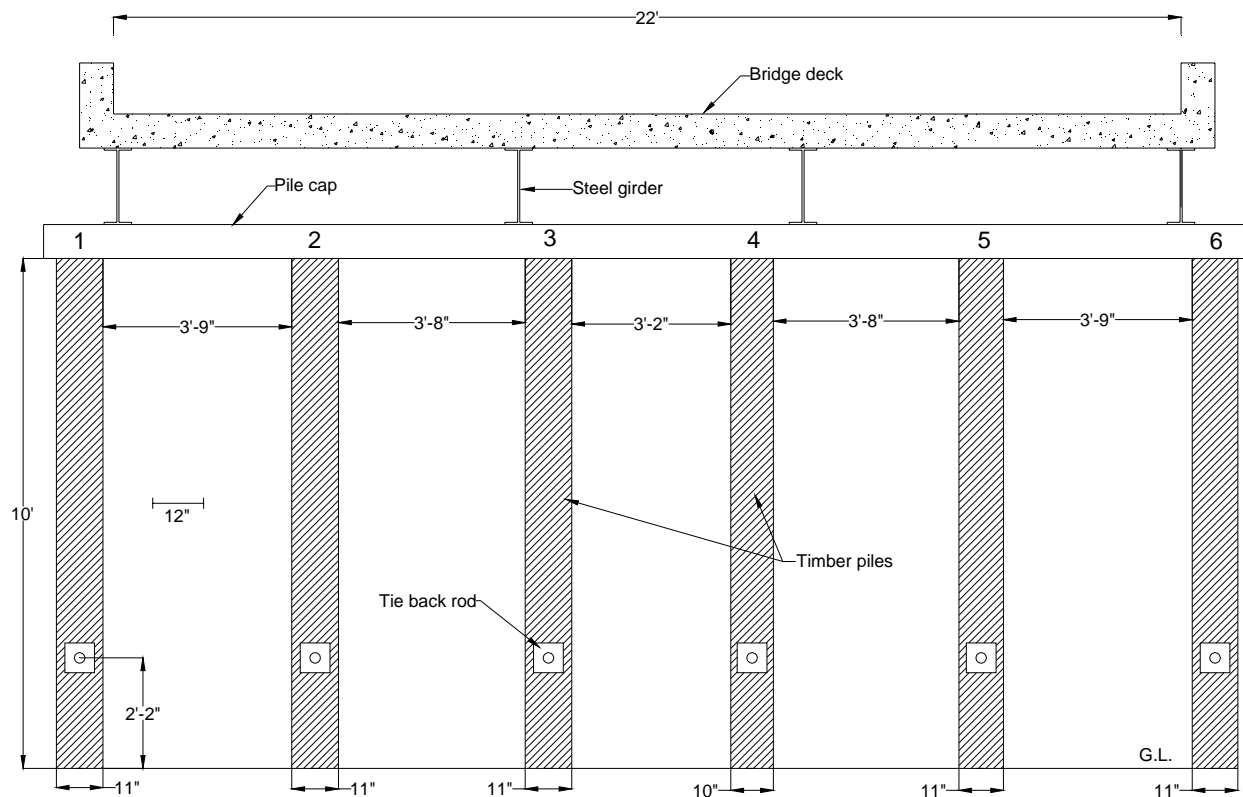
Figure 10.8. Schematic diagram of the south abutment (Bridge No. 094680 – Carroll County)

Pile cores were obtained from each abutment using an increment borer. At the north abutment, the densities of pile nos. 3, 4, and 5 were higher than the other piles. The lowest density was measured in pile no. 6. In addition, coring pile no. 1 revealed that there was a hollow section under the pile surface. The intact diameter of pile no. 1 was estimated to be 9 inches. At the south abutment, pile nos. 3, 4, and 5 had higher densities. The results also revealed that the pile density varied longitudinally along the pile length. For example, three cores were obtained from pile no. 1 at 12, 36, and 42 inches from the ground level; each resulted in a different density value. The average creosote penetration depth at this bridge was about 4 inches. Table 10.1 provides a summary of the measured pile densities. As can be seen in this table, the wood density ranged from 28.6 lb/ft³ to 57.1 lb/ft³.

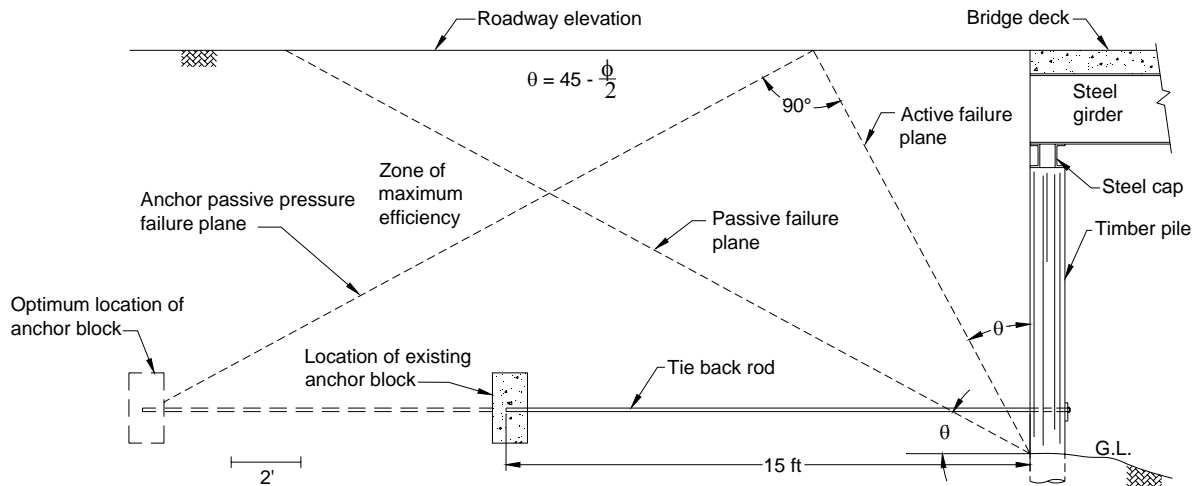
Figure 10.10. Anchor block located outside the zone of maximum efficiency (Bridge No. 094680 – Carroll County)

The bridge plans showed that the location of the anchor block was about 15 ft from the backwall and about 1.3 ft from the ground level. According to the design method proposed by Bowles (1996), the optimum location for the anchor block is in the zone of maximum efficiency, which would be located at 26 ft from the backwall at the current height (See Figure 10.10). The existing location, however, was still outside the active and passive failure zones.

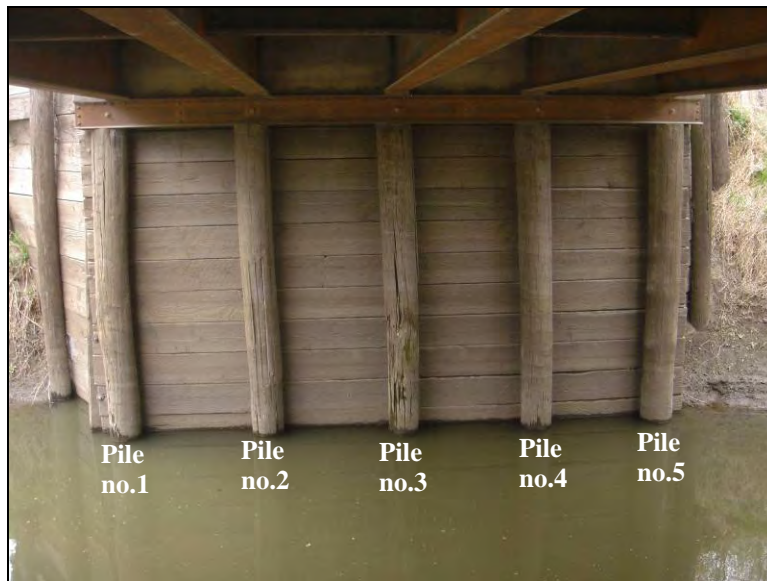
Figure 11.3. Northwest abutment (Bridge No. 237380 Mahaska County – April 16 2006)

The substructure consisted of five timber piles in front of a timber backwall, two timber piles in each wingwall, and double c-channel pile cap. The average exposed pile length and pile spacing at the northwest abutment are about 11.5 ft and 4.5 ft, respectively (See Figure 11.2). The water depth at the time of inspection was about 1 ft. During the time of testing, the northwest abutment piles showed signs of biological deterioration as shown in Figure 11.3. Pile no. 1 at the southwest end also showed signs of biological deterioration at the water level, and was bulging at about 4 ft from the water level (See Figure 11.4). Pile nos. 2 and 3 also suffered from biological deterioration as shown in Figure 11.5. No tie back rods were observed at this abutment. The elevation of the southeast abutment is higher than the water level as shown in Figure 11.6. The average exposed pile length and pile spacing in this abutment were about 3.6 ft and 4 ft, respectively. The pile diameters were approximately 1 ft (See Figure 11.7). Similar to the northwest abutment, no tie back rods were observed.

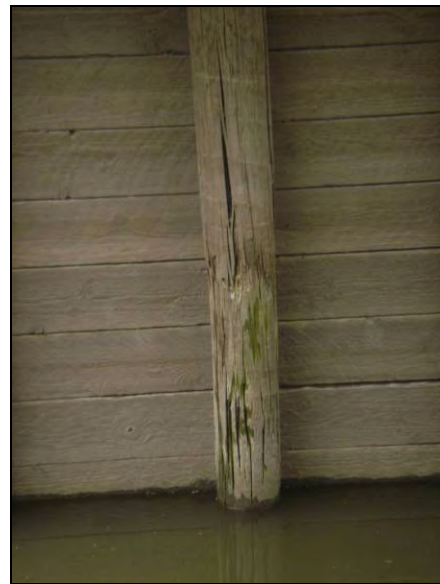
(b) Pile no. 3

Figure 11.5. Biological deterioration at the northwest abutment (Bridge No. 237380 Mahaska County – April 16 2006)

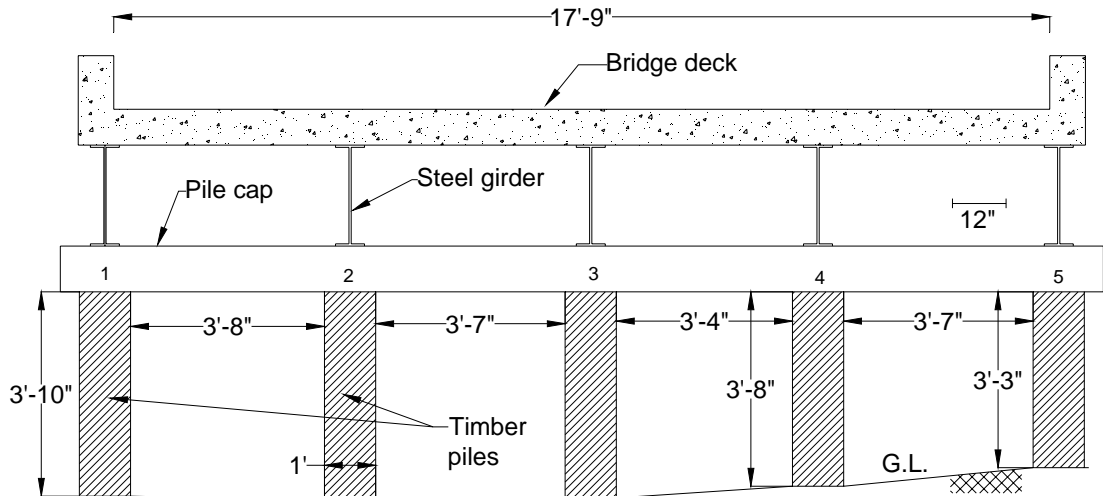
Figure 11.7. Schematic diagram of the southeast abutment (Bridge No. 237380 – Mahaska County)

Using the increment borer, pile cores were obtained from the piles both abutments. The density determined from each core and the elevation at which the cores were obtained are summarized in Table 11.1. Coring the piles revealed that pile nos. 2 and 4 at the southeast abutment are hollow near the pile core. It is estimated that the remaining intact diameters of pile nos. 2 and 4 are about 3 and 3.5 inches, respectively. As may be seen in Table 11.1, the wood density ranged from 35.8 lb/ft³ to 53.9 lb/ft³.

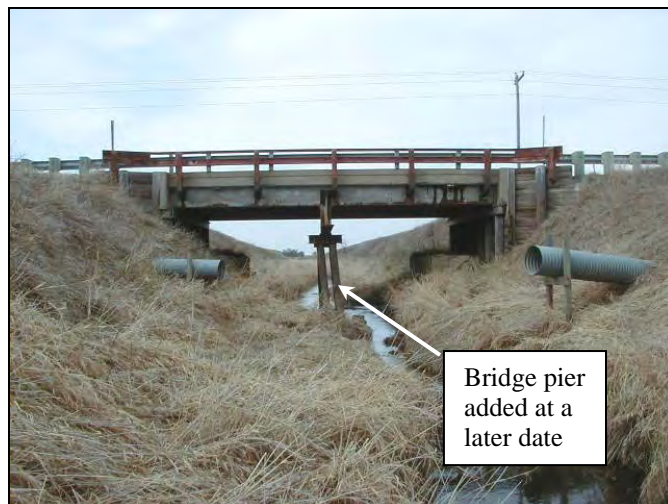
Figure 12.2. Center pier added in the 1970s (Bridge No. 029070 Humboldt County – April 4 2006)

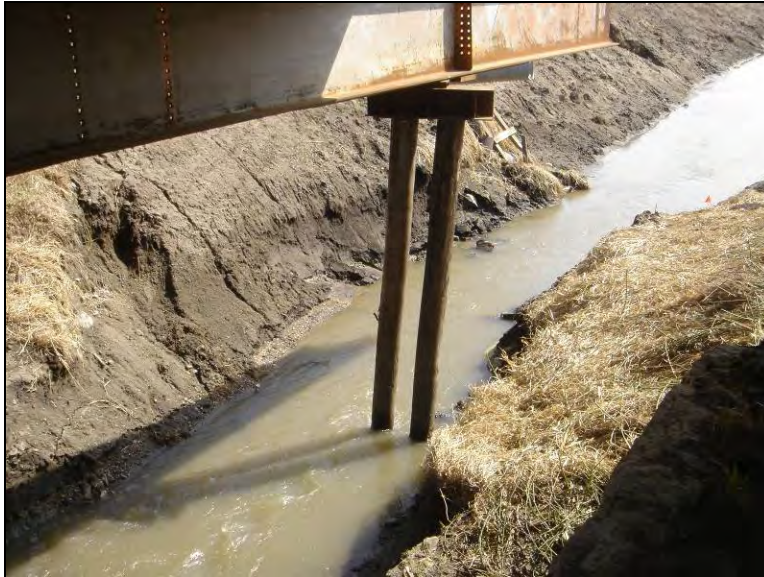
Figure 12.3. Center pier supported by 2 timber piles on each side of the bridge (Bridge No. 029070 Humboldt County – April 4 2006)

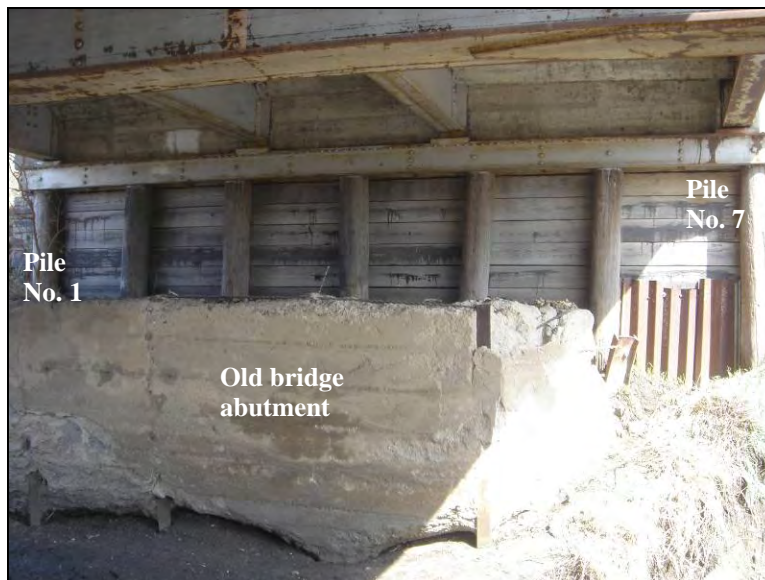
Figure 12.7. East abutment (Bridge No. 029070 Humboldt County – April 4 2006)

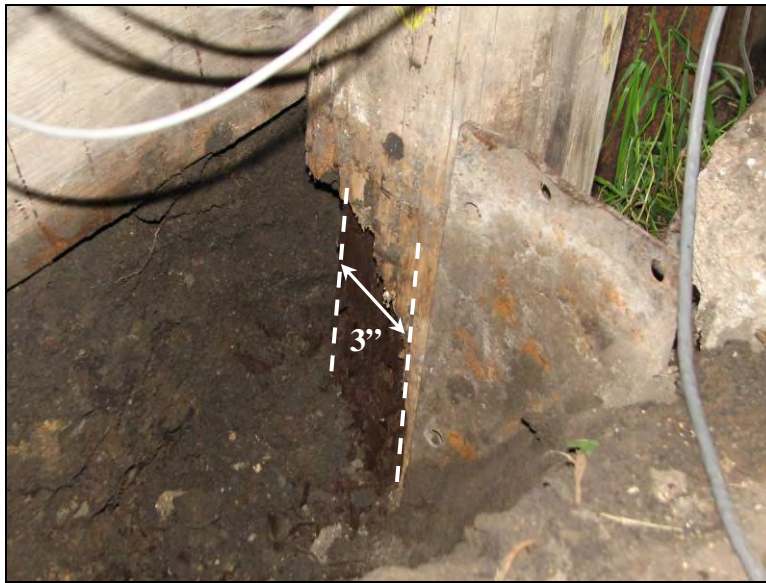
Figure 12.9. Advanced section loss at pile No. 6 at the east abutment (Bridge No. 029070 Humboldt County – July 12 2006)

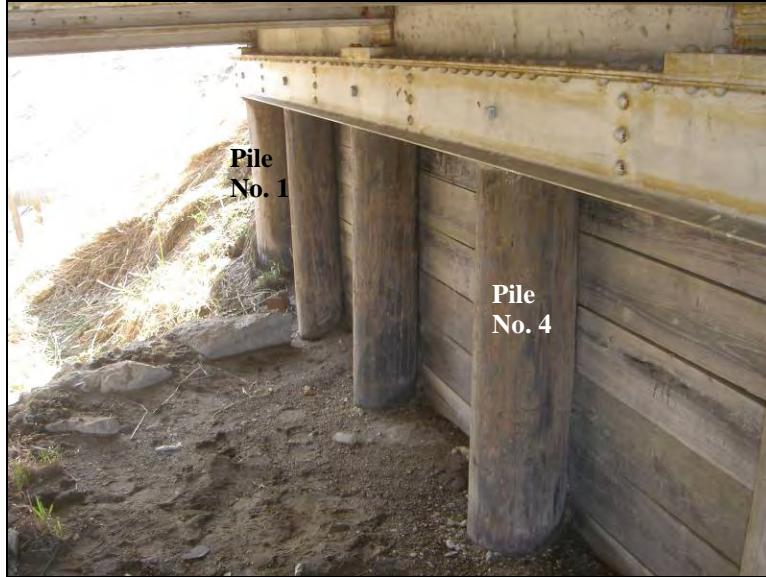
Figure 12.10. West abutment (Bridge No. 029070 Humboldt County – April 4 2006)

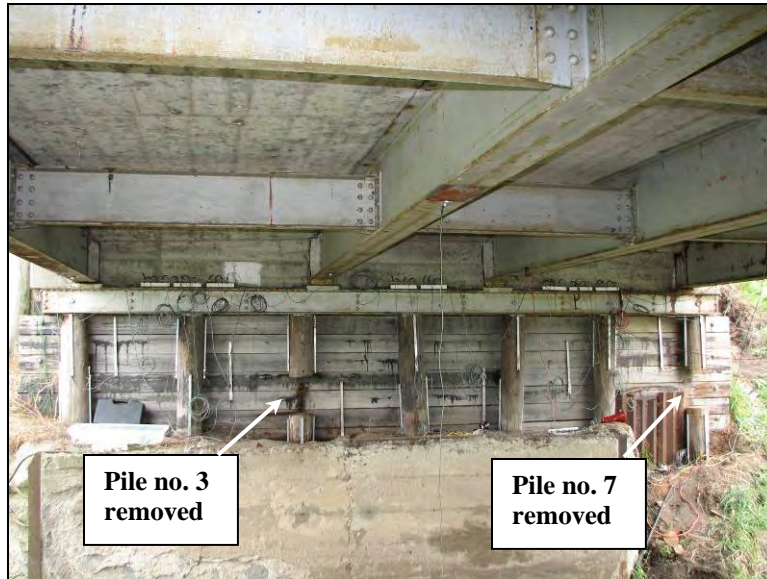
The destructive load test was carried out at the east abutment by consecutively removing a 16 inch section from three of the seven supporting piles to simulate pile deterioration (See Figure 12.17). Pile nos. 7, 3, and 6 were removed consecutively. After removing each pile, the bridge was load tested and strains in the intact piles were measured. The east abutment with pile nos. 3 and 7 removed is shown in Figure 12.18. To measure the load carried by the removed piles, a load cell and a mechanical jack were installed as shown in Figure 12.19. Before statically loading the abutment, the mechanical jack was used to apply load on the pile. The load was gradually increased in order to restore the dead load, which was initially carried by the pile before removing the section. This was accomplished by monitoring the pile strain before and after removing the pile section and restoring the pile strain to its initial value. Once the initial strain was restored, the load carried by the pile was recorded using a readout attached to the load cell. This procedure was carried out for pile nos. 3 and 7. The section from Pile no. 6 that was removed near the ground level was not restored (See Figure 12.20).

Figure 12.18. Pile nos. 3 and 7 removed at the east abutment (Bridge No. 029070 Humboldt County – July 12 2006)

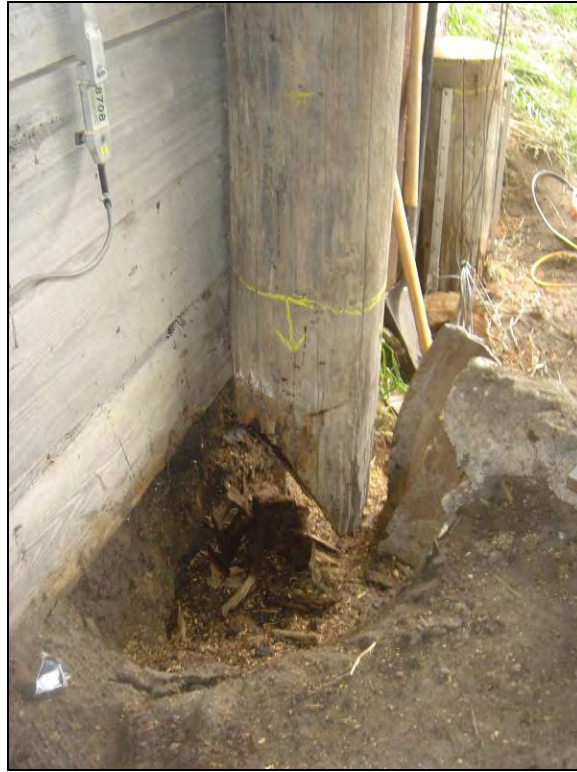
Figure 12.20. A section of Pile no. 6 removed near the ground level (Bridge No. 029070 Humboldt County – July 12 2006)

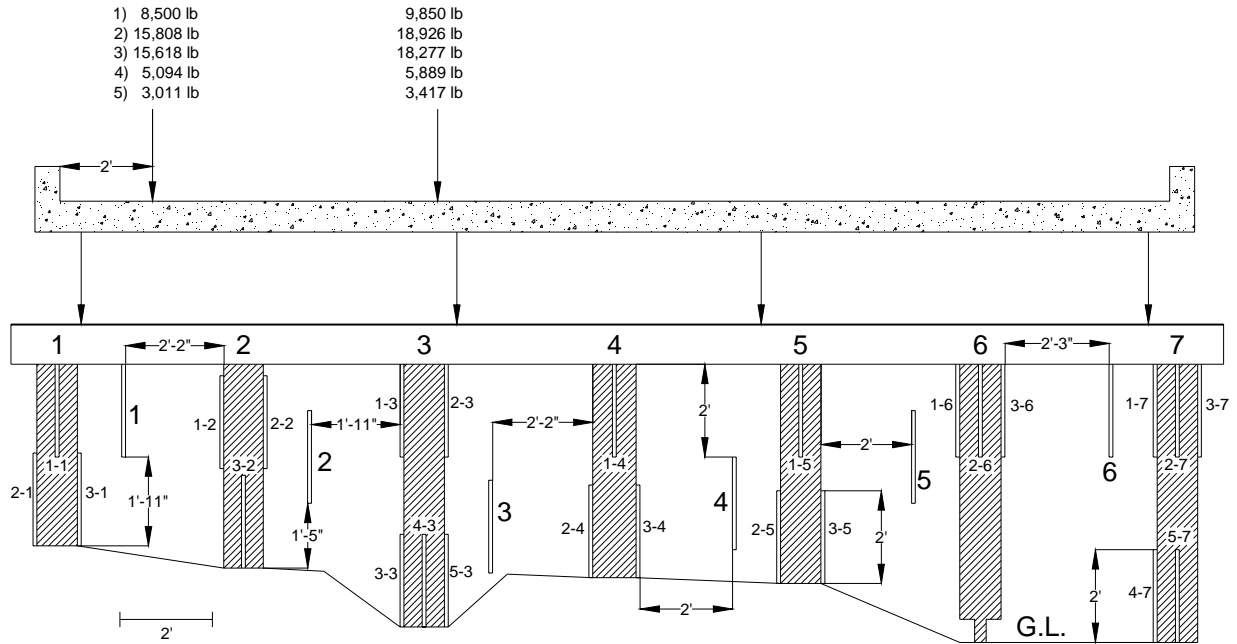
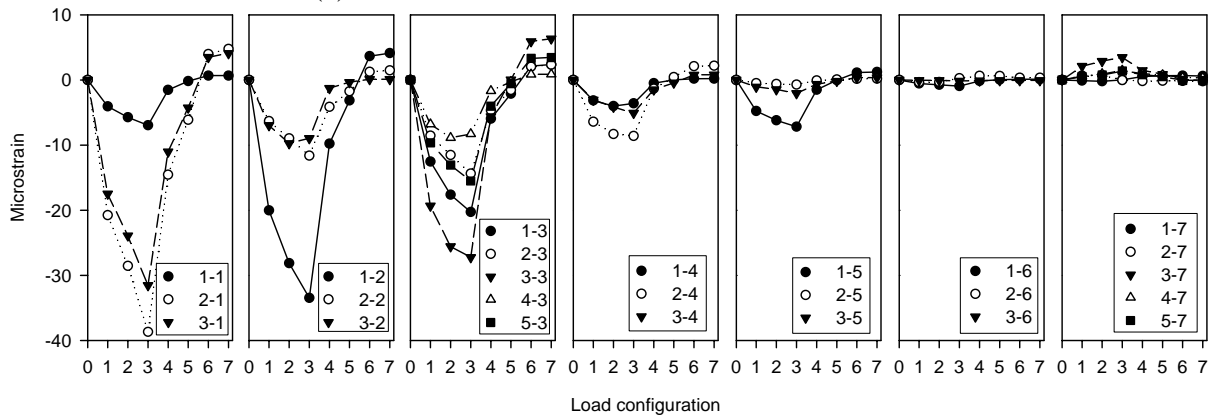
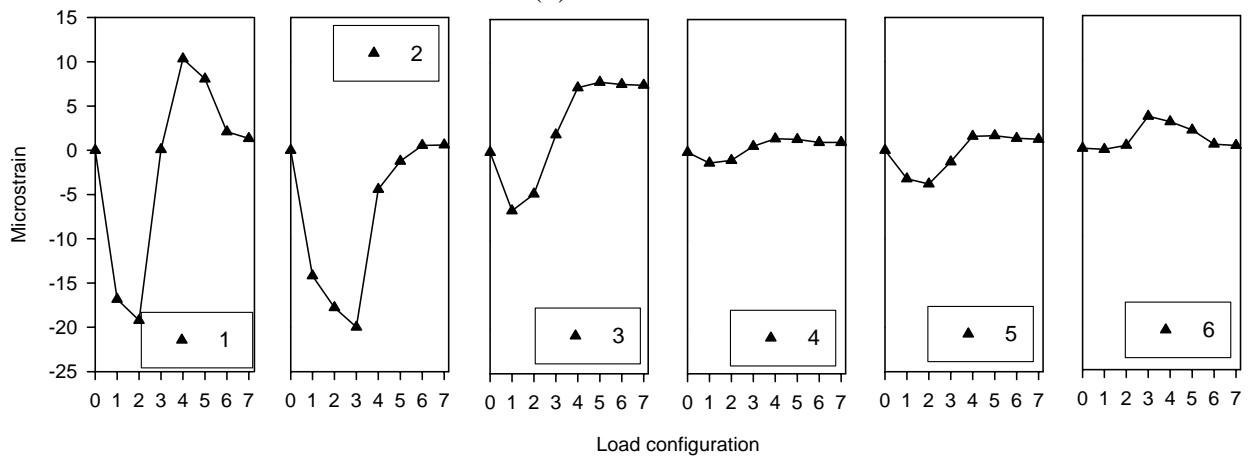
Figure 12.26. Static load test at the north edge of the east abutment (Bridge No. 029070 – Humboldt County)

The east abutment was first loaded at the north edge (See Figure 12.26a). Pile nos. 1, 2, and 3, which were directly under the axial loads, experienced the highest strains (See Figure 12.26b). The highest strain, which was about -39 microstrains in pile no. 1, was in load configuration 3. At higher load configurations, the pile strains were reduced because some of the loads were being transferred to the west abutment. The strains also decreased in piles away from the location of the applied loads. The backwall was in compression in load configurations 1 through 4. The backwall strains at higher load configurations were either zero or positive (See Figure 12.26c).

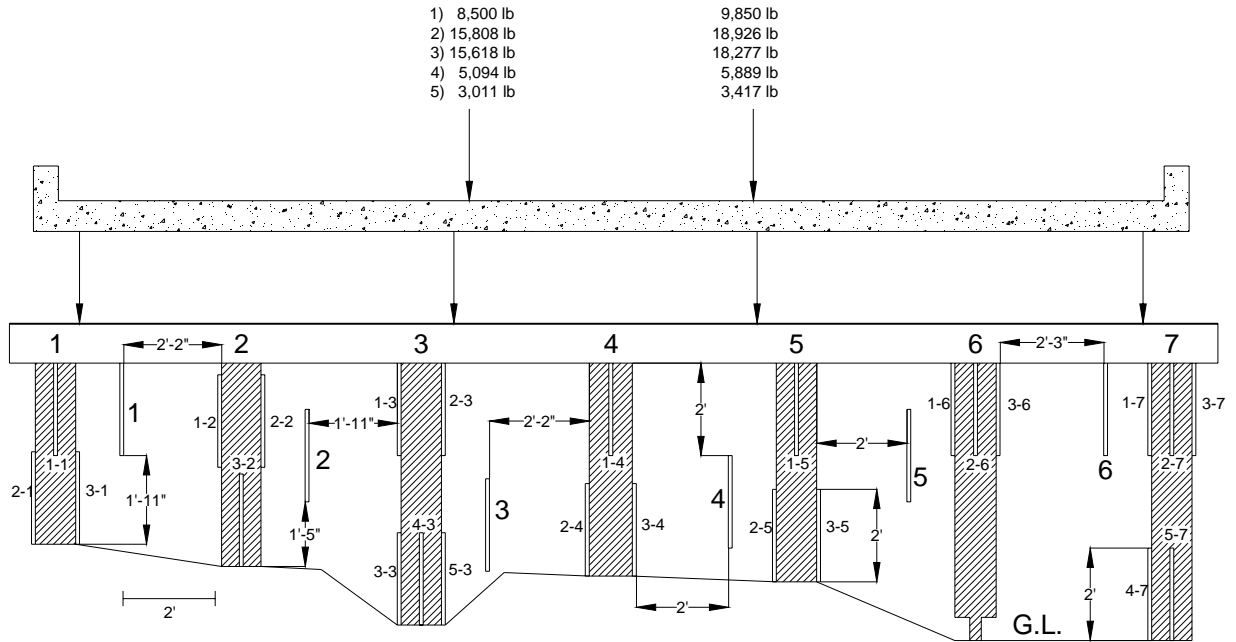
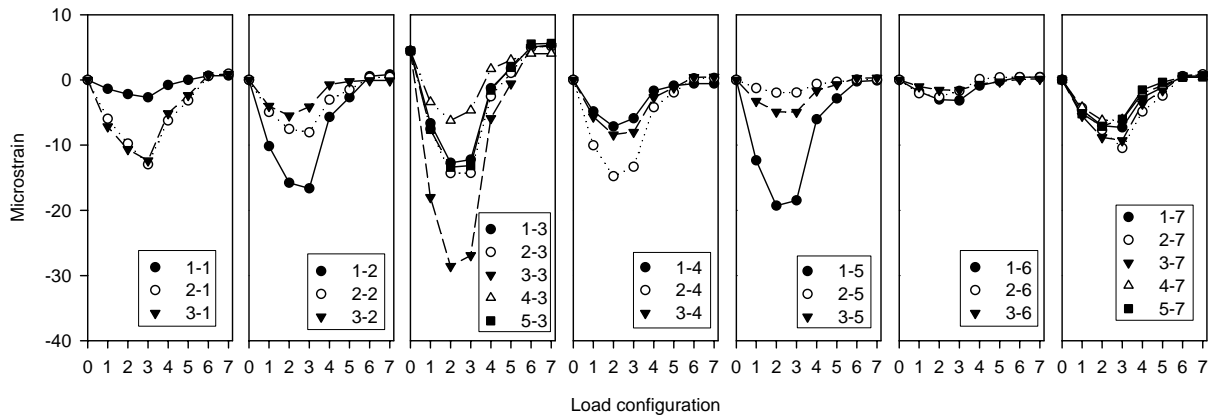
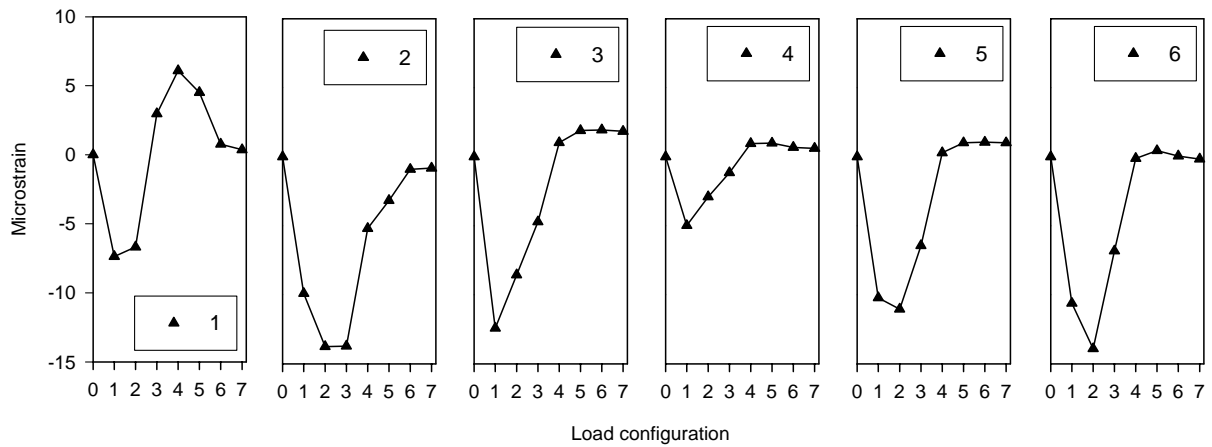
Figure 12.27. Static load test at the centerline of the east abutment (Bridge No. 029070 – Humboldt County)

The location of the applied loads at the centerline of the east abutment, pile strain measurements, and backwall strains are shown in Figure 12.27. The results demonstrate that the load was mainly transferred to pile nos. 3 and 5, which were directly under the axial loads. The highest strain measured was in pile no. 3 and was about -30 microstrains. Moving the load to the centerline of the bridge deck resulted in about 30% reduction in the backwall strains between pile nos. 1 and 2, 2 and 3, and 3 and 4. At the south edge of the bridge (between pile nos. 4 and 7) the backwall strains increased by approximately a factor of 4.
