Investigation of Steel-Stringer Bridges: Superstructures and Substructures, Volume II

Final Report
October 2007

Sponsored by
the Iowa Highway Research Board (Project TR-522)
and the Iowa Department of Transportation (CTRE Project 04-184).

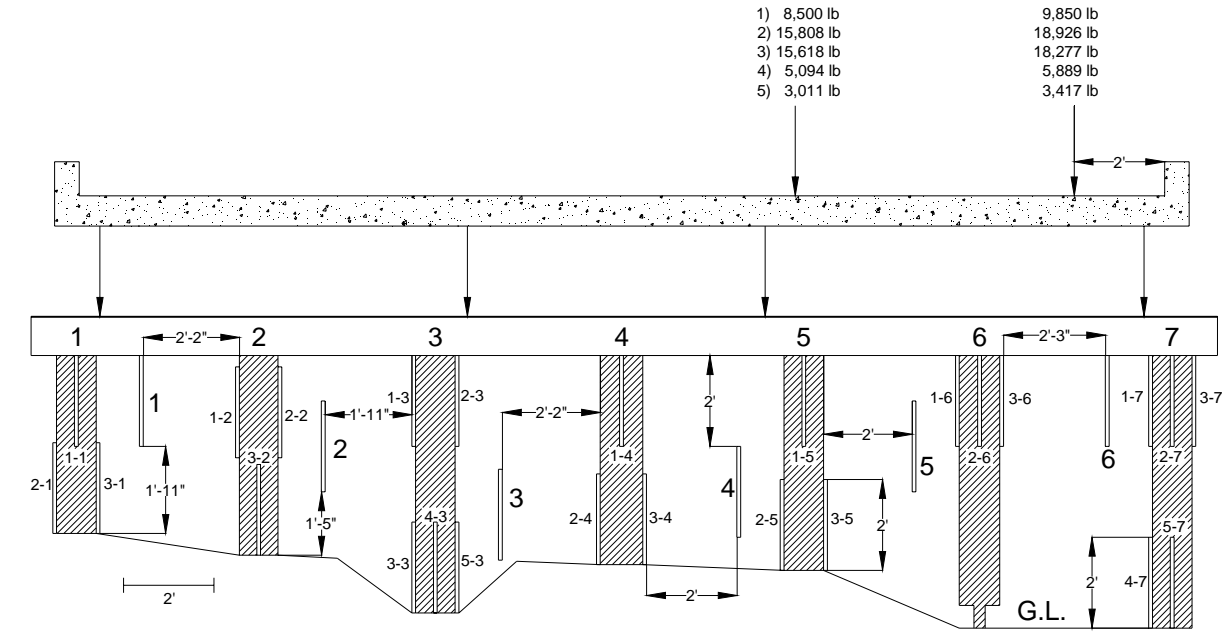
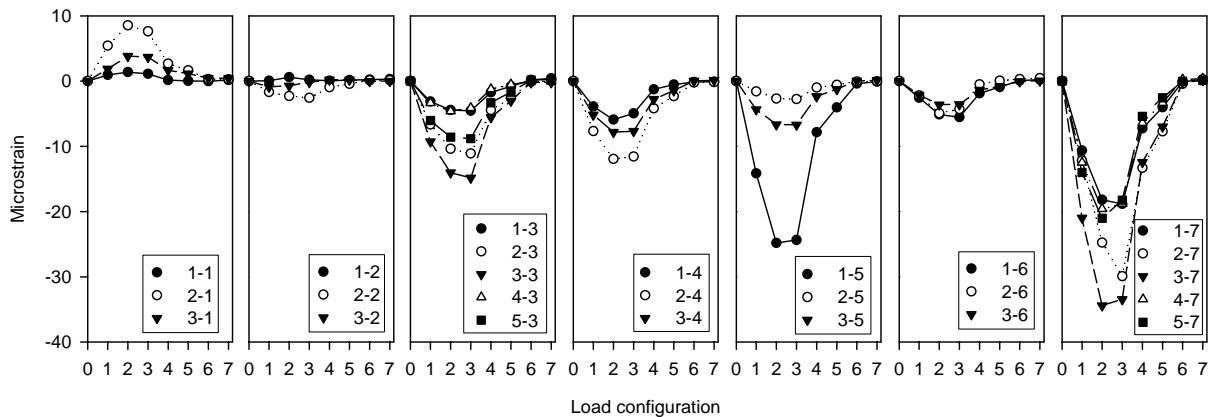
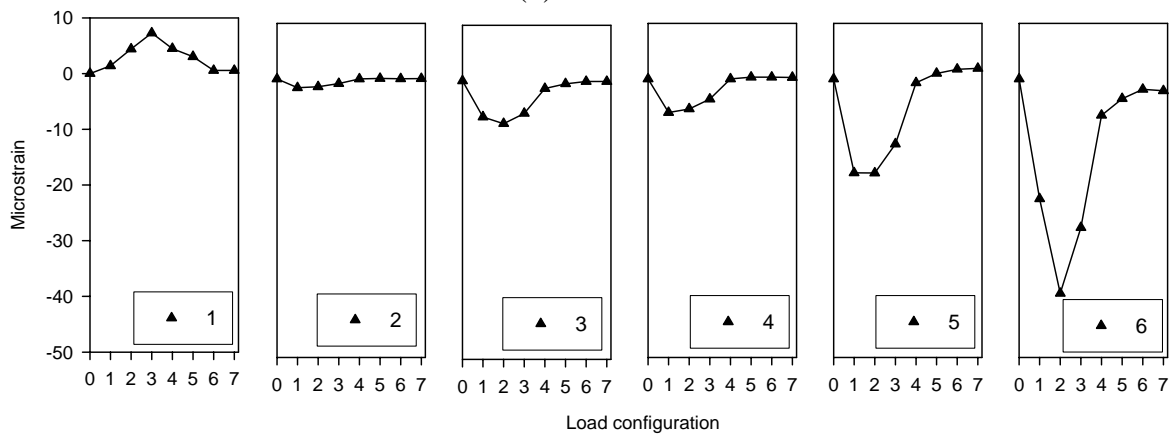
Figure 12.28. Static load test at the south edge of the east abutment (Bridge No. 029070 – Humboldt County)

The third test was completed with the applied load at the south edge. The location of the applied loads, pile strain measurements, and backwall strains are presented in Figure 12.28. Similar to previous tests, the load was concentrated under the location of the applied loads. Pile no. 7 experienced the highest strain, which was about -34 microstrains in load configuration 2. The load decreased with increasing distance from the location of axial loads. Pile no. 6, which had a diameter of about 3 inches near the ground level, experienced small strains. Strains measured in pile no. 1 were positive, which may be due to pile bending caused by loading the bridge at the north edge.

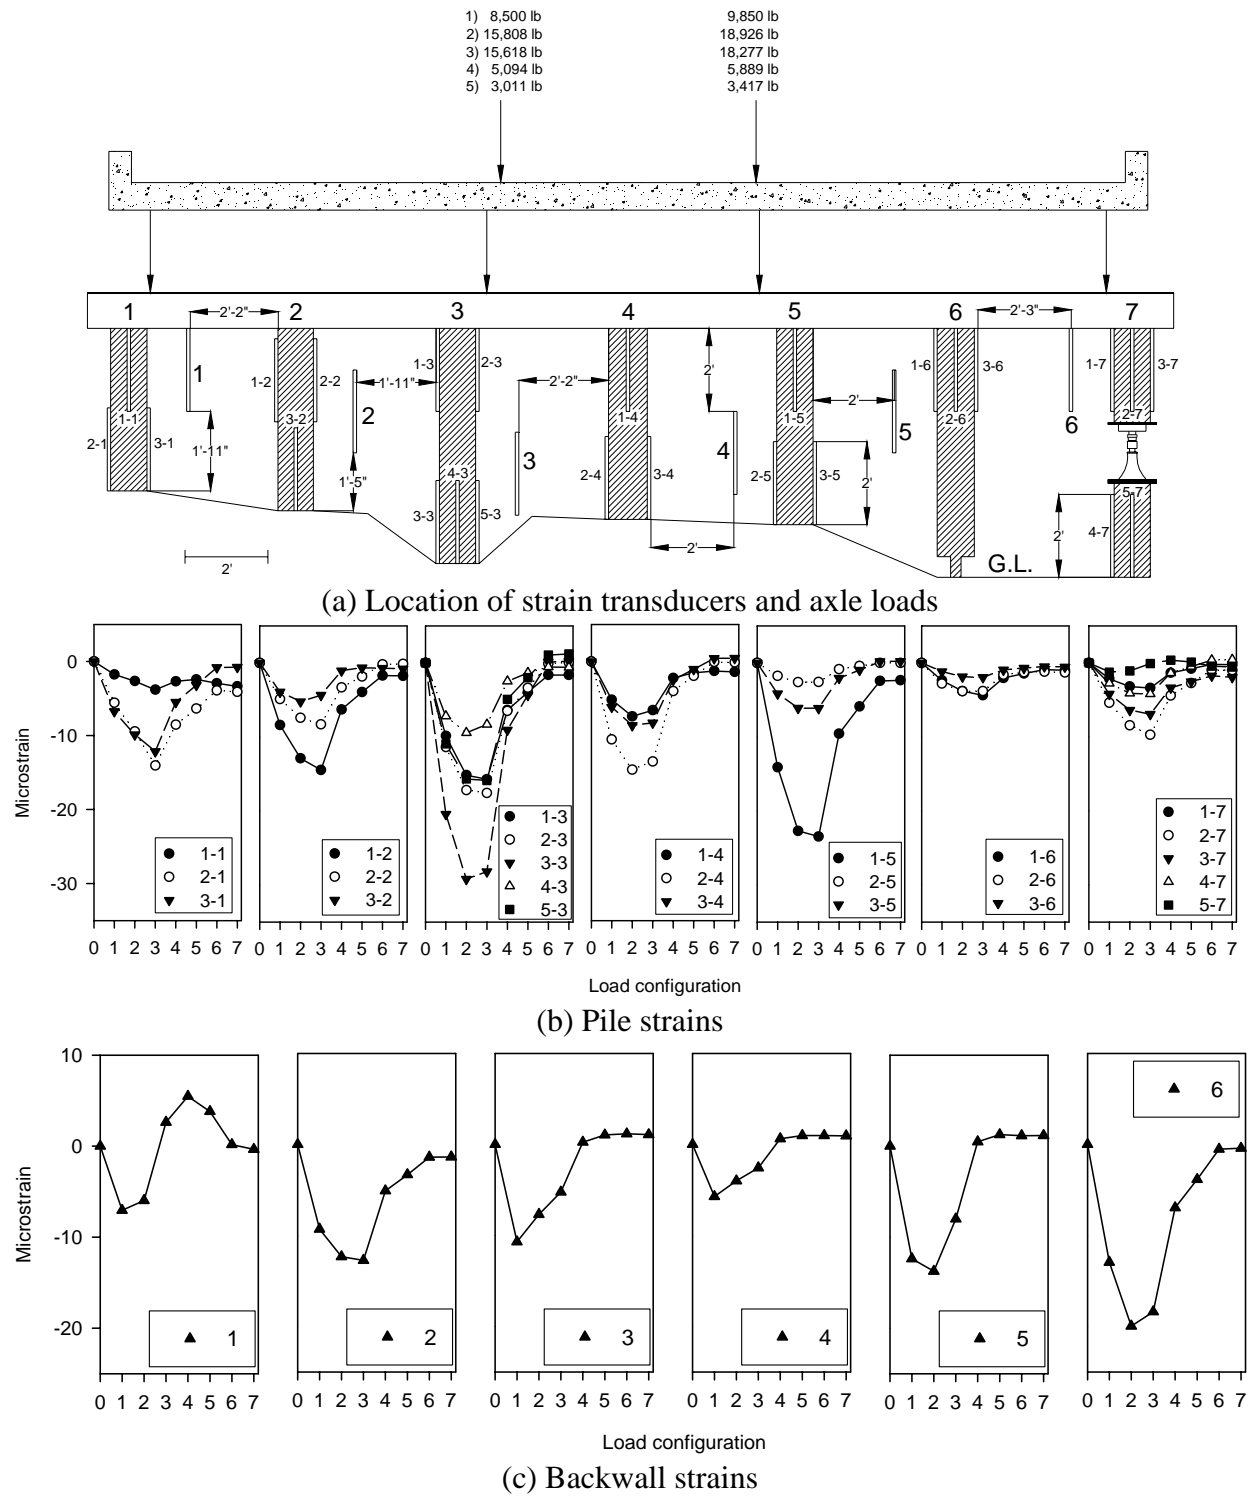
Figure 12.29. Static load test at the centerline with pile No. 7 jacked (Bridge No. 029070 – Humboldt County)

The results of loading the east abutment along the centerline of the bridge deck are shown in Figure 12.29. The strain data were essentially the same strain data obtained in the nondestructive load test at the centerline that was previously conducted (Refer to Figure 12.27). This indicates that the procedure of jacking pile no. 7 was successful in restoring the abutment initial loading condition. Using the load cell, the load carried by pile no. 7 (minus the dead load) was recorded and the stresses in the pile were determined. The stresses varied laterally and longitudinally through the pile section illustrating the non-homogeneity of wood. The results also demonstrate that the load carried by pile no. 7 was about 8% of the total applied axial load.

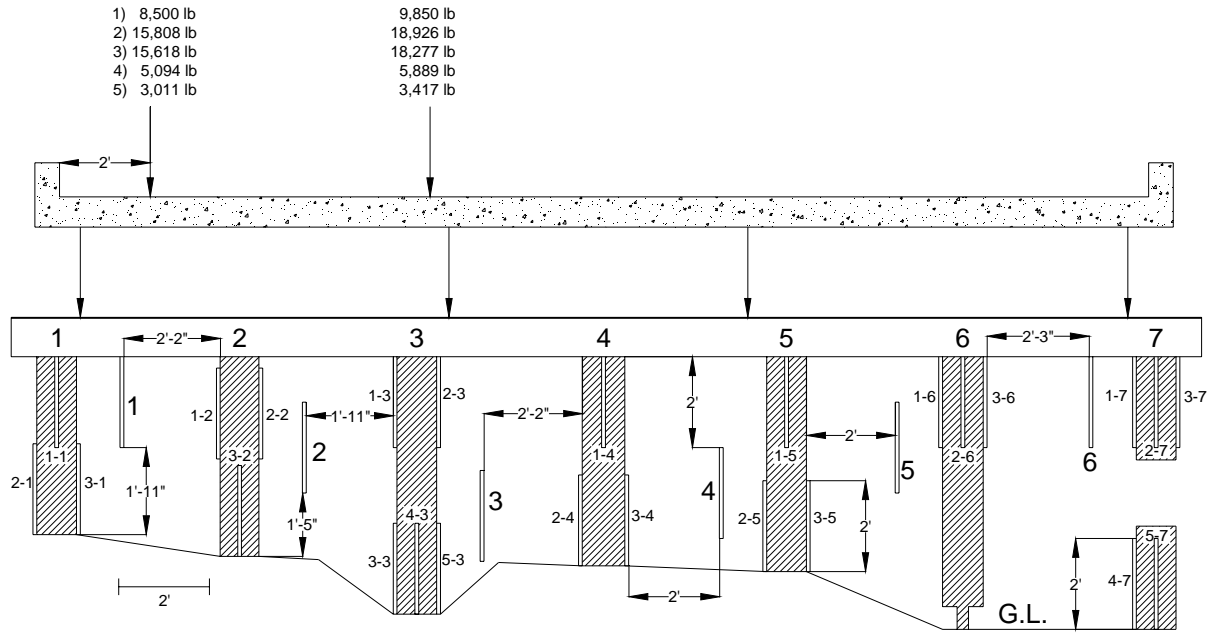
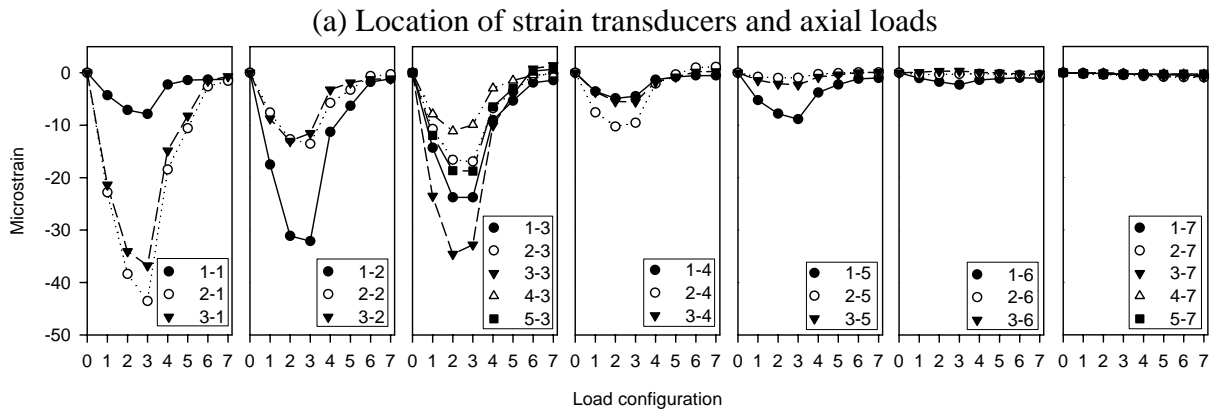
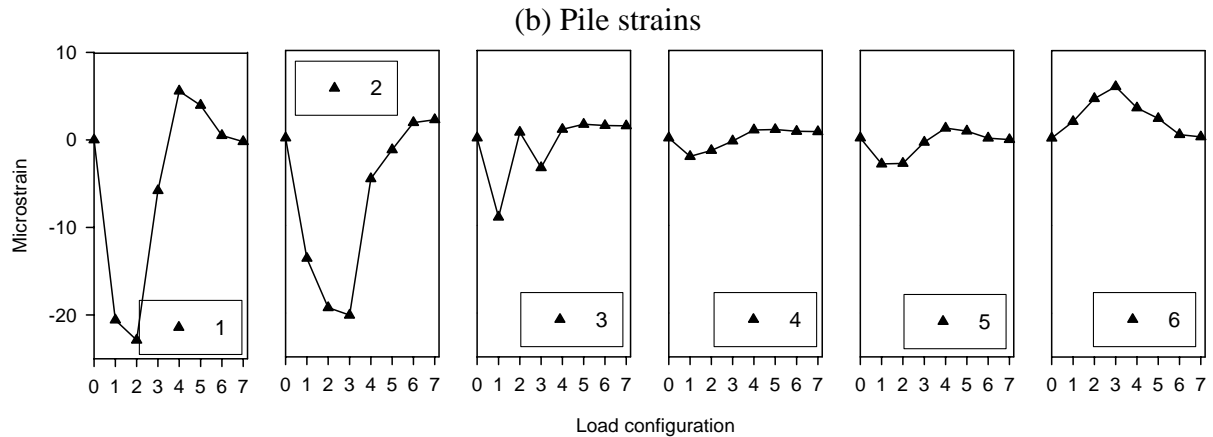
Figure 12.31. Static load test at the north edge with pile No. 7 removed (Bridge No. 029070 – Humboldt County)

The first load test was completed with the loading at the north edge of the bridge. The location of loads, pile strain measurements, and backwall strains are shown in Figure 12.31. The pile strains were approximately equal to those measured during the nondestructive load test, which was carried out at the north edge of the east abutment (Refer to Figure 12.26). This is because pile no. 7 did not endure any load when the abutment was loaded at the opposite edge. The backwall strains were also similar to the nondestructive test except those measured between pile nos. 6 and 7, which increased by about 60%. It can therefore be concluded that an exterior pile will not have a significant influence if the live load is concentrated on the edge opposite to the location of the deteriorated pile in the bridge.

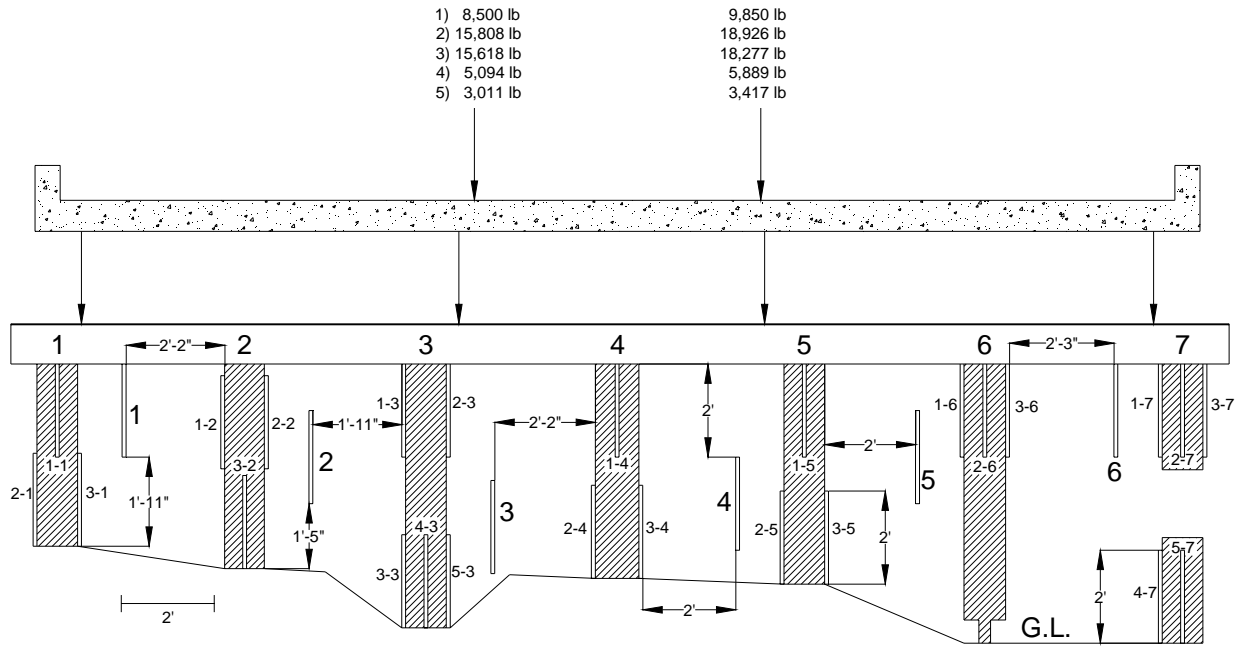
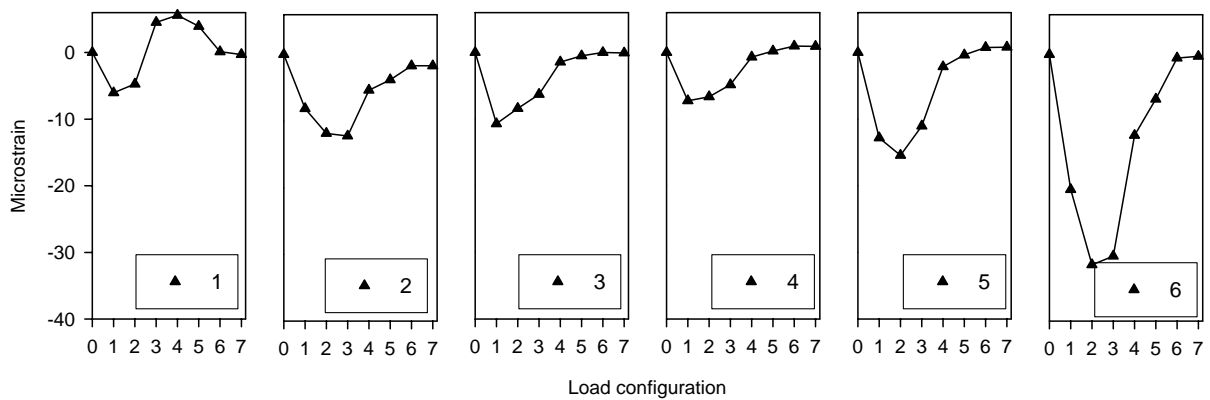
Figure 12.32. Static load test at the centerline with pile No. 7 removed (Bridge No. 029070 – Humboldt County)

The east abutment was then loaded at the centerline of the bridge deck. The location of loads, pile strain measurements, and backwall strains are presented in Figure 12.32. The results reveal a 25% increase in strain in pile no. 5 and about a 3% increase in the measured strains in pile nos. 3 and 4 compared to the nondestructive test at the same location. Most of the load carried by pile no. 7 was transferred to the next adjacent sound pile. The backwall strains also increased in the areas between pile Nos. 4 and 5, 5 and 6, and 6 and 7. About 63% strain was measured between pile nos. 6 and 7. Due to the partial bearing of the pile cap on the backwall, and due to the removal of pile no. 7, the backwall resisted a higher load as evidenced by the increase in negative strain at this location.

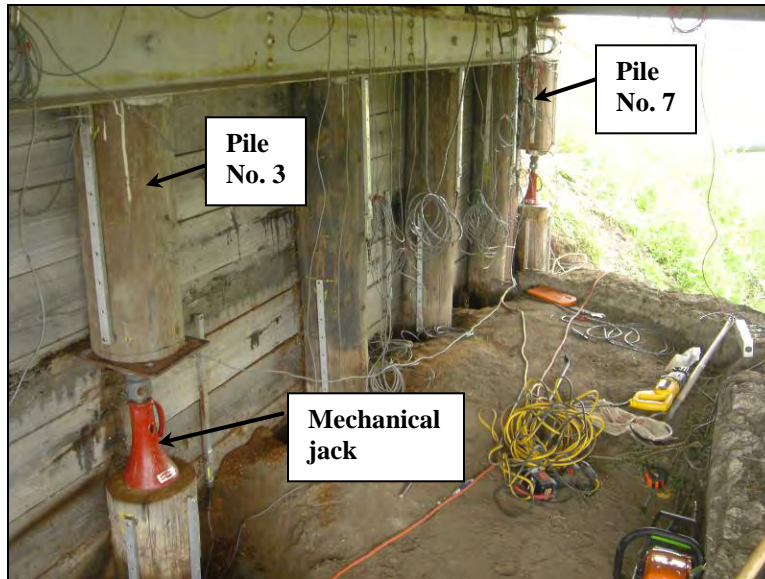
Figure 12.34. Pile Nos. 3 and 7 jacked (Bridge No. 029070 Humboldt County – July 12 2006)

In this destructive test, a section was removed from pile no. 3 after which both pile nos. 3 and 7 were jacked to their initial measured strain values (See Figure 12.34). A load cell was placed above each mechanical jack to measure the load carried by each pile due to live load. Three load tests were conducted with the load being applied at the north, centerline, and south edges.

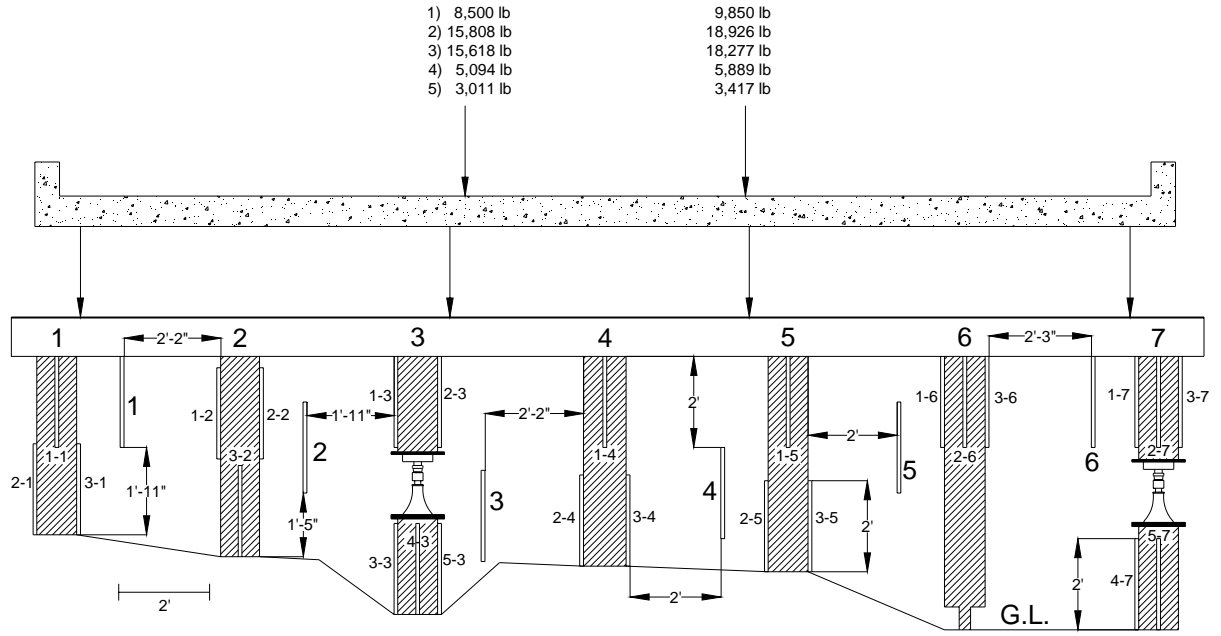
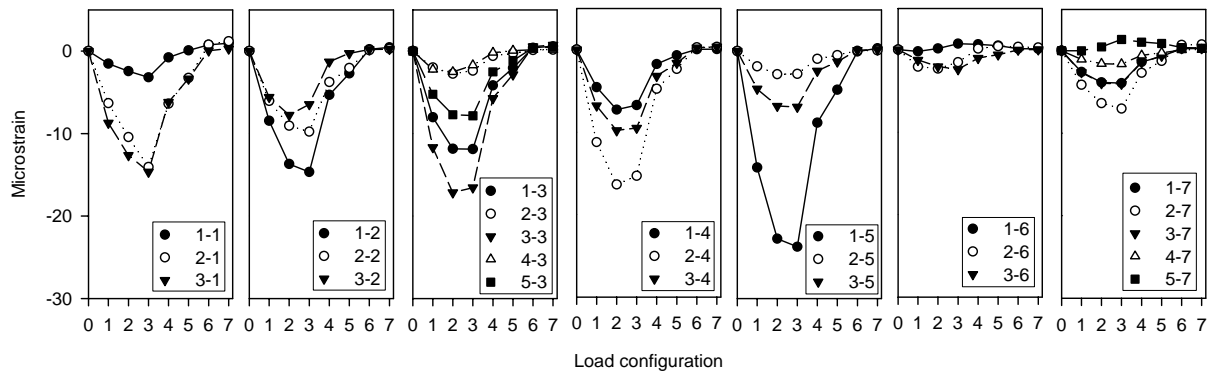
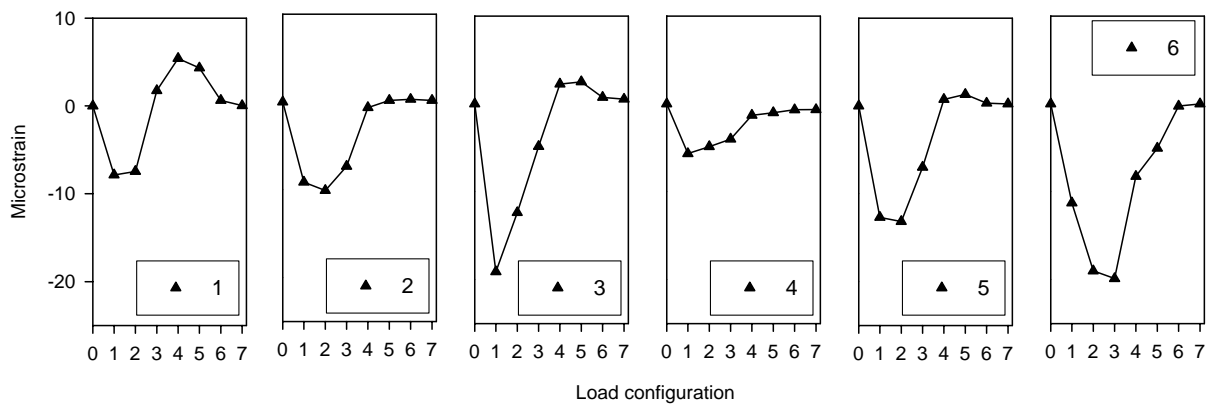
Figure 12.36. Static load test at the centerline pile Nos. 7 and 3 jacked (Bridge No. 029070 – Humboldt County)

The abutment was then loaded at the centerline of the bridge deck. The location of the loads, the pile strain measurements, and the backwall strains are shown in Figure 12.36. Similar to previous load tests conducted at this location, the load was primarily transferred to pile nos. 3 and 5 (See Figure 12.36a). The highest strain, which was about -23 microstrains, was in pile no. 5 in load configuration 3. When compared to the nondestructive test and destructive test nos. 1 and 2, the strain at pile no. 3 was reduced by approximately 40%. As a result, the backwall strain between pile nos. 3 and 4 increased by 60%. Similarly, the strain measured in pile no. 7 was reduced by approximately 35% compared to the nondestructive test at this location, whereas the backwall strain between pile nos. 6 and 7 increased by 45% increase. The same percent increase in backwall strain was recorded in destructive test no. 1. As mentioned earlier, removing a timber section and replacing it with the mechanical jack reduced the load carrying capacity of the piles, which transferred more axial load to the backwall. The percent load resisted by pile nos. 3 and 7 relative to the total load was 13 and 9%, respectively.

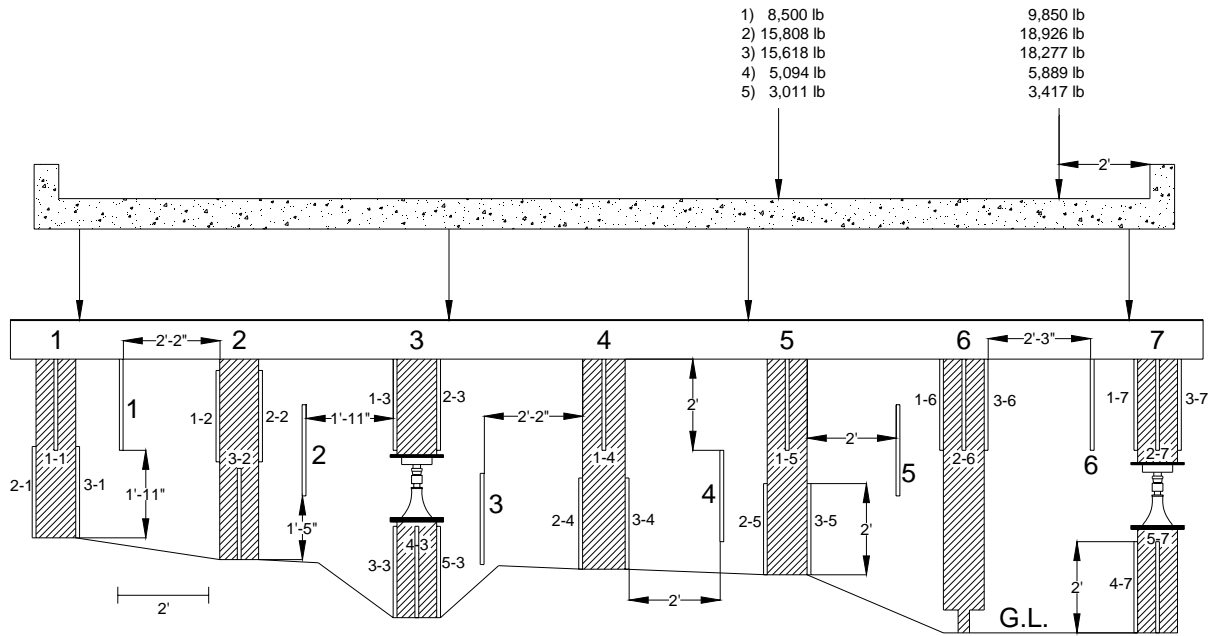
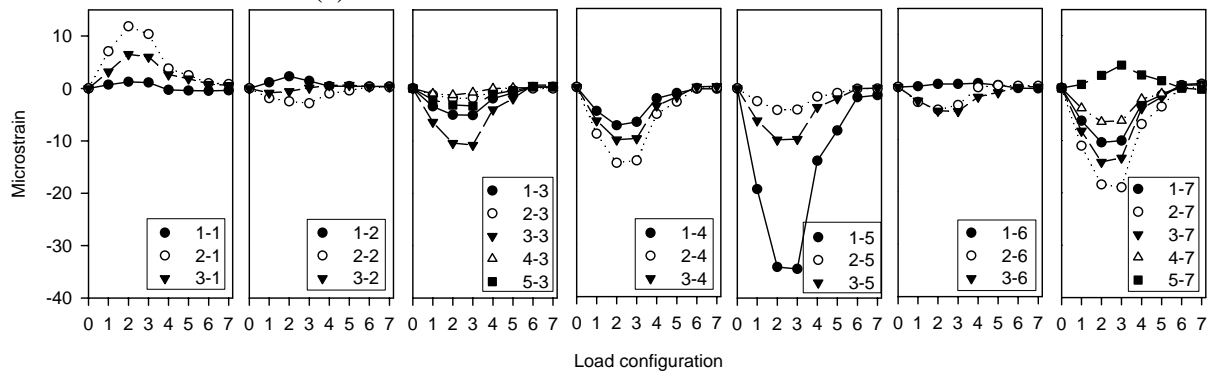
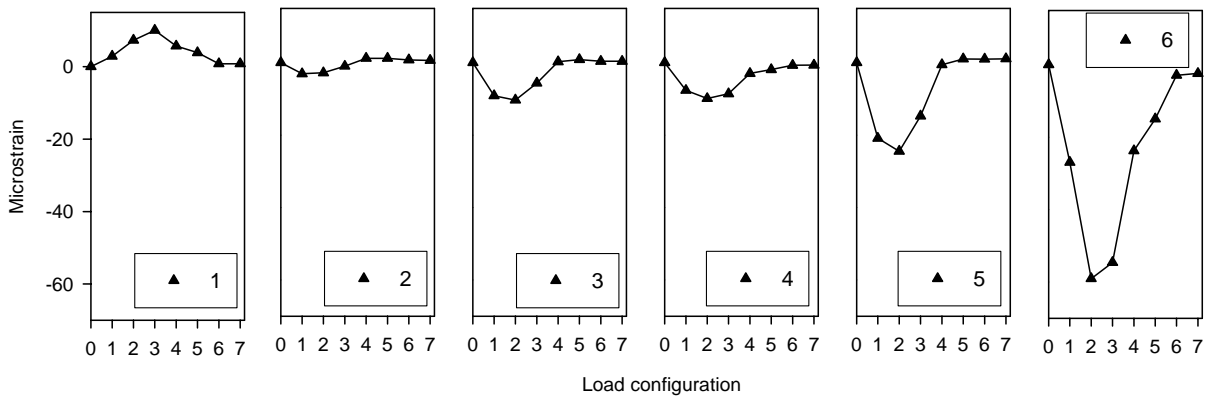
Figure 12.37. Static load test at the south edge pile Nos. 7 and 3 jacked (Bridge No. 029070 – Humboldt County)

The east abutment was finally loaded at the south edge of the bridge. The location of the axial loads, which were offset 2 ft from the curb, pile strain measurements, and backwall strains are shown in Figure 12.37. The results show a decrease in strain in pile nos. 3 and 7 compared to the nondestructive test and test no. 1 where pile no. 7 was jacked. The strain measurement of pile no. 3 decreased by about 25, 34, and 36% in load configuration 3 compared to the nondestructive test, test no. 1, and test no. 2, respectively. The decrease in pile no. 3 strain was coupled with an increase in backwall strain between pile nos. 3 and 4. The backwall strain at this location increased by 33 and 28% compared to the nondestructive test and test no. 1, respectively. The results also show that the strain in the adjacent pile no. 4 increased by 27 and 6% compared to the nondestructive test and destructive test no. 1, respectively. This indicated that part of the load that was resisted by pile no. 3 was transferred to the adjacent pile no. 4. However, no significant increase in the strains in pile no. 2 was observed. In the north edge test, most of the strain increase was noted in pile no. 2, whereas at the south edge, most of the strain increase occurred in pile no. 4. It can therefore be concluded that when an interior pile is partially deteriorated, the load may not be distributed equally among adjacent piles, and the live load location should be taken into consideration.

Similar to pile no. 3, the strain measured in pile no. 7 decreased by approximately 50 and 30% compared to the nondestructive test and test no. 1, respectively. This was accompanied by an increase in backwall strain due to partial bearing of the pile cap on the backwall. The percent increase was 55 and 11% compared to the nondestructive test and test no. 1, respectively. Furthermore, the strain in the adjacent pile no. 5 increased by 40% compared to the nondestructive test. No considerable difference was noted relative to the strains measured during test nos. 1 since pile no. 7 was jacked during both tests. When compared to test no. 2 (pile no. 7 removed) the results demonstrate that the backwall strain between pile nos. 6 and 7 was reduced by 25%, and the strain in pile no. 5 was also reduced by 13%. The percent load carried by pile nos. 3 and 7 were 6 and 27%, respectively.

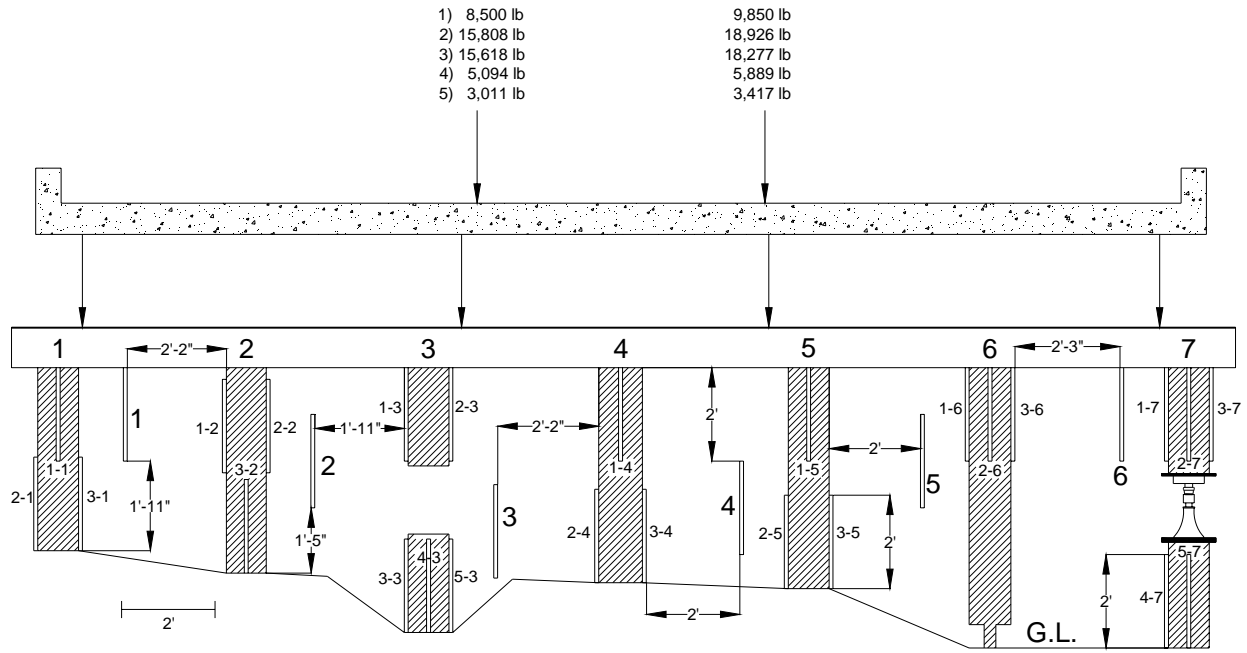
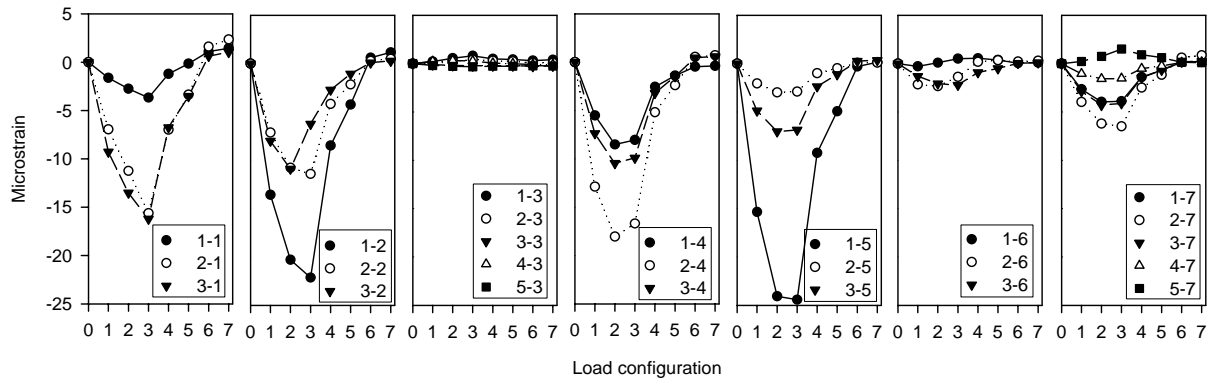
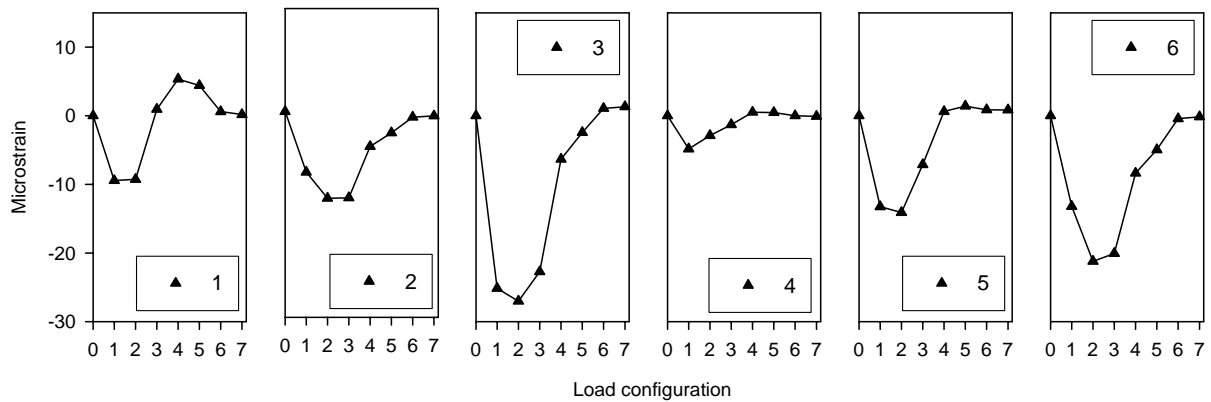
Figure 12.39. Static load test at the centerline pile No. 3 removed and pile No. 7 jacked (Bridge No. 029070 – Humboldt County)

Loading the abutment at the centerline of the bridge deck resulted in an increase in strain at pile nos. 2 and 4 by 50 and 12%, respectively, compared to the strains that occurred in destructive test no. 3 (See Figure 12.39b). Furthermore, a 40% increase in the backwall strain between pile nos. 3 and 4 was measured (See Figure 12.39c). The percent load carried by pile no. 7 was 9%, which is equal to that measured during test no. 3.

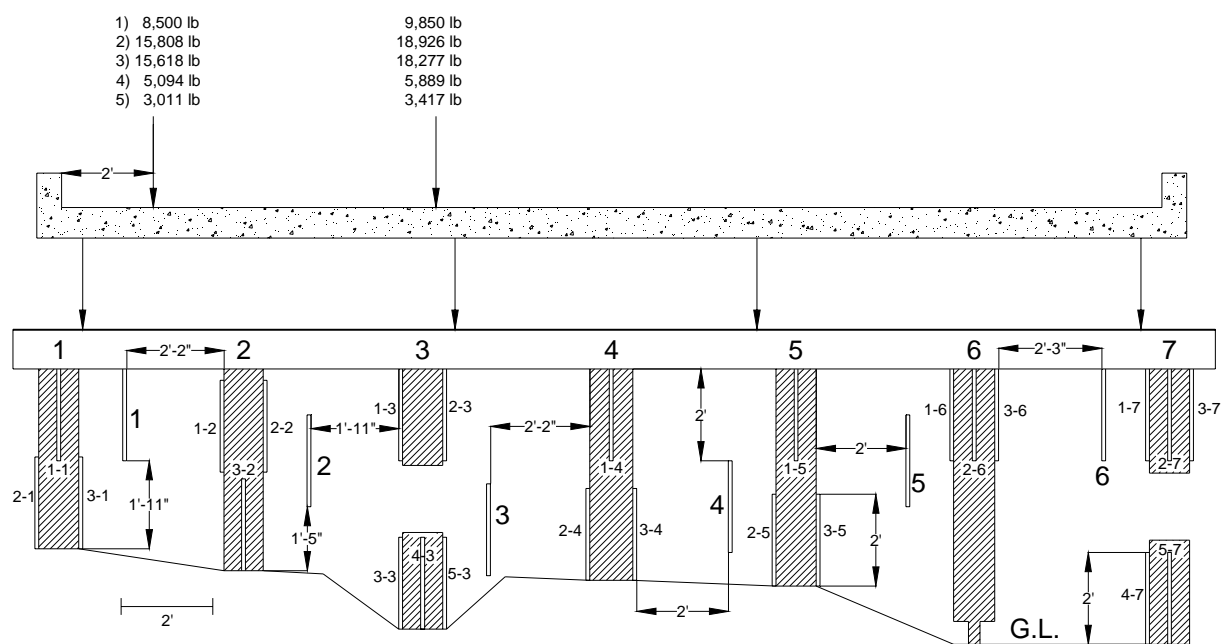
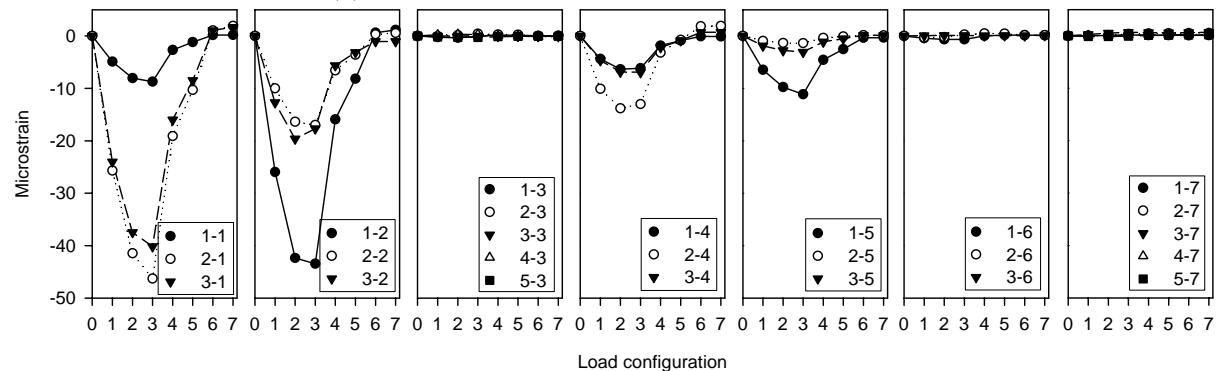
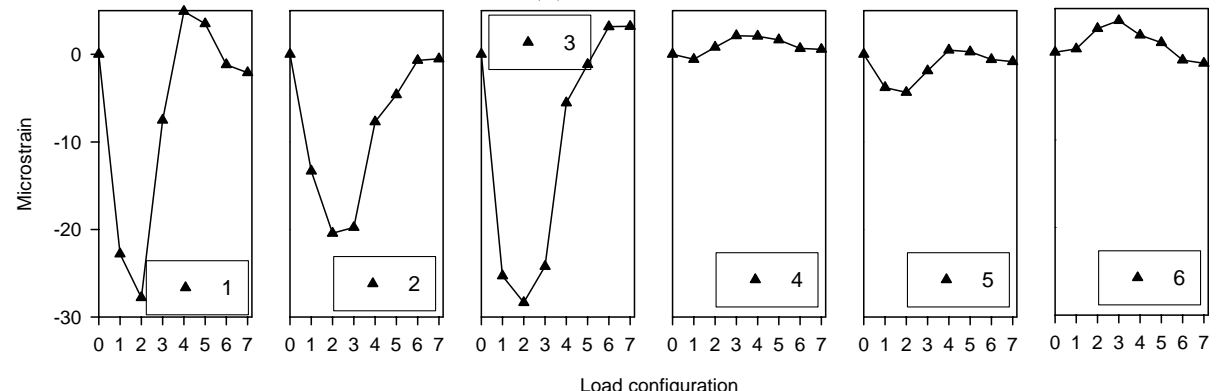
Figure 12.40. Static load test at the north edge with pile Nos. 3 and 7 removed (Bridge No. 029070 – Humboldt County)

The first load test was carried out with the load applied at the north edge of the bridge. The location of the axial loads, pile strain measurements, and backwall strains are shown in Figure 12.40. The pile strain measurements, shown in Figure 12.40a, were compared to the previous destructive test (test no. 4 where pile no. 3 was removed and pile no. 7 was jacked). The pile and backwall strain measurements in both tests were very similar. This confirms previous conclusions and demonstrates that a deteriorated interior pile has more influence than a deteriorated exterior one on load distribution through the substructure when the bridge is loaded at the opposite edge of the exterior pile location.

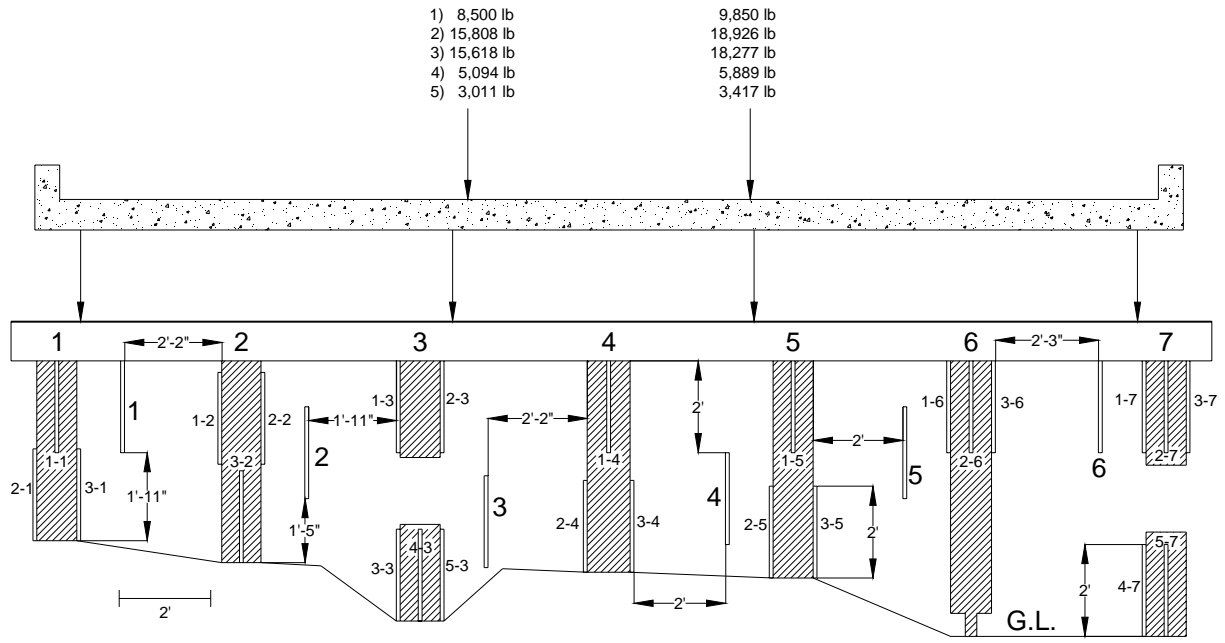
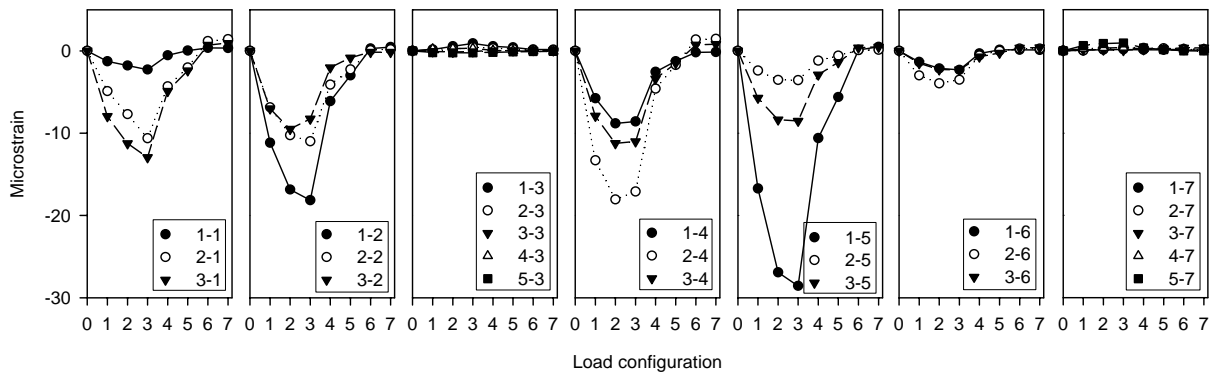
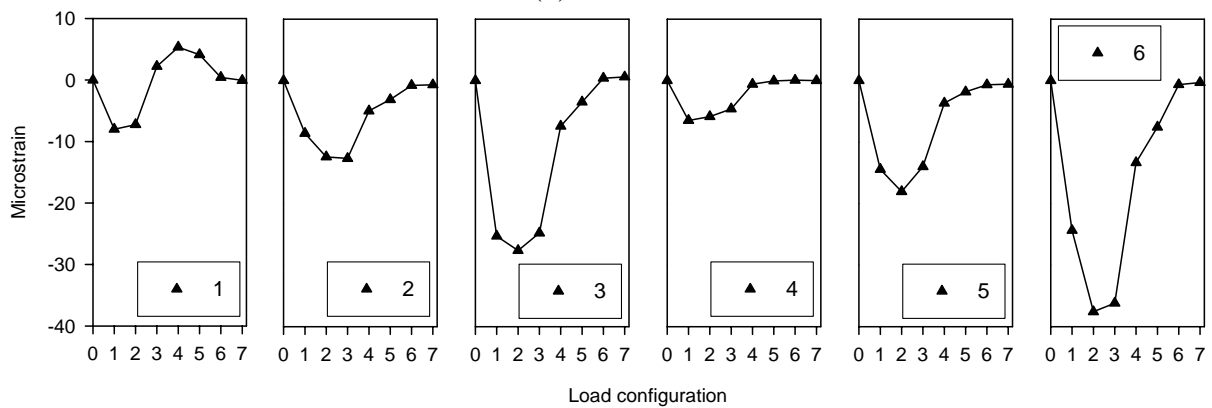
Figure 12.41. Static load test at the centerline with pile Nos. 3 and 7 removed (Bridge No. 029070 – Humboldt County)

When the abutment was loaded at the centerline, the influence of the exterior pile no. 7 became more apparent (See Figure 12.41). This was determined by comparing the strains in load configuration 3 for pile no. 5 during test nos. 3, 4, and 5. The strain in test no. 3 was about -23 microstrains. When pile no. 3 was removed, the strain increased to -24 microstrains (about 4% increase), however, when pile no. 7 was removed the strain increased to -28 microstrains (20% increase). The exterior pile no. 7 does not appear to have any influence on pile nos. 1 through 4 since the strains did not change compared to test no. 4.

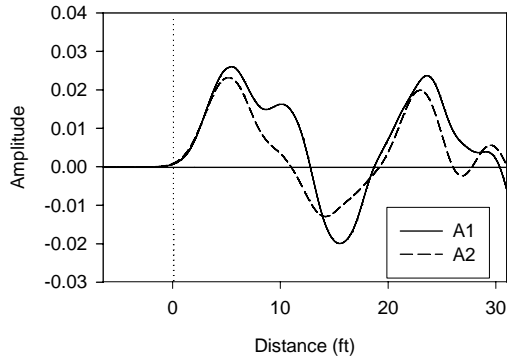
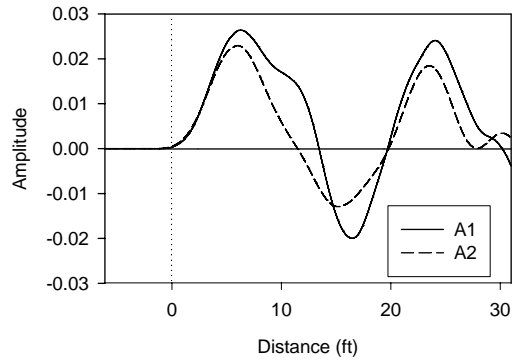
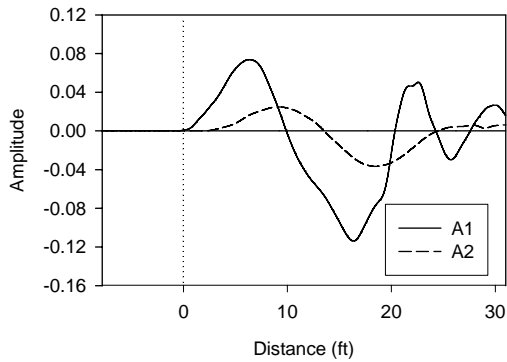
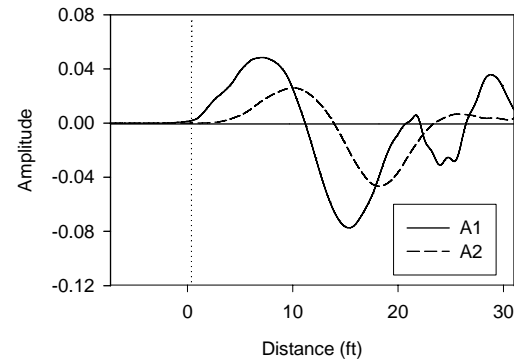
Figure C8. Pile integrity test results at pile no. 3 at the south abutment (distance between A1 and A2 = 4.5 ft)

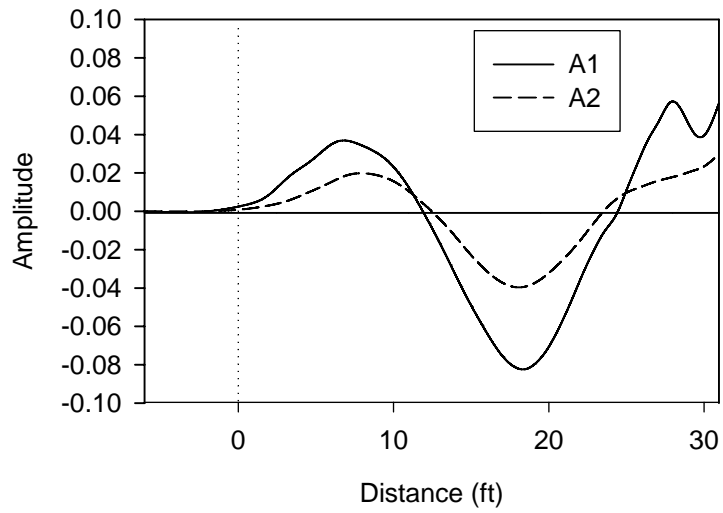
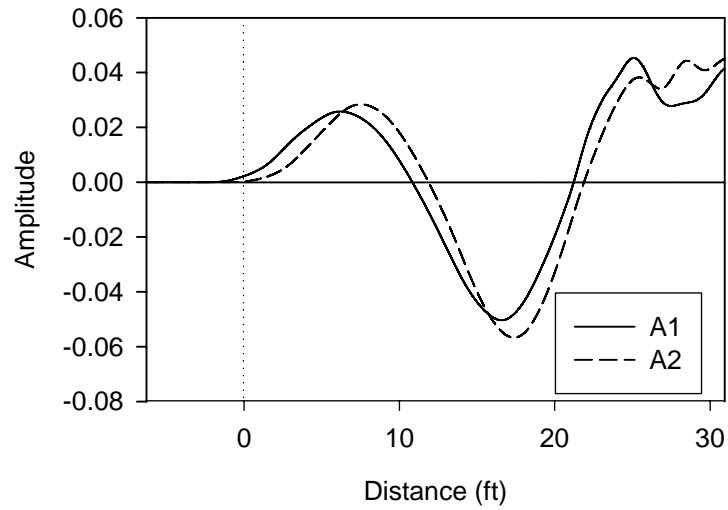
Figure C9. Pile integrity test results at pile no. 3 at the south abutment (distance between A1 and A2 = 2.5 ft)

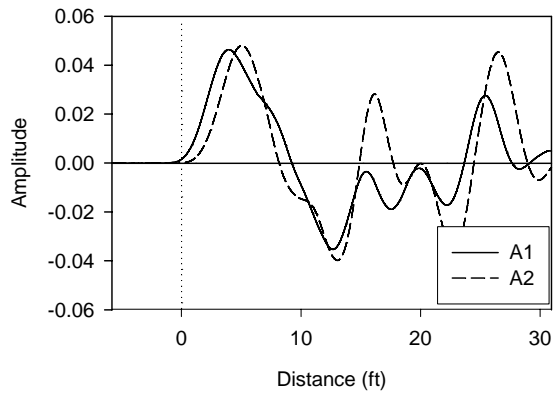
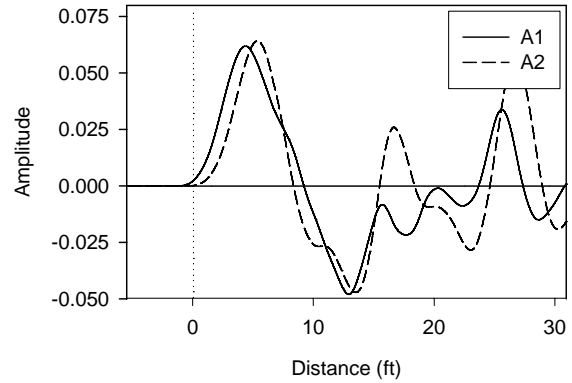
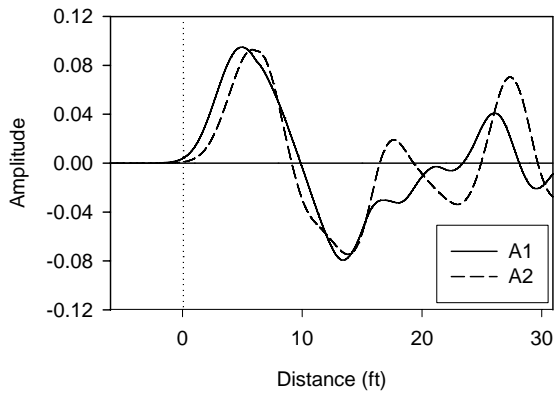
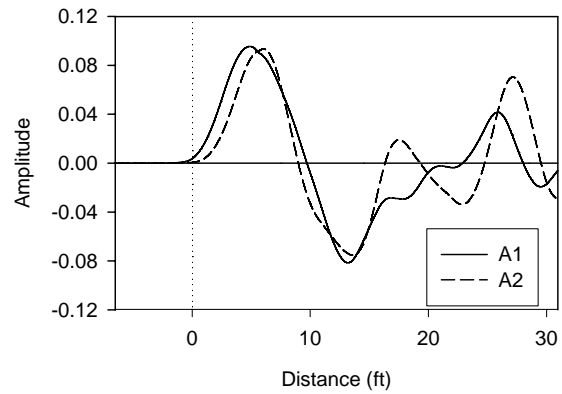
Figure C10. Pile integrity test results at pile no. 2 at the south abutment (distance between A1 and A2 = 2 ft)
