Fiber Reinforced Polymer Composite–Wood Pile Interface Characterization by Push-Out Tests

Roberto Lopez-Anido, M.ASCE¹; Antonis P. Michael, S.M.ASCE²; and Thomas C. Sandford, M.ASCE³

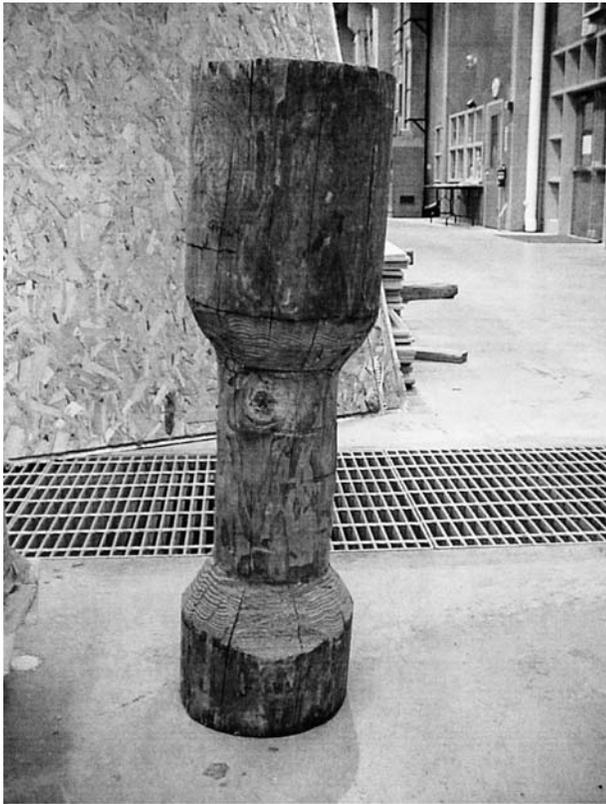
Fig. 1. Predamaged wood pile specimen

Predamage to wood piles was achieved by reducing the diameter of the cross section of a segment. The reduction in radius simulated the type of *Limnoria* damage found in a field inspection of the Portland, Maine, harbor (Lopez-Anido et al. 2004b). Approximately 62% reduction of the total cross-sectional area was applied in the laboratory to simulate *Limnoria spp.* necking damage (see Fig. 1). The extent of predamage adopted was based on
