Repair of corroded and buckled short steel columns using concrete-filled GFRP jackets

A. Kaya, M. Dawood*, B. Gencturk

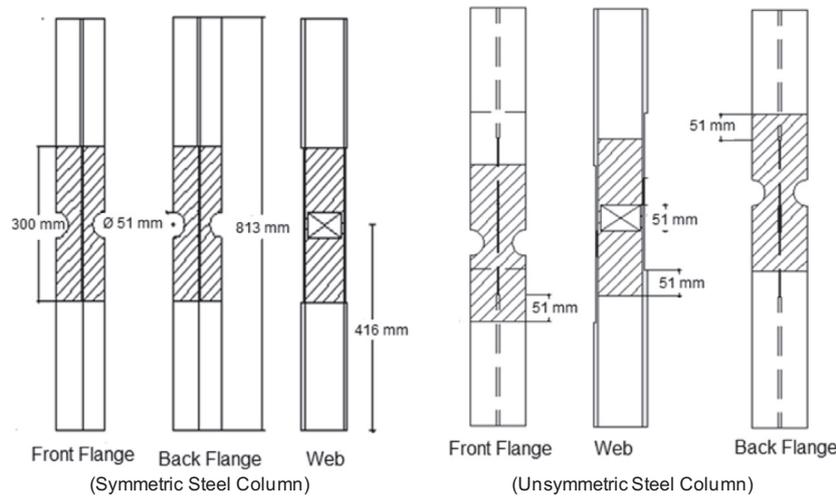
Fig. 1. Schematic representation of the corrosion patterns of the tested steel columns (adapted from [11]).

A total of thirteen short steel columns were tested in this study. The columns consisted of W4 × 13 (US designation) columns with different patterns of simulated corrosion. The columns were previously tested to evaluate the capacity of short steel columns with localized severe corrosion [11]. After testing, the columns were repaired with different configurations of concrete-filled GFRP jackets to investigate the effectiveness of this repair technique. The configurations of the corrosion patterns are illustrated schematically in Fig. 1. In the previous study, the columns were assigned unique identifiers of up to five parts. The first two parts indicated the percentage reduction of flange and web thickness, respectively. The third part of the identifier, V or NV, indicated the presence or absence, respectively, of a 51 mm void at the mid-height of the web to simulate through web corrosion. The fourth part, S or US, indicated a symmetric or unsymmetric corrosion pattern, respectively, as illustrated in Fig. 1. The final part, WR if present, indicated the presence of a semi-circular reduction of the flanges to simulate the presence of flange perforations due to extreme corrosion.

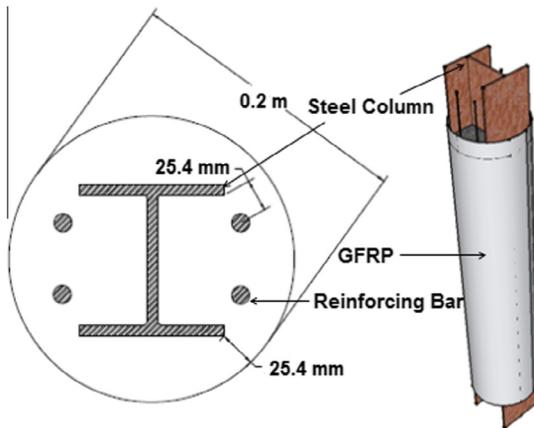
Fig. 2. Schematic representation of repaired steel columns.

The GFRP jackets that were used in this study were fabricated from a continuous flexible GFRP laminate that was wrapped around the pile and bonded to itself to produce a multi-layered closed, circular GFRP tube around the pile. The benefit of this system is that the GFRP tube can be manufactured on site to any length, diameter, and thickness desired to meet the demands of the specific repair application at hand. The repair procedure included nine steps: (1) the steel surface was cleaned using a wire brush and alcohol; (2) the GFRP sheets were cut to the appropriate dimensions; (3) wooden spacers were placed on the flanges of the steel columns to prevent direct contact between the steel columns and the GFRP jackets; (4) the GFRP jackets were wrapped around the steel columns to a nominal diameter of 203 mm; (5) the two-component epoxy was mixed for 3 min using a low speed mixer until achieving a uniform color; (6) the epoxy was applied to both sides of the GFRP laminate prior to wrapping the laminate around the column; (7) the jacket was secured using plastic zip ties for 48 h while the epoxy cured; (8) the reinforcing bars were placed inside the jackets (depending on the specimen); and (9) the grout and gravel were mixed using a gravity-based mixer and cast into the FRP jackets. Fig. 2 shows a schematic representation of the repaired columns.

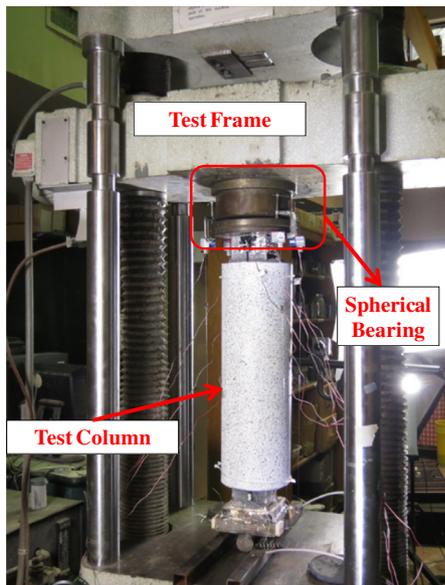
Fig. 3. Test setup.

The boundary conditions of the columns were designed to provide a nominally simply-supported condition about the weak axis of the column and a nominally fixed/pinned condition about the strong axis. A thin layer of plaster was applied at the end caps to fill the gap between the specimen and the support plate. Fig. 3 shows the test setup. Four string potentiometers were placed at the four corners of each specimen to measure the axial shortening. The string potentiometers were installed in such a manner so as to measure the vertical displacement between the two end caps. Data was collected using a Micro-Measurements System 7000 data acquisition system.

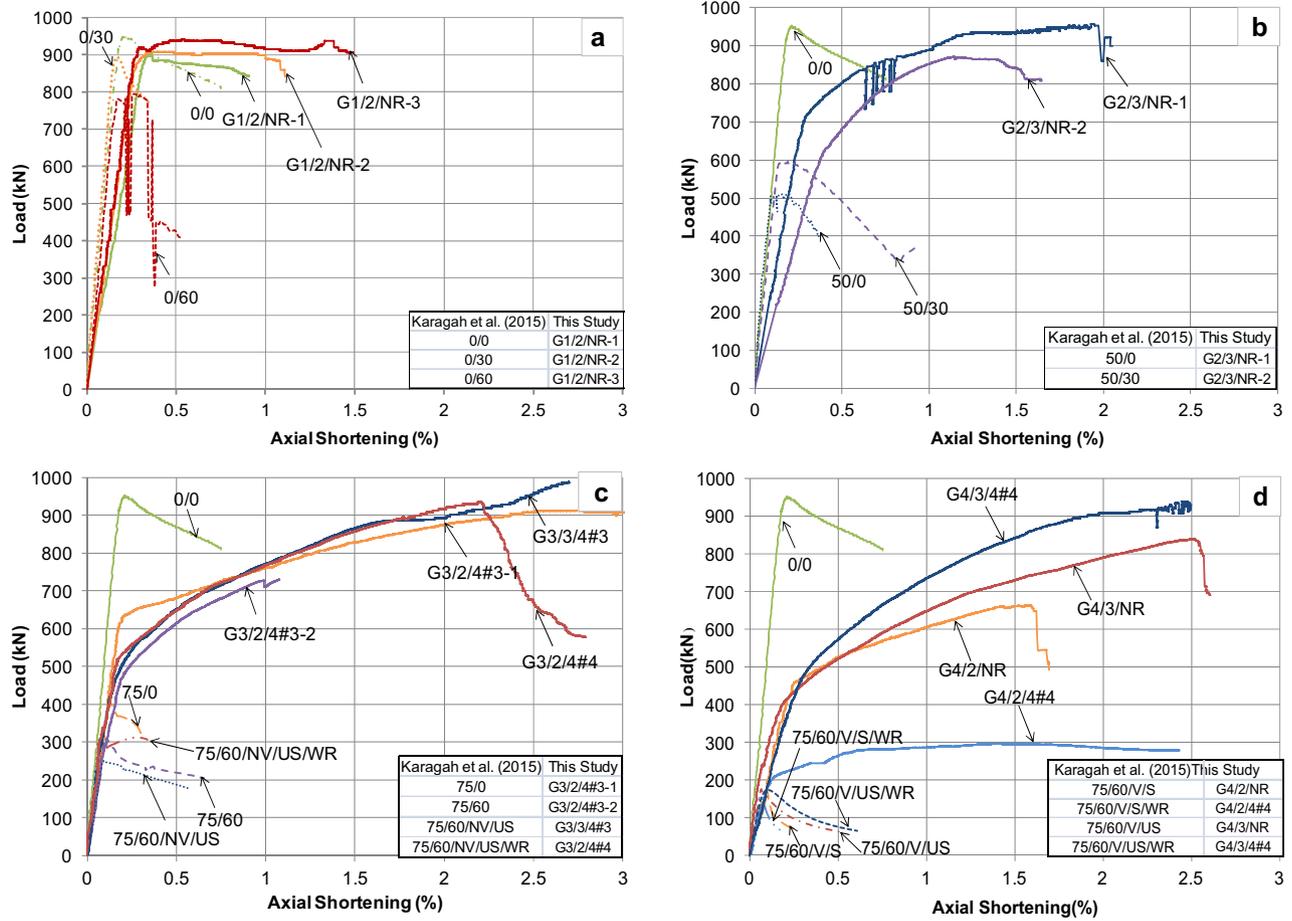
Fig. 4. Axial load-shortening behavior of the columns (a) group #1, (b) group #2, (c) group #3 and (d) group #4.

As mentioned previously, the columns that were tested in this study were grouped into four groups based on the behavior of the corroded columns prior to strengthening. The following sections summarize the behavior of the repaired columns in each of the four tested groups. Fig. 4(a–d) presents the axial load–deflection response of the columns in groups #1 – #4, respectively. The figures present the response both prior to and after repair for all of the tested columns. Table 7 summarizes the measured peak load and axial stiffness of the tested columns, prior to and after repair. The following sections summarize the observed behavior of the tested columns in each group and discuss the influence of the key test parameters.

Fig. 4(a) shows the axial load–shortening behavior of all three of the tested columns before and after repair. All three columns were repaired with a two-layer GFRP jacket and no internal rebar. The repaired columns all failed by global buckling accompanied by splitting of the GFRP near the ends of the jackets with localized cracks forming in the grout near the flange tips as illustrated in Fig. 5(a). The repair system was capable of restoring the capacities of the columns to between 94% and 99% of the capacity of the undamaged, uncorroded control column, 0/0. However, the elastic axial stiffnesses of the piles were only between 54% and 67% of the undamaged control column. This was attributed to the increased initial out-of-straightness of the buckled columns. Inspection of the axial load–deformation response of the repaired columns in Fig. 4(a) indicates that all three columns exhibited a similar response suggesting a high degree of repeatability of the results.

Fig. 4(b) shows the axial load–shortening behavior of the group #2 columns before and after repair. The figure also shows the axial load–shortening behavior of the 0/0 control column for comparison purposes. Both of the repaired columns failed by global buckling accompanied by vertical splitting of the GFRP near the ends of the jackets and localized cracking of the grout. The observed failure was similar to that of the columns in group #1 as shown in Fig. 5(a). Inspection of Table 7 indicates that the repair was capable of restoring the capacities of the buckled columns to between 91% and 100% of the capacity of the undamaged, uncorroded control column. Further, the capacities of the repaired columns were between 51% and 84% higher than the capacities of the corroded columns prior to installation of the repair. However, the axial

Fig. 4(c) shows the axial load-shortening behavior of the group #3 columns before and after repair. The figure also presents the axial load-shortening behavior of the 0/0 control column for comparison purposes. Due to the extensive section loss and reduction of capacity of these columns, extra measures were implemented to increase the effectiveness of the repair system. Columns

Fig. 4(d) shows the axial load-shortening behavior of the group #4 columns before and after repair along with the behavior of the 0/0 control column for comparison purposes. Columns G4/2/NR and G4/3/NR were similar except that they were repaired with

Column G4/3/4#4 failed by global buckling, as illustrated in Fig. 5(d), at a measured load of 943 kN. The test was stopped when excessive rotations were observed at the upper and lower supports. Inspection of Fig. 4(d) indicates that the axial load-shortening response had achieved a plateau at this stage. Comparing the results of columns G4/3/NR and G4/3/4#4 indicates that the presence of the additional reinforcing bars helped to increase the capacity of the repaired columns by 12% despite the fact that the initial out-of-straightness of column G4/3/4#4 was twice that of column G4/3/NR.

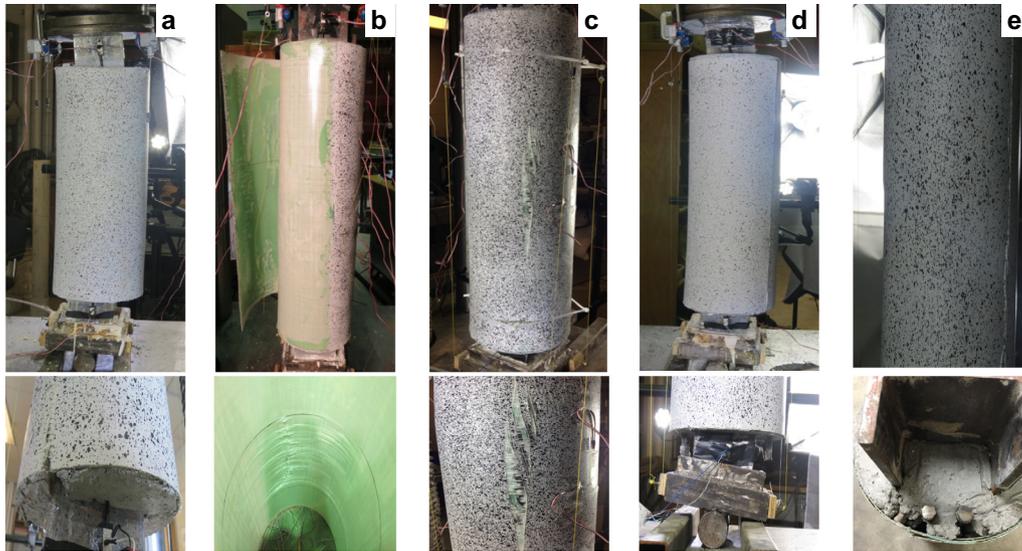
Fig. 5. Failure of test columns (a) G2/3/NR-2 (b) G3/2/4#3-2 (c) G3/2/4#4 (d) G3/3/4#3 (e) G4/2/4#4.

G3/2/4#3-1 and G3/2/4#3-2 were both repaired with two-layer GFRP jackets and four 9.5 mm diameter steel internal reinforcing bars. Column G3/2/4#3-1 failed by global buckling and rupture of the GFRP, as illustrated in Fig. 5(c), at a load level of 912 kN, which corresponded to 95% of the capacity of the uncorroded control column. Column G3/2/4#3-2 was the only column for which the surface of the GFRP jacket was only sanded on one side prior to installation. Consequently, the column failed by delamination of the GFRP jacket, as shown in Fig. 5(b). Delamination initiated at the free end of the GFRP at a load level of 730 kN. This load level corresponded to the 76% of the capacity of the uncorroded control column. The failure of this column highlights the importance of proper surface preparation and bonding of the jacket prior to installation.

Column G3/2/4#4 was similar to the previous two columns, but included 12.7 mm diameter internal steel reinforcing bars rather than 9.5 mm diameter bars. The repaired column failed due to GFRP rupture as shown in Fig. 5(c) at a load level of 934 kN, which corresponded to 98% of the capacity of the control column.

Column G3/3/4#3 was repaired with a three-layer GFRP jacket rather than a two-layer jacket like the previous columns. It failed due to global buckling of the column without rupture of jacket as shown in Fig. 5(d) at a load level of 992 kN, which corresponded to 104% of the capacity of the control column. Testing was halted when excessive rotation was observed at the upper and lower supports. Comparison of the behavior to that of column G3/2/4#3-1 indicates that increasing the jacket thickness helped to increase the failure load by 9%. Further, increasing the jacket thickness prevented rupture of the jacket at failure.

two-layer and three-layer GFRP jackets, respectively. Comparison of the results indicates that both columns exhibited a similar trend of behavior. Both columns failed by rupture of the GFRP jacket as illustrated in Fig. 5(c) at loads of 664 and 841 kN, respectively. The results indicate that increasing the number of layers in the GFRP jacket increased the capacity of the repaired column by 25%. This increase of capacity was achieved despite the fact that the initial out-of-straightness of column G4/3/NR was 1.5 times that of column G4/2/NR.
