Repair of Earthquake-Damaged RC Columns with FRP Wraps

by Hamid Saadatmanesh, Mohammad R. Ehsani, and Limin Jin

An investigation was conducted into the flexural behavior of earthquake-damaged reinforced concrete columns repaired with prefabricated fiber reinforced plastic (FRP) wraps. Four column specimens were tested to failure under reversed inelastic cyclic loading to a level that can be considered higher than would occur in a severe earthquake. The columns were repaired with prefabricated FRP wraps and retested under simulated earthquake loading. The test specimens were designed to model single-bent, nonductile concrete columns in existing highway bridges constructed before the modern seismic design provisions were in place. FRP composite wraps were used to repair damaged concrete columns in the critically stressed areas near the column footing joint. The physical and mechanical properties of FRP composite wraps are described. Seismic performance of repaired columns in terms of their hysteretic response is evaluated and compared to those of the original and unretrofitted columns. The results indicate that the proposed repair technique is highly effective. Both flexural streng

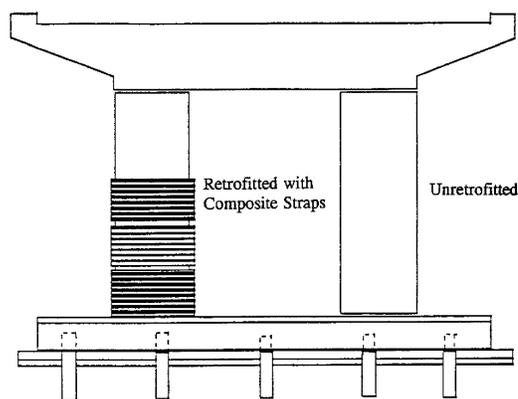
Fig. 1—Retrofitted and unretrofitted concrete columns.

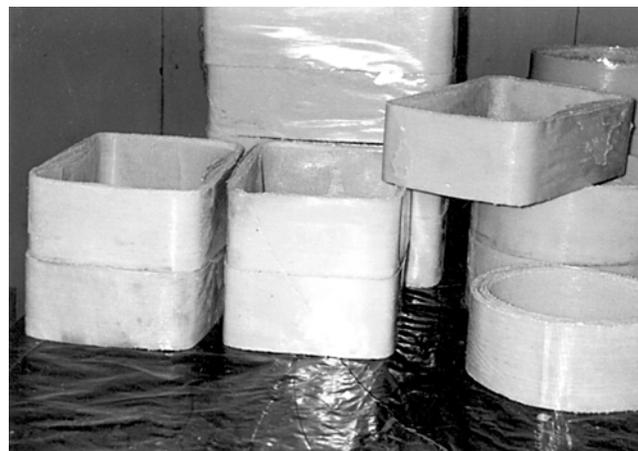
Fig. 2—FRP composite straps for seismic repairs.

In this paper, an effective technique for repairing earthquake-damaged columns with FRP composite wraps is presented. FRP composite wraps, constructed from high-strength glass fibers weaved to form a fabric-like material of specified width and length, are externally wrapped around the damaged regions of columns in continuous rings, as shown in Fig. 1. The desired confinement to the core concrete at the critical sections is achieved by hoop stresses developed in the composite wrap as a result of the dilation of the core concrete undergoing inelastic deformations. It is noted that the filaments of glass are very strong in tension and could reach an ultimate strength of about 3447 MPa (500 ksi) and a tensile modulus of elasticity of 72.4 GPa (10,500 ksi). The composite straps, which were fabricated in the Structural Engineering Laboratory of the University of Arizona, possessed sufficient flexibility to be easily wrapped around circular as well as rectangular columns. Fig. 2 shows typical composite wraps used in this study.

curing. The wet composite wrap was cured at 160 F for 40 min. Fig. 2 shows the finished FRP wraps ready to be used in the column repair. Due to the small thickness, the cured wrap was flexible enough to be wrapped around circular as well as rectangular columns.

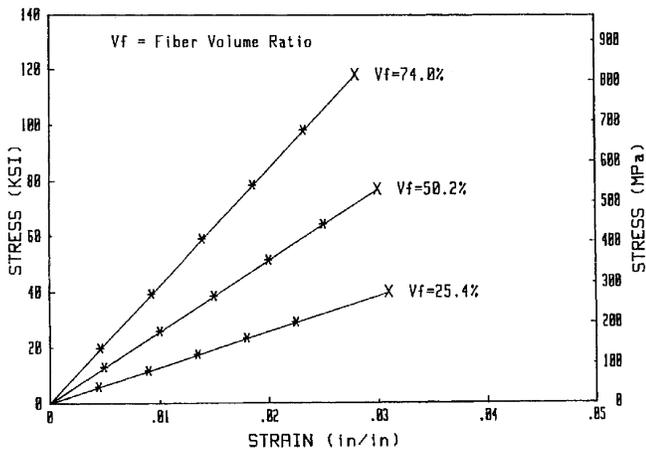
Fig. 3—Typical stress-strain curves for FRP composite wraps.

The stress-strain curves throughout the entire range of loading up to failure were plotted for the specimens with different fiber volume ratios as shown in Fig. 3. In this

figure, V_f defines the ratio of volume of fibers over the total volume of the strap. The data for the stress-strain curves were obtained by averaging the test results from three identical specimens for each of the three fiber volume ratios. The material properties determined from the tests are summarized in Table 1. Composite wraps with $V_f \approx 50.2$ percent were used in this study.

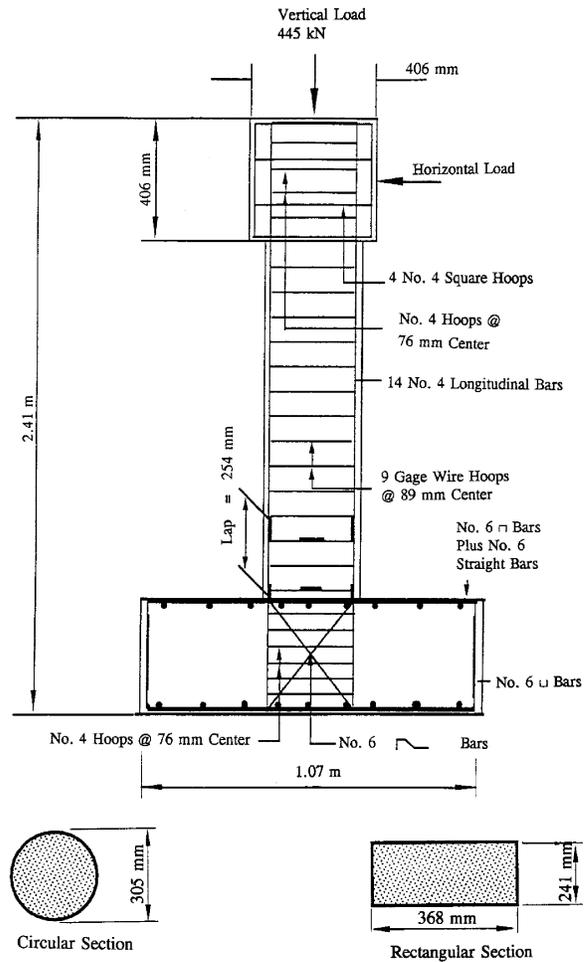
Fig. 4—Design details of test columns.

Each specimen consisted of a single column bent with a strong footing details, as shown in Fig. 4. The design details

All column specimens were 1/5-scale of prototype bridge columns. The dimensions of concrete footings were determined so that the test units fit the hold-down points in the Structural Engineering Laboratory. The overall height of the test units was 2.413 m (7 ft 11 in.). The height of the columns was 1.892 m (6 ft) from the center of pins where the cyclic loading was applied to the top of the footing. A 1067 x 914 x 381 mm (42 x 36 x 15 in.) concrete block was designed as the footing for the specimens, as shown in Fig. 4.

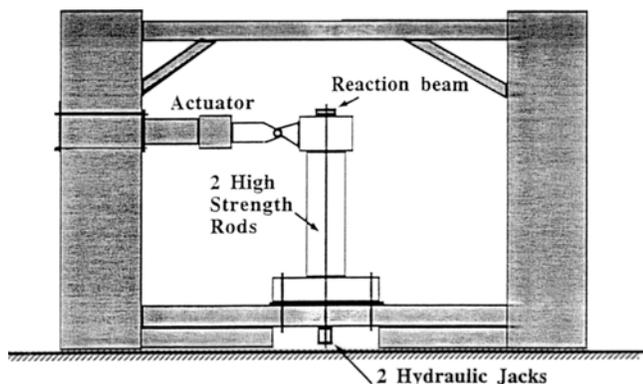
Fig. 5—Test setup.

Each column (C-1, C-2, R-1, and R-2) was first tested laterally subjected to inelastic earthquake load reversals in a reaction frame, as shown in Fig. 5. Hydraulic rams at the base of the specimens were used to apply a constant axial

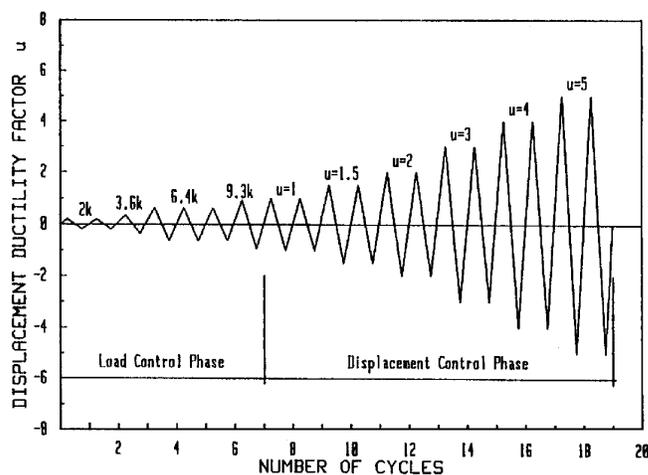
Fig. 6—Loading sequence for Circular Column C-1.

load of 445 kN (100 kips) to simulate the dead load. A typical loading sequence for one of the specimens (Column C-1) is shown in Fig. 6. The loading cycles were divided into two phases: load control and displacement control. Load control phase was used up to yielding of the longitudinal bars; beyond that point, a displacement control loading sequence was used. In Fig. 6, u , defined as the displacement ductility factor, is the ratio of the applied displacement at the top of the column over the displacement at first yield. At the end of the initial tests to failure, the original specimens (C-1, C-2, R-1, and R-2) experienced severe damage, such as debonding of starter bars, spalling and crushing of concrete in the compression zone, local buckling of longitudinal steel, and the separation of the main bars from the column core concrete, as shown in Fig. 7 through 10. The column specimens to be repaired were pushed back to the original position (i.e., zero lateral displacement) before the repair operation began.

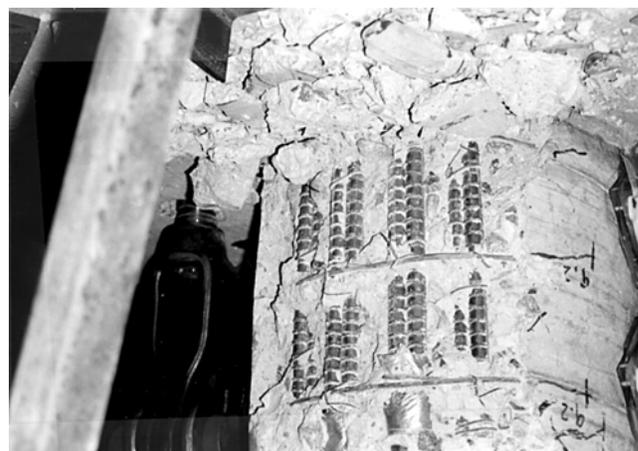
Fig. 7—Bond failure of lapped starter bars in Column C-1.

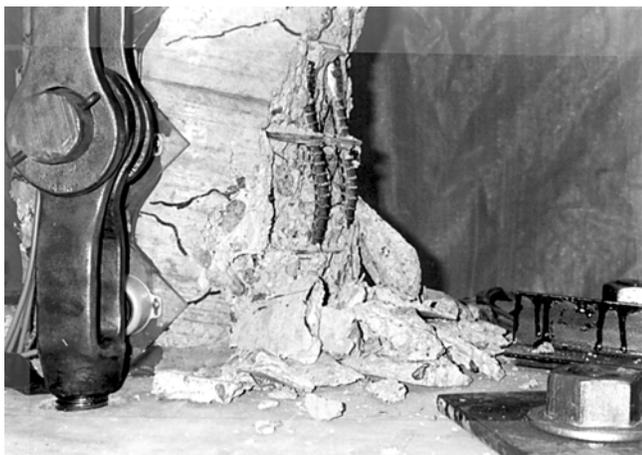
Fig. 8—Buckling of continuous longitudinal bars in Column C-2.

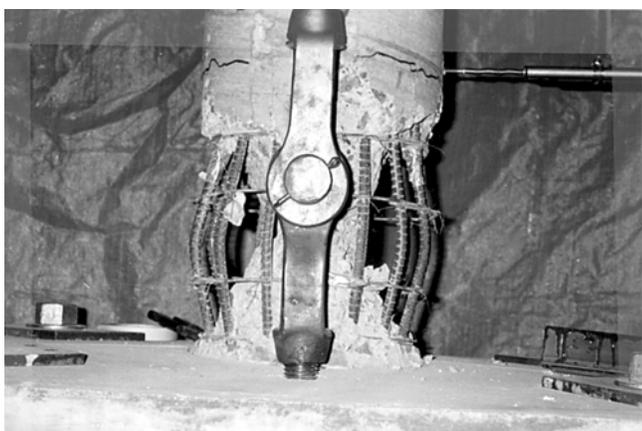
Fig. 9—Column C-2 at conclusion of test.

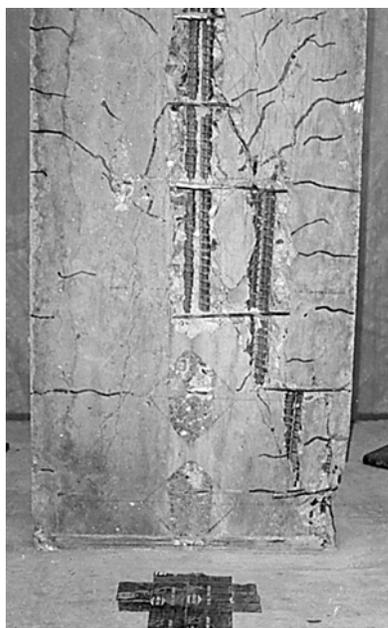
Fig. 10—Separation of main bars from core concrete in Column R-2.

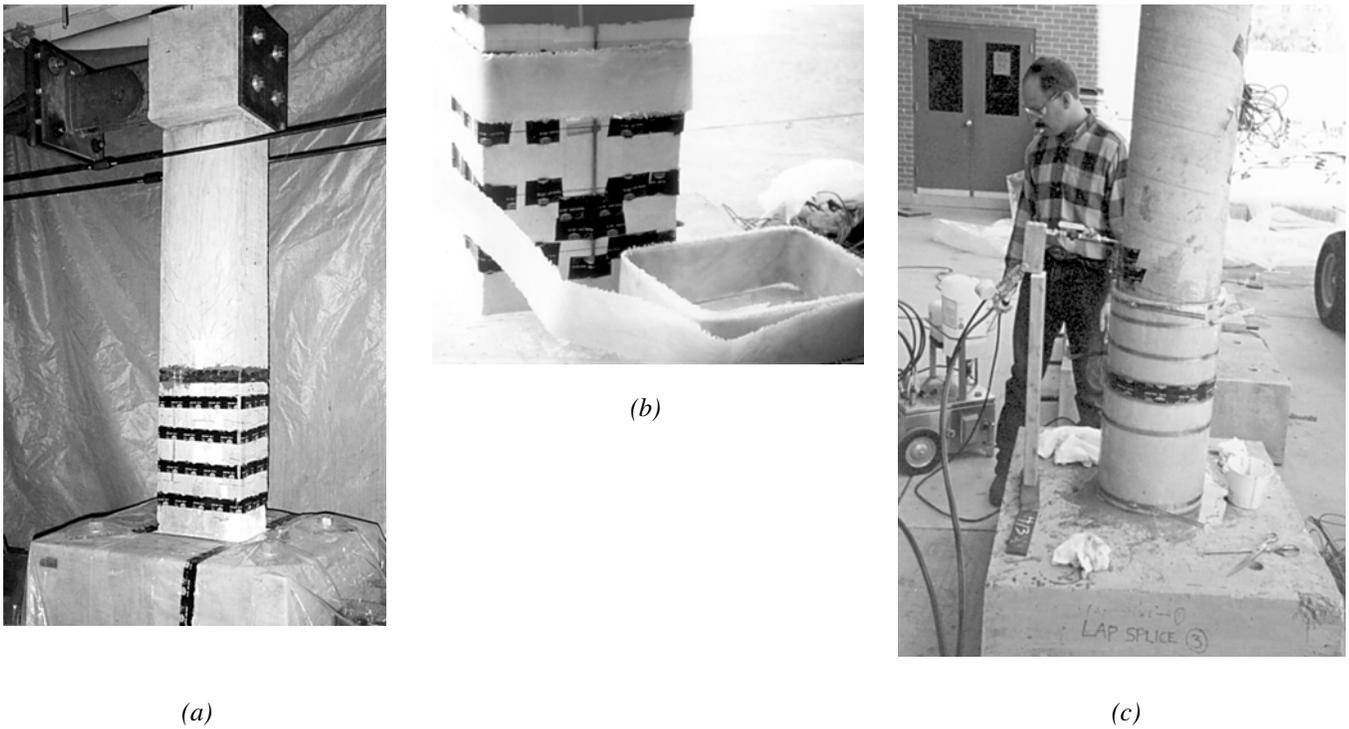
Fig. 11—Various steps of repair operation: (a) replace spalled concrete and finish column surface to original shape; (b) wrap continuous FRP composite strap in multitude of layers around failure zone of column; and (c) pressurize gap between composite wrap and column with epoxy wrap.

column face) and filling the gap between the column and the composite wrap with pressurized epoxy. Fig. 11(a) through 11(c) illustrate various steps of the repair operation for a typical damaged column. The first step in repair involved replacing spalled and damaged concrete with quick-setting new concrete and finishing the surface to the original shape and dimension [Fig. 11(a)]. The replaced concrete was not vibrated; however, effort was made to fill the cavity as fully as possible. 3 mm (1/8 in.) rubber spacers were bonded to the finished surface of the columns to allow for the gap to be pressurized later; the composite strap was then wrapped on top of the spacers as shown in Fig. 11(b). Based on design requirements, either six or eight plies of the strap were wrapped around circular and rectangular columns, respectively. The number of layers of wraps was selected based on the additional confinement pressure required to bring the column to current design standards. A thin layer of two-component, low-viscosity epoxy was brushed onto the strap while it was being wrapped around the column. Each strap was 151 mm (6 in.) wide and was placed butt-to-butt along the height of the column. The final step of the repair was pressure-injecting epoxy in the gap between the composite wraps and the concrete surface. Hose clamps were provided at the top and bottom of the repair zone to prevent outflowing of the epoxy during pressurization [Fig. 11(c)]. The four repaired column specimens, C-1/R, C-2/R, R-1/R, and R-2/R, were subjected to the same loading sequences as those for the original columns, approximately 1 week after the repair operation was completed.

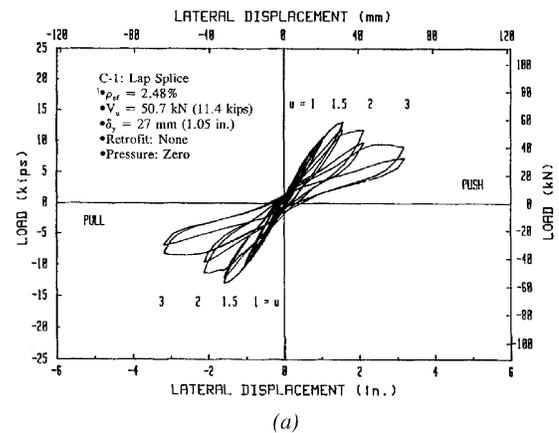
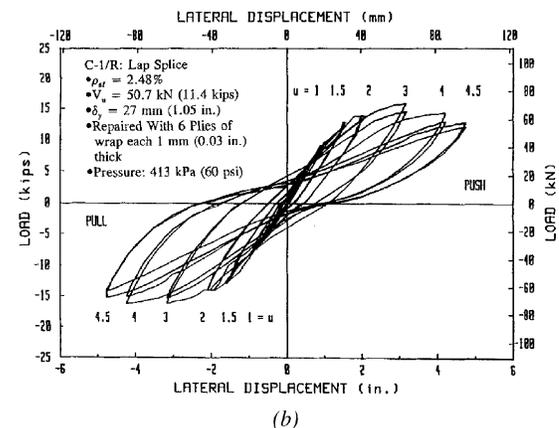
Fig. 12—Load-versus displacement responses of C-1 before and after repair: (a) Column C-1; and (b) Column C-1/R.

In general, all repaired columns performed extremely well under the simulated earthquake loading. Load-versus-displacement results for these columns are presented in Fig. 12 through 15. In these figures, δ_y indicates lateral displacement at the top of the column at first yielding of the longitudinal steel reinforcing bars and V_u is the calculated lateral strength of the column.

Fig. 12(a) shows the hysteresis loops of the original column C-1. As can be seen from this figure, the lateral load dropped significantly after the displacement ductility level of $u = 1.5$. In subsequent load cycles, the resistance to lateral load dropped until failure reached as a result of debonding in the lapped region, as was shown in Fig. 7. Fig. 12(b) shows the hysteresis loops of the failed column after it was wrapped with the composite straps in the failure region, that is, in the 635 mm (25 in.) from the top surface of the footing along the

height of the column. Clear improvements in the response to cyclic lateral loads can be seen from this figure. At the displacement ductility level of $u = 3$, where the original column had failed, no structural degradation was observed in the repaired column. In fact, the response of the repaired column had improved over the original, undamaged column. The remaining columns had similar or even more improved response as compared to the behavior of Column C-1 after repair. The measured and calculated lateral strength (based on ACI 318) of the repaired columns are summarized in Table 3.

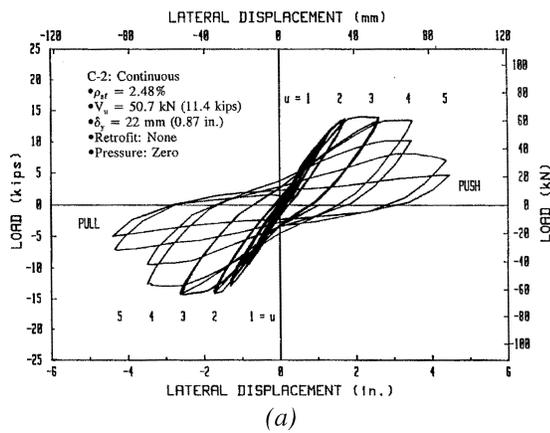
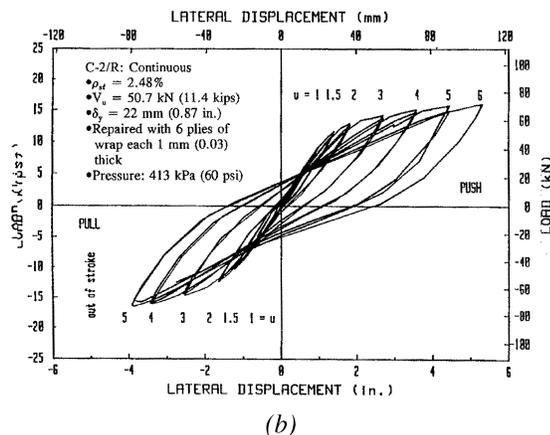
Fig. 13—Load-versus displacement responses of C-2 before and after repair: (a) Column C-2; and (b) Column C-2/R.

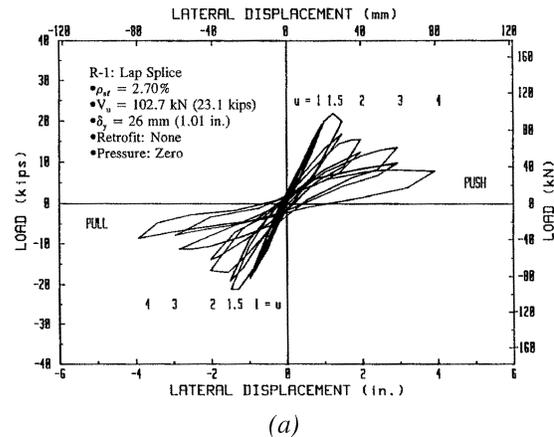
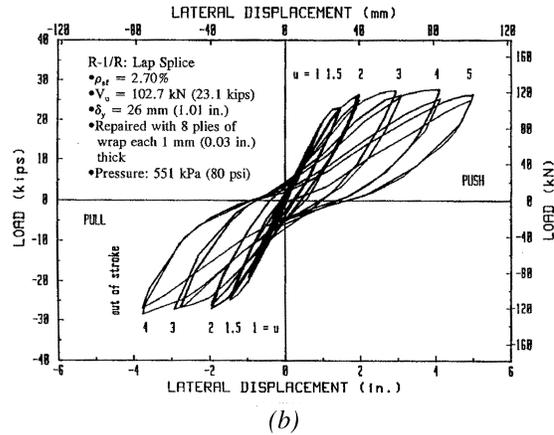
Fig. 14—Load-versus displacement responses of R-1 before and after repair: (a) Column R-1; and (b) Column R-1/R.

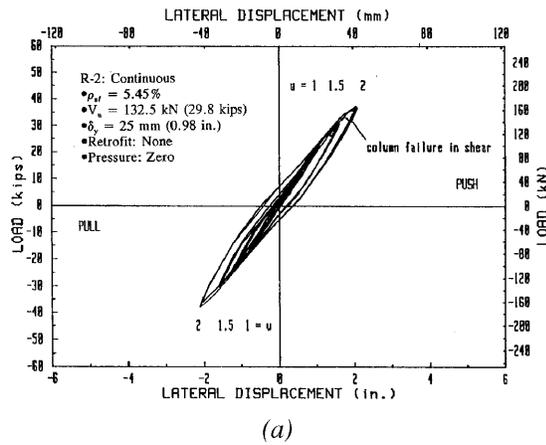
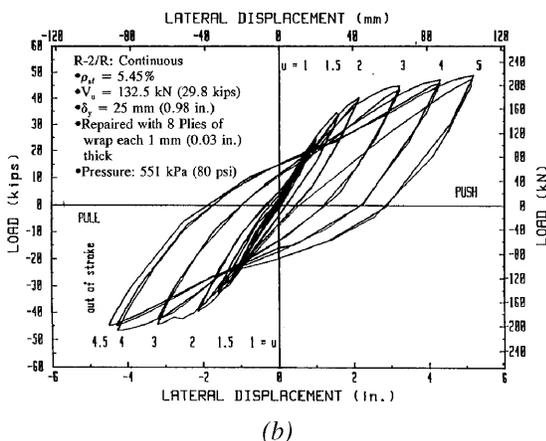
Fig. 15—Load-versus displacement responses of R-2 before and after repair: (a) Column R-2; and (b) Column R-2/R.

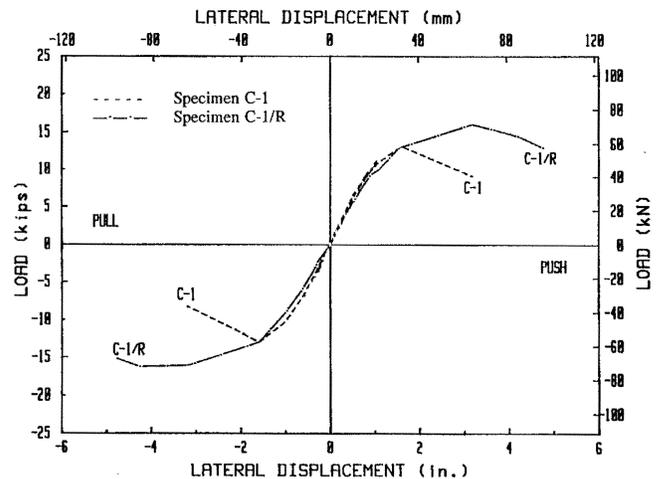
Fig. 16—Strength envelopes of Column C-1 with starter bars.

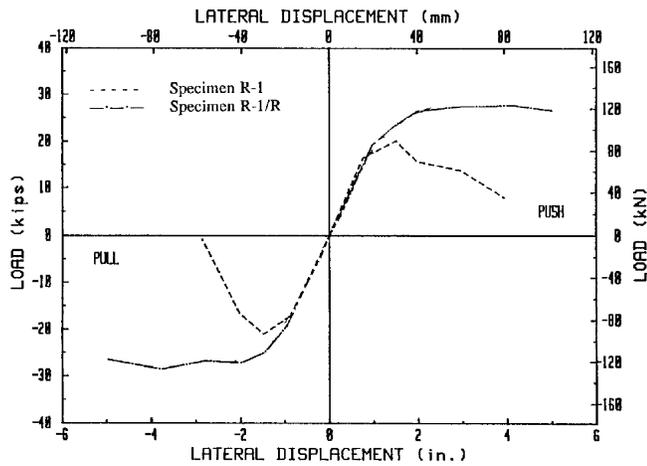
Fig. 17—Strength envelopes of Column R-1 with starter bars.

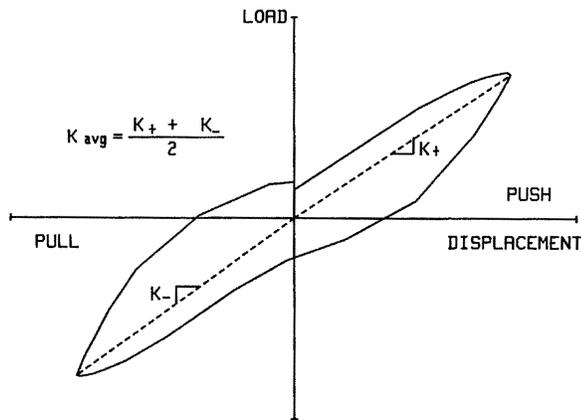
Fig. 18—Calculation of column stiffness.

For each test cycle, the overall stiffness for both positive and negative directions was defined as shown in Fig. 18. The estimated value of the stiffness was determined by dividing the maximum load reached within a cycle by the displacement at the peak of the load cycle in the direction considered. The final stiffness for each cycle was then calculated as the average of the stiffnesses for the positive and negative directions. Tables 4 and 5 summarize average stiffnesses for the circular and rectangular columns.

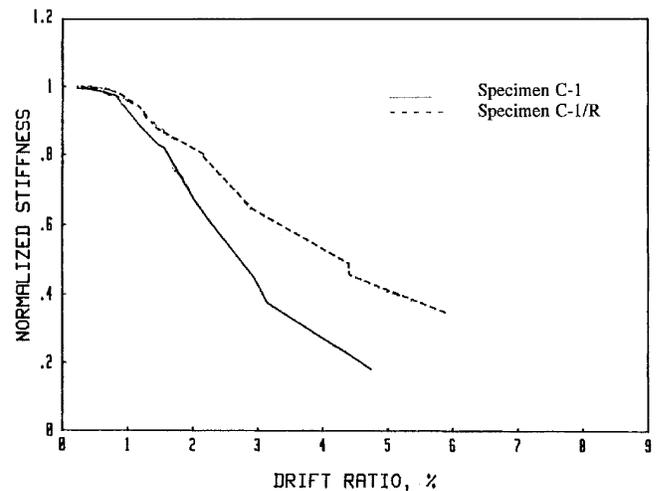
Fig. 19—Normalized stiffness versus story drift of Column C-1.

For comparison, the calculated stiffness for each cycle was normalized with respect to the stiffness of the first cycle and was plotted versus the storey drift ratio as shown in Fig. 19 and 20 for Specimens C-1 and R-1 before and after repair. A close examination of these plots indicates that the column retrofitting has influenced the rate of stiffness degradation. The columns repaired with the composite straps show a slower rate of stiffness degradation than the unretrofitted specimens. Due to concrete crushing and bond failure in longitudinal bars, Columns C-1 and R-1, both designed with lapped starter bars, exhibited a sudden drop in stiffness when the storey drift reached approximately 1.0 percent. They both lost approximately 85 percent of their initial stiffness at the end of the test. The repaired specimens had more than

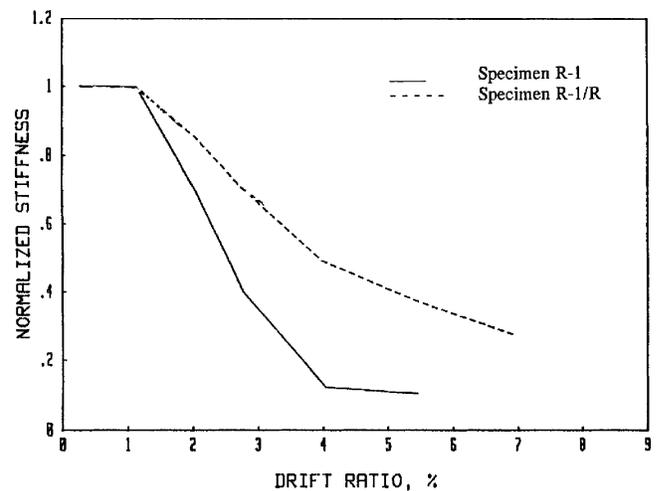
Fig. 20—Normalized stiffness versus story drift of Column R-1.
