Experimental characterization of FRP composite-wood pile structural response by bending tests

A special prefabricated fiber reinforced polymer (FRP) composite shield or jacket was developed to repair wood piles in the field. Two types of load-transfer mechanisms between the wood pile and the FRP composite shield were developed and tested: (1) cement-based structural grout; and (2) steel shear connectors with an expanding polyurethane chemical grout. The objective of this paper is to characterize the structural response of full-size pre-damaged wood piles repaired with the FRP composite shield system. A three-point bending test procedure was used to simulate the response of a pile subjected to lateral loads. The load-deformation response, deflected shape profile, relative longitudinal displacements (slip), strain distribution, ultimate bending moment capacity and mode of failure were evaluated. Wood piles were pre-damaged by reducing approximately 60% of the cross-section over a portion of the pile. It was found that a pre-damaged wood pile repaired using the FRP composite shield with cement-based grout exceeded the bending capacity of a reference wood pile. The repair system using

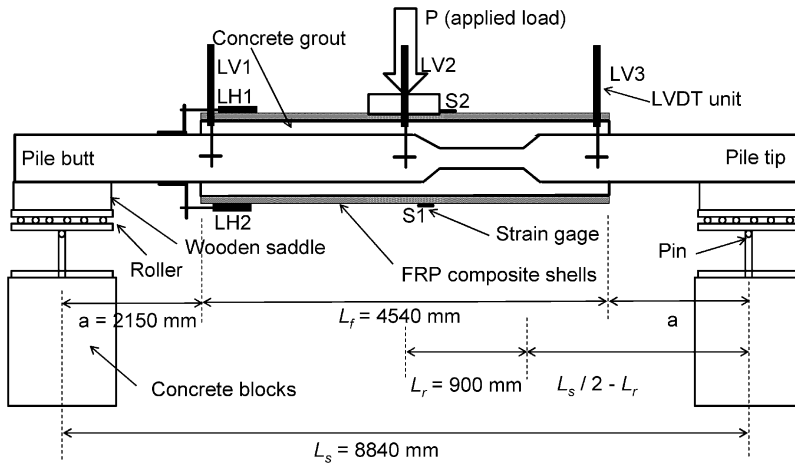
Fig. 1. Schematic of test set-up for repair system B.

The span length between the two end supports was $L_s = 8.84$ m, while the total length of the piles was $L = 9.14$ m. Each steel end support had a roller mounted on a hinge that was resting on a concrete block (See Figs. 1 and 2), which provided enough space under the pile to accommodate deflection. Since the wood piles are circular in cross-section, wooden saddles and straps were placed on top of the end

direction, to monitor strains during the test (See [Figs. 1 and 2](#)). Lab View 6.0 [15] was used to collect deflections, load and strain data.

Two LVDT units (LH1 and LH2) that measured the horizontal differential movement (slip) between the wood pile and the FRP composite shield were located close to the end of the shield, as shown in Fig. 1. Load-slip curves are presented in Fig. 7. Positive slip, which was measured on the bottom side of the pile, indicates that the wood surface moved out of the shield, and thus the shield was subjected to tension stresses. The negative slip at the top indicates that the shield was subjected to compressive stresses. The maximum slip value recorded was approximately 5 mm for both LVDTs. The load-slip curve indicates that there is partial interaction between the wood pile and the FRP composite shield. Since top and bottom slip values are similar, this indicates that the FRP composite shield bent about the same neutral axis as the wood pile. Having the two components, shield and wood pile, bending about

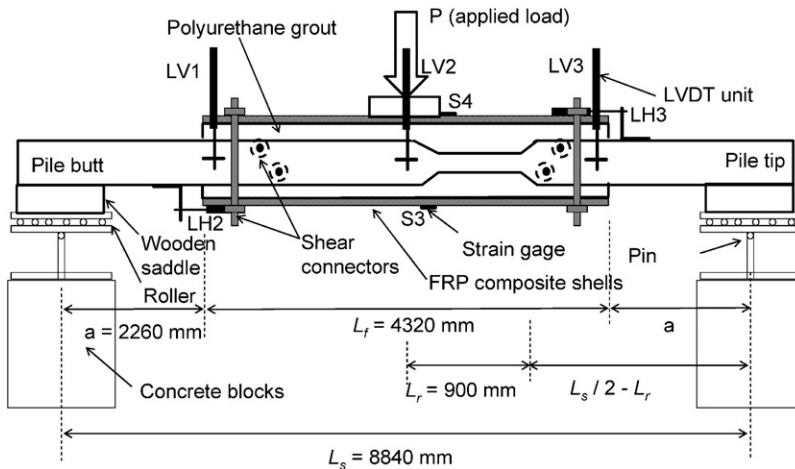
Fig. 2. Schematic of test set-up for repair system C.

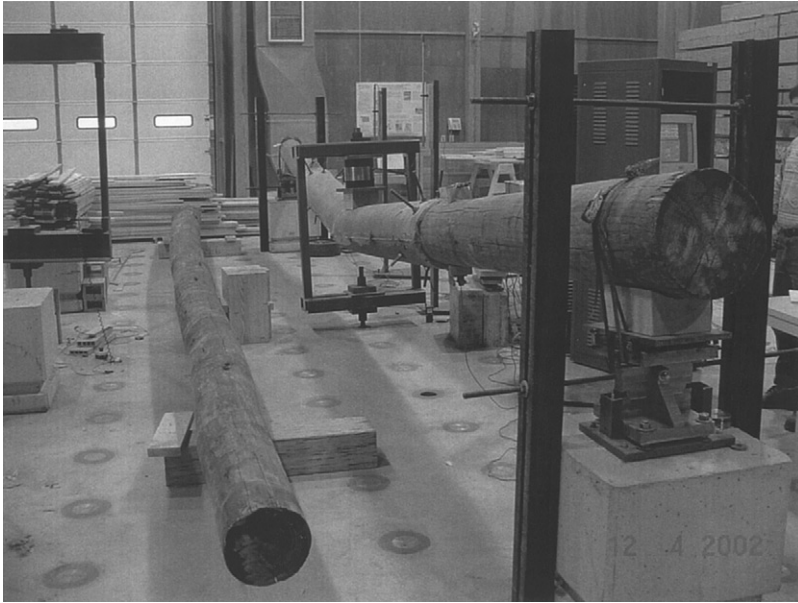
Fig. 3. Test set-up for repair system C.

supports to avoid lateral movements (See Fig. 3). Another saddle with a length of 305 mm was used at mid-span for load transfer from the actuator to the pile without slippage. The load was applied with an Instron servo-hydraulic actuator mounted underneath the structural floor using a steel frame placed on top of the wooden saddle, which resulted in a stable loading configuration.

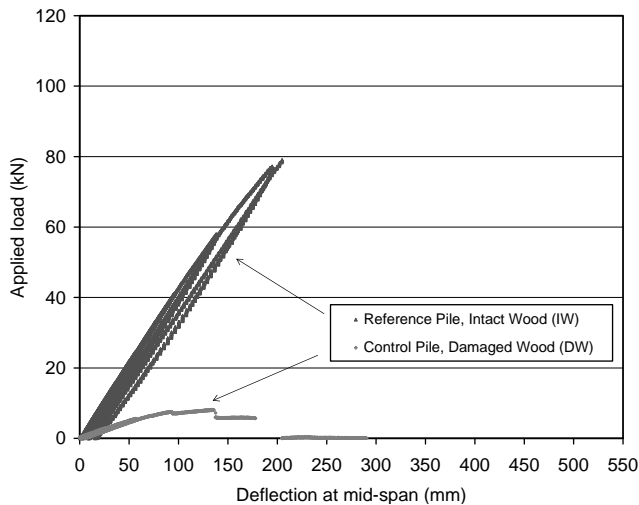
Fig. 4. Load-deflection response for intact reference pile (IW) and damaged control pile (DW).

The reference wood pile, IW, was tested intact to provide the baseline response. The load-deflection response of the reference pile was linear to failure, as shown in [Fig. 4](#). The peak load reached by the reference pile was 79 kN. The wood pile under bending failed in tension at the mid span location where the load was applied. After failure, re-loading was not possible for the reference pile.

The control pile, DW, was pre-damaged with its cross-sectional area reduced by 63%. This pile was tested to characterize the behavior of a damaged wood pile. The load-deflection response of the control pile is shown in [Fig. 4](#). The peak load corresponding to the control pile was 8.1 kN. The 63% reduction in cross-sectional area diminished the wood pile bending capacity to one-sixth of the intact reference pile (IW) value. Under bending, the damaged control pile failed in tension at the damaged section. After failure, re-loading was not possible for the control pile.

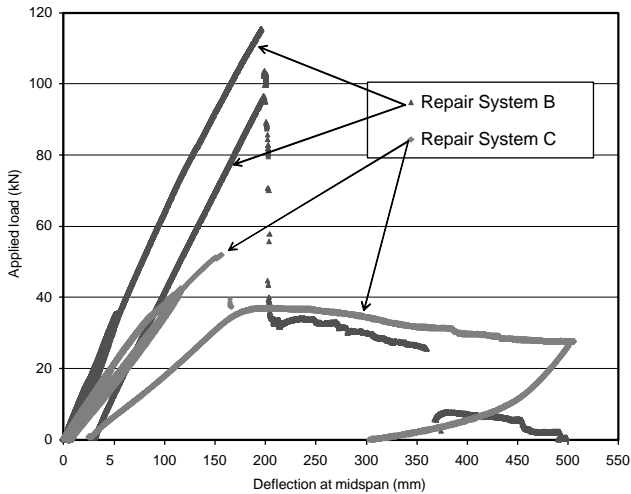
Fig. 5. Load-deflection response for repair systems B and C.

A pre-damaged pile with its cross-sectional area reduced by 62% over a portion of the pile was repaired using system B (FRP Composite Shield/Cement Grout). The response of the repair system B was linear to failure (See Fig. 5). Under bending, the wood pile failed at a peak load of 115 kN (see Table 2) in tension at the end of the FRP composite shield, as shown in Fig. 6(a). After unloading, approximately 15% of the total deflection was not recovered, which was attributed to damage accumulation. The specimen was reloaded after failure (See second loading curve depicted in Fig. 5). The re-loading curve was also linear with approximately the same load-deflection slope as the peak loading curve. Failure occurred in the wood pile outside the segment encased with the FRP composite shield. It was hypothesized that the FRP composite shield restored enough bending capacity to the wood pile pre-damaged section to prevent failure at this location.

A pre-damaged pile with its cross-sectional area reduced by 61% over a portion of the pile was repaired using system C (FRP composite shield/shear connectors/polyurethane grout). The load-deflection response of system C was linear up to failure, as shown in Fig. 5. The peak load for the pile specimen was 52 kN. At the peak load, the FRP composite shield failed in compression in the axial direction at mid-span (end of wood saddle), as depicted in Fig. 6(b). This damage was attributed to the observation that the compressible polyurethane grout did not provide load bearing support between the wood pile and the FRP composite shield. Approximately 16% of the total deflection was non-recoverable (inelastic).

The pile specimen was re-loaded after reaching the peak load. The pile was able to support approximately 70% load of the peak load during reloading with a lower load-deflection slope. As more damage was introduced to the FRP composite shield, the load capacity of the system was reduced (see Fig. 5). The flexibility of the system

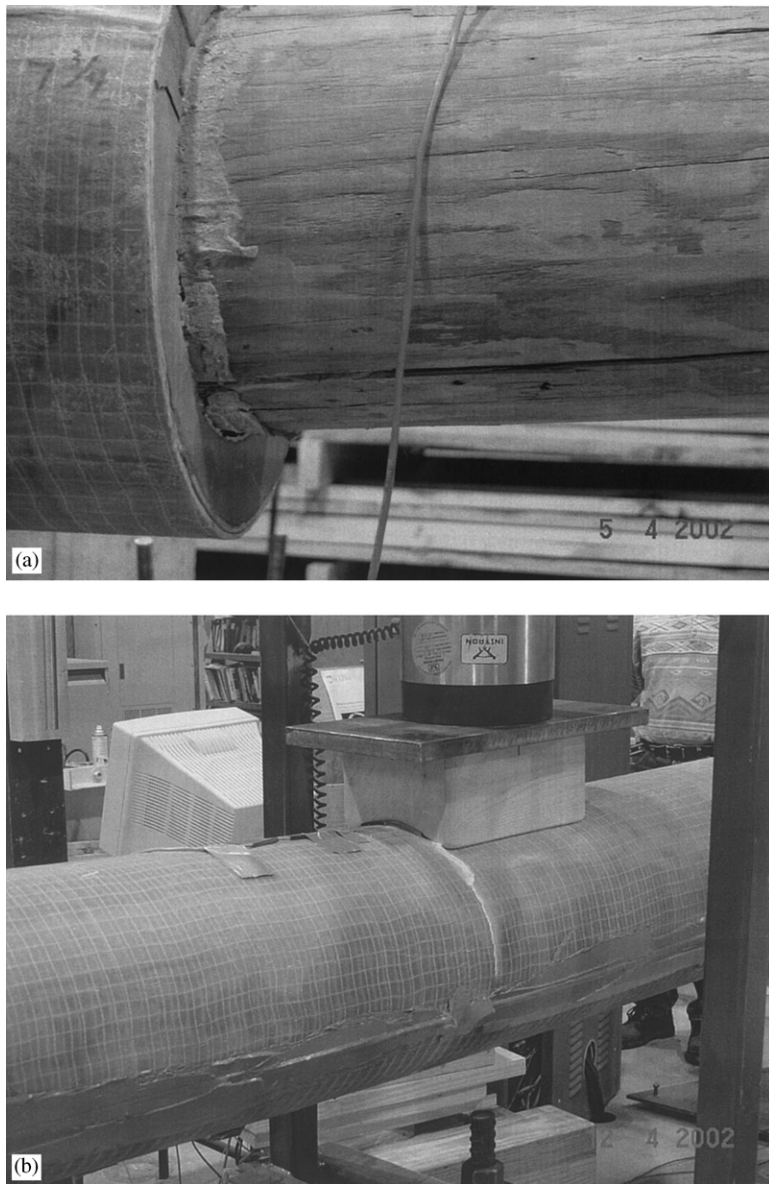
Fig. 6. Failure modes: (a) Tension failure in wood pile at shield end (repair system B); (b) Compression failure in FRP composite shield (repair system C).

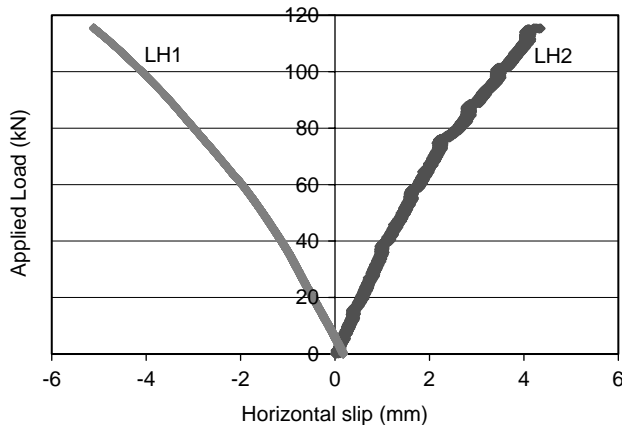
Fig. 7. Load-slip response for repair system B (load cycle to failure).

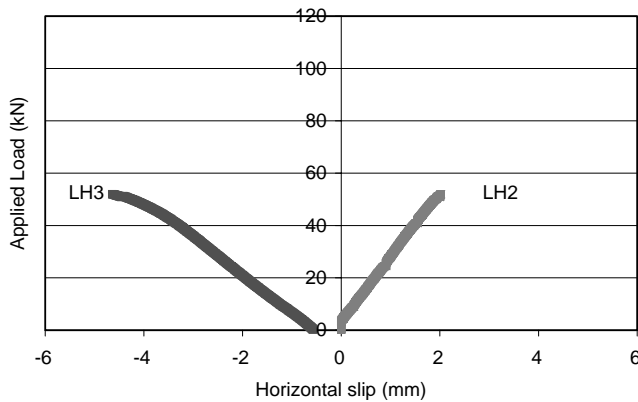
Fig. 8. Load-slip response for repair system C (load cycle to failure).

Maximum relative horizontal movement (slip) between the wood pile and the FRP composite shield measured with two LVDT units (LH2, and LH3) is presented in Fig. 8. The maximum horizontal slip recorded was approximately 5 mm for the bottom LVDT (LH2), and less than half of that value for the top LVDT (LH3). The difference in horizontal slip at the top and the bottom indicates that the FRP composite shield does not bend about the same neutral axis as the wood pile does. The observed failure mode, localized FRP composite compression failure, also supports the observation that the shield does not behave in beam bending with the wood pile.

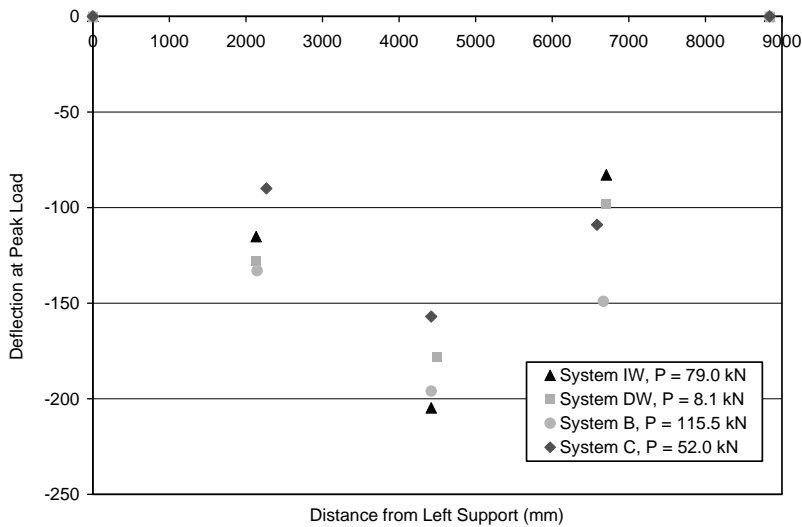
Fig. 9. Deflected shape at peak load for all pile systems.

The deflected profiles at peak load for all pile systems are depicted in Fig. 9. It was found that the repair system B with the cement-based grout resulted in a maximum

mid-span deflection of 196 mm, which is similar to the corresponding value for the reference intact wood pile IW, 205 mm. The repair system B resulted in a decrease in curvature in the maximum bending moment region compared to the reference and control piles (i.e., smoother change in deflection slope along the pile axis). This is a consequence of the increase in bending stiffness over the repaired length of the pile.

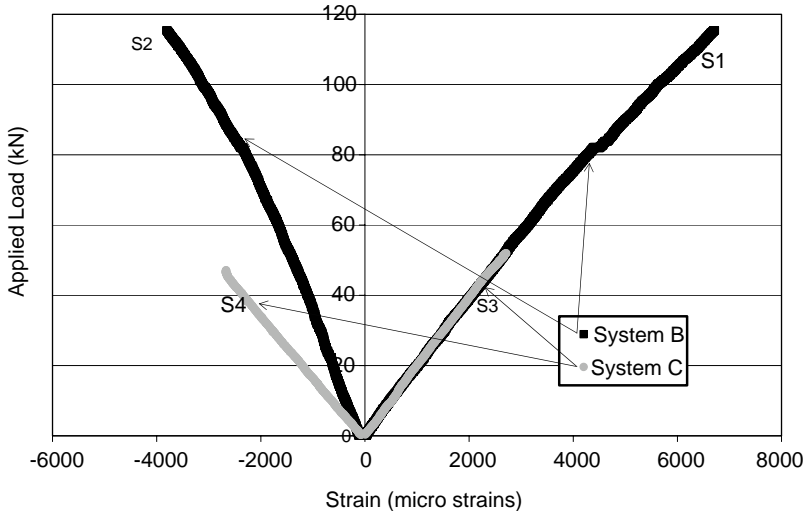
Fig. 10. Load-strain response for repair systems B and C.

Longitudinal strains at the top and bottom of the FRP composite shield were monitored during the load test for repair systems B and C. Load–strain distribution for both repair systems are presented in Fig. 10 (see Figs. 1 and 2 for strain gage locations). The axial strains at peak load for the repair system with the cement-based grout, B, were -3800 micro strains on the top and 6700 micro strains on the bottom of the FRP composite shield. Axial strains at peak load for the repair system with the steel shear connectors, C, were -2760 micro strains on the top and 2710 micro strains on the bottom of the FRP composite shield.

The difference in axial strains between the two repair systems was attributed to the different load transfer mechanisms and flexibility. The cement-based grout in repair system B transferred stresses between the FRP composite shield and the wood pile resulting in higher strains before failure compared to repair system C. In repair system C, the flexibility resulting from using the steel shear connectors between the shield and the wood pile was much greater than the repair system B with the cement-based grout system. The polyurethane grout did not contribute to reducing the overall flexibility in repair system C.

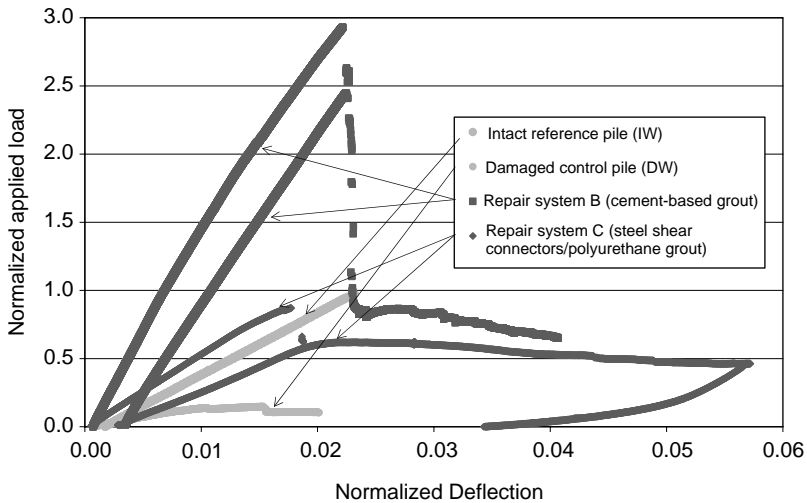
Fig. 11. Normalized load-deflection responses for all wood pile systems.

It is worth noticing that the proposed normalization is only based on the bending stiffness of the wood pile and does not represent the partial composite action developed by the FRP composite shield. The normalization method is only valid for comparing piles that exhibit a linear response to failure. Based on the load-deflection response observed for the intact reference and pre-damaged control piles (Fig. 4), and the repair pile systems B and C (Fig. 5), the normalization method was implemented. The normalized load-deflection response for all four specimens is shown in Fig. 11. The normalized maximum load and deflection for all pile specimens is summarized in Table 3. The normalized load capacity of the damage specimen, DW, was approximately 15% of the intact reference wood pile, IW. Repair system B exhibited the highest load-deflection slope of all the tested pile systems due to the stiffness and quasi-integral response provided by the cement-based grout. For example, repair system B had a normalized peak load of 2.93 and a normalized maximum deflection at mid-span of 0.022, while repair system C with a normalized peak load of 0.87 had a normalized maximum deflection of 0.018. Bending of the shear connectors in repair system C with the non-structural polyurethane grout resulted in a relatively flexible response.
