# **REHABILITATION OF DETERIORATED TIMBER PILES USING FRP COMPOSITES**

**Final Report**

**Southern Plains Transportation Center**

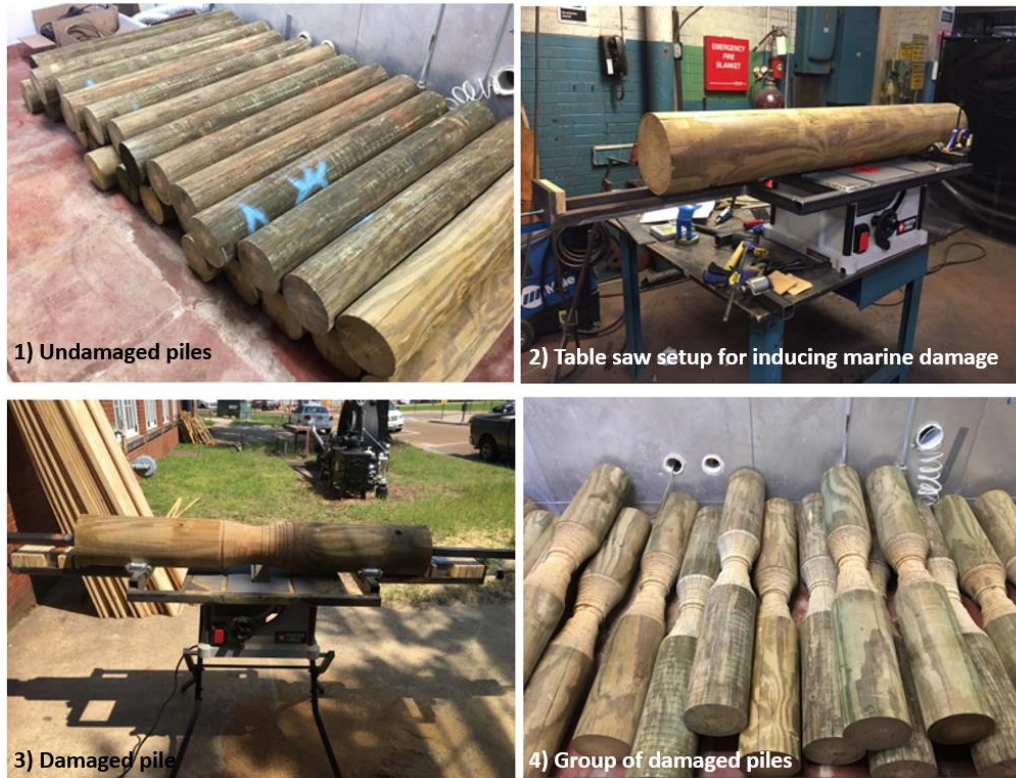
Figure 4. a) Undamaged piles, b) setup for inducing marine damage, c) damaged single pile, d) damaged group of piles

damage in terms of depth and length was controlled to evaluate the efficiency of the repair techniques and to be able to draw generalized conclusions. All piles with the exception of the undamaged pile were taper cut into an hourglass shape resulting in five different deterioration zones. Figure 2 illustrates the configuration of the induced damage and features two damage depths and four damage lengths. The piles that featured a 1 in. damage depth represent moderate decay and those that feature a 2 in. damage depth represent severe decay. Damage lengths varied from 12 in. to 18 in. The nominal diameter of all piles was 8 in. and the material was Yellow Southern Pine. The actual diameter of each pile was measured and recorded. All piles were acquired from the same jungle and they were all treated with Chromate Copper Arsenate (CCA). Figure 4 illustrates the undamaged piles, the setup that was used to induce marine damage, and the intentionally damaged piles. A table saw was used to induce the damaged described in Figure 3. The depth of cut was adjusted such that it matched the desired depth at a given location in the damaged region. Two adjacent blades were used to induce damage incrementally as shown in Figure 4.

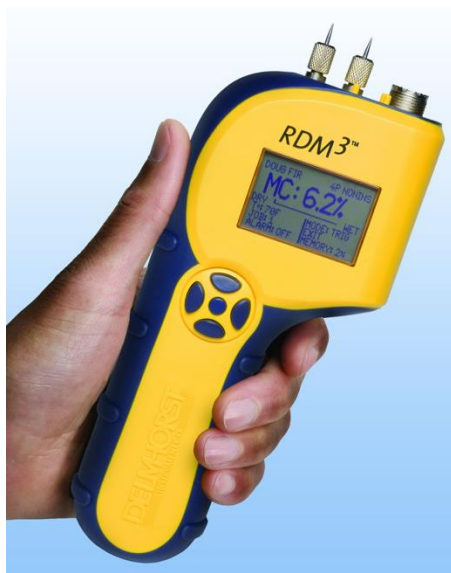
Figure 5. a) Delmhorst Moisture Meter used to measure moisture content, b) moisture content versus time

All piles were fully saturated by immersing them in a water container. Table 1 illustrates the moisture content before and after saturation. After the initial moisture content of the piles was recorded, all piles were immersed in a water container and the moisture content was measured every three days using a moisture meter (Figure 5a). When moisture content readings reached the point where there was no appreciable increase between subsequent readings the piles were taken out of the water container and were prepared for repair. The amount of time that it took for the piles to be fully saturated was approximately 30 days. Figure 5b shows the moisture content as a function of time for 26 out of the 42 tested piles. After the piles were repaired they were immersed in the water container again for 30 days to allow the infill grout and epoxy to gain their design strength. The moisture content was measured only after 30 days when the repaired piles were taken out of the water container and were prepared for testing. No intermediate moisture readings were taken between the time the piles were repaired and the time that they were tested due to the weight of the piles (approximately 300 lbs). However the moisture readings taken before the piles were tested are similar with those taken prior to the repair, which suggests that the piles were fully saturated during that time. The reference undamaged and damaged unrepaired piles were left in the water container until the day they were tested.

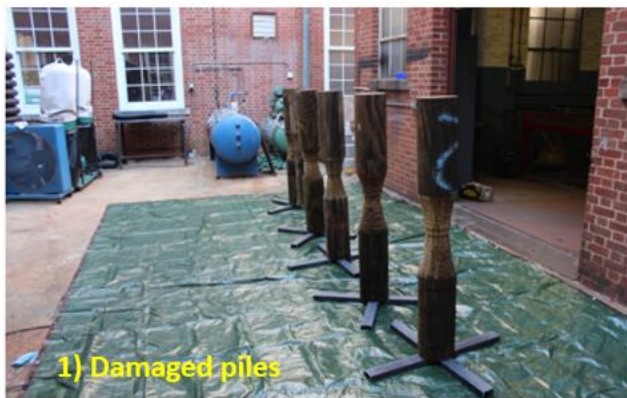
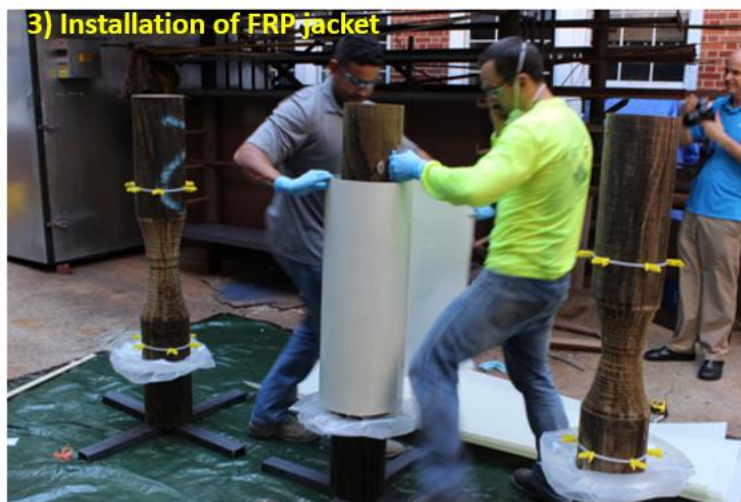
Figure 10. Repair of damaged timber piles – Pilemedic

Figure 10 shows the repair of the damaged timber piles with Pilemedic products. The damaged piles were secured vertically on the steel cross stands and spacers were installed above and below the damaged region to create the desired annular space. Plastic pour stops were installed at the bottom prior to the installation of the FRP laminates. The FRP laminates in this case came in flat sheets and were custom cut to match the diameter of the pile and the desired annular space. Two layers of bidirectional FRP laminates were wrapped around the damaged piles to create an 8 in. minimum overlap. After the spacers were installed, a coat of underwater epoxy was applied to the outside of the first FRP layer and the laminate was wound around the damaged pile to create an 8 in. minimum overlap (Figure 7c). Similarly, a coat of underwater epoxy was applied to the inside of the second FRP layer and the laminate was

wrapped around the first layer to create an 8 in. minimum overlap. Zip ties were used to additionally secure the laminates in the desired position and tie the plastic pour stops to the FRP laminates to seal any voids. Finally, the annular void was filled with either underwater epoxy or grout.

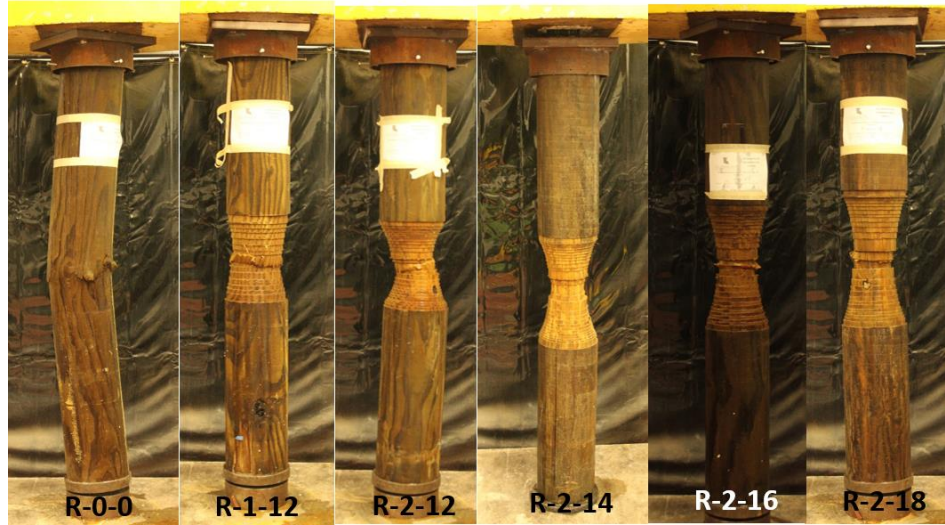
Figure 12: Testing of undamaged and damaged-unrepaired timber piles loaded concentrically

Table 2 provides a summary of the maximum loads measured for all reference piles. The maximum load was divided by the net cross-sectional area to calculate the failure stress in the reference piles. The average failure stress was 2.5 ksi and the coefficient of variation was 15.2%. The differences in the peak stress are attributed to the variability of the wood material despite the fact that all samples were obtained from the same jungle. This variability stems from the presence of knots, orientation of grains, etc. All failure modes featured a material failure due to the short length of the piles. Figure 12 illustrates the failure mode in the undamaged pile and the damaged unrepaired piles. In both cases the failure occurred at mid-height of the pile. For the damaged unrepaired pile this was expected because the smallest cross section of the pile was at mid-height. For the undamaged pile the failure was expected to occur in the weakest cross section.
