# A Novel Solution for Restoration of Deteriorated Piles - Part 1

*Missouri DOT Pioneers the Implementation of the Next Generation of FRP Products*

# A Novel Solution for Restoration of Deteriorated Piles - Part 2

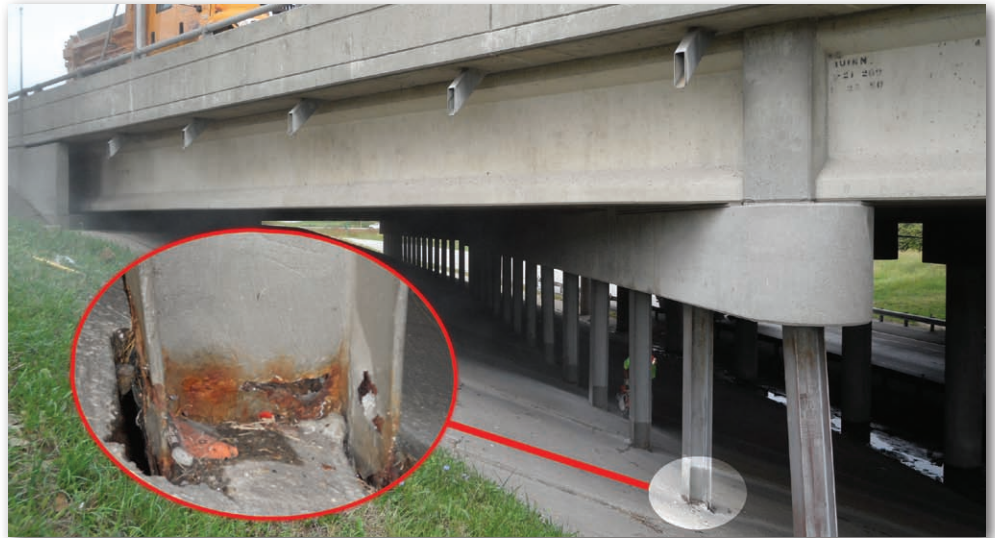
One of the 49 corrosion-damaged piles in the I-70/I-270 interchange (St. Louis, Missouri) that was repaired with this technique.

The first installation of this product on a highway project was recently completed in St. Louis, Missouri, on four bridges at the I-70 and I-270 interchange. The four structures are five span bridges that carry I-270 traffic and two of the intermediate bents are constructed of exposed H piling. The H piling bents allow for expansion between the cap and the deck, while the other two intermediate bents on these bridges are constructed of concrete columns that are integral with the deck. The H piling bents had 26 to 32 steel 10X42 steel piles that

are located behind the barrier wall on a 3:1 concrete slope with limited overhead space, so all work had to be performed by hand. The pile lengths in place varied between 30 and 46 feet. A total of 49 piles near the edges of the bridges were severely corroded with the section loss of the piling to be repaired varying from 20 to 80 percent and were repaired. The damage caused by

polluted rain runoff was concentrated over a 1-foot-high section at the base of the piles. ■

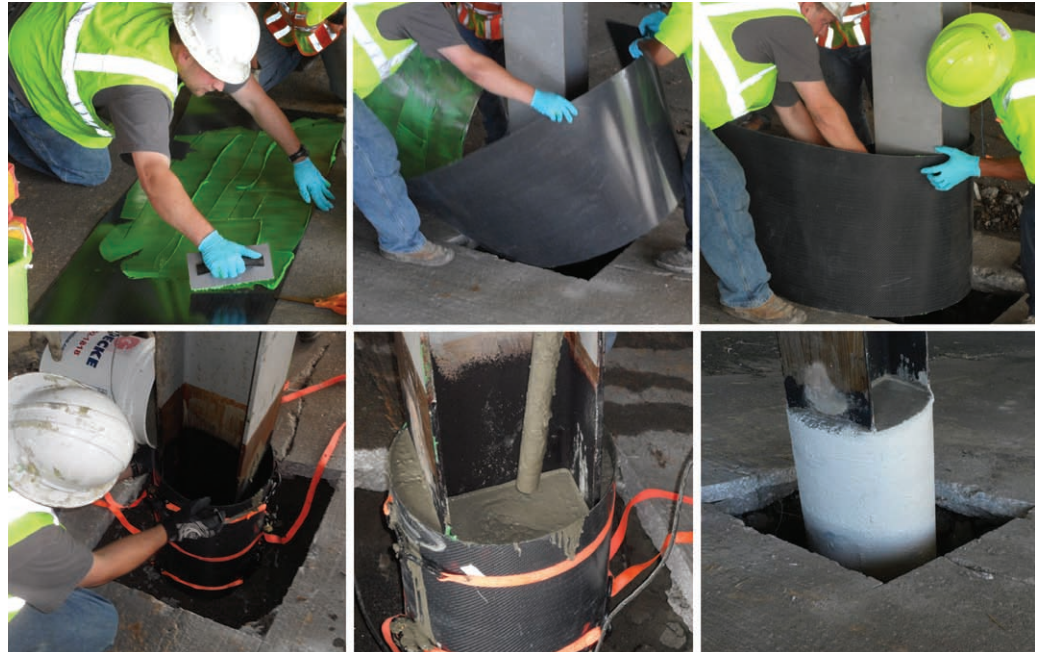
*Steps in installation of PileMedic™ clockwise from upper left: application of epoxy to laminate, creating the shell around the pile, positioning the shell, filling with grout and vibrating, finished painted shell.*

The Missouri DOT (MoDOT) determined that it would be sufficient to repair a 2-foot-high length of the pile in the corroded area. A section of the concrete slab approximately 2.5 feet by 2.5 feet was cut and removed to expose the pile. The corroded area was cleaned by sandblasting; mechanical grinders can also be used to remove rust from the surface of the steel. As added protection, a corrosion-inhibiting paint was used to coat the repair area of the steel pile.

A piece of PileMedic™ 2-feet wide by 9-feet long was used for each pile. A special two-component epoxy was mixed in the field and applied to an approximately 2-foot by 5-foot section of the laminate. The mixed epoxy has a paste-like consistency and is applied with a trowel to a thickness of 30 to 40 mil. The laminate is then wrapped loosely around the pile to create a two-ply shell. The 9-foot length of the laminate allows creation of a two-ply, 16-inch-diameter shell with 8 inches of overlap beyond the starting point.

At this stage, before the epoxy cures, ratchet straps must be used to hold the shell in a cylindrical shape to maintain the diameter of the shell. The shell can be moved up or down to be centered around the damaged portion of the pile. In this project, the soil below the slab formed the seal at the bottom of the shell.

The annular space between the shell and the pile was filled with a high-strength, non-shrink cementitious grout. The grout

was mixed in a 5-gallon pail with a hand-held jiffy mixer and required no special heavy equipment. Consolidation of the grout was completed with a small vibrator and the top of the grout was finished with a trowel. Before the grout sets, the hydrostatic pressure from the grout pushes the inner layer of the shell outward against the outer layer and forces the two plies of the PileMedic™ laminate to be tightly pressed against each other. After several hours, the ratchet straps are removed, and if desired, the exterior of the shell can be painted. The entire repair operation, excluding the painting, was completed in about 2 hours.
