New Advances in Repair of Submerged Piles

Mo Ehsani, PhD, PE, SE, President, QuakeWrap Inc. and
Centennial Emeritus Professor of Civil Engineering, The U. of Arizona

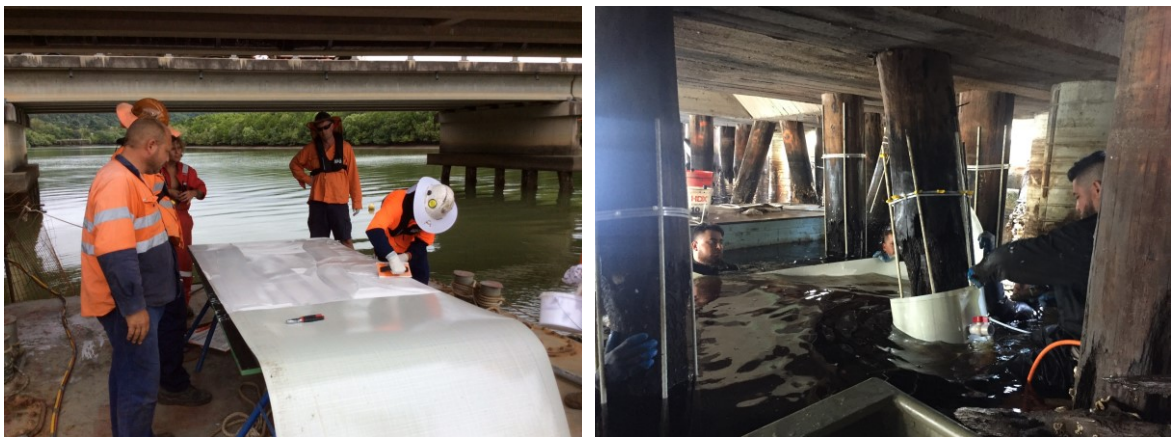
Fig. 1. Laminate being cut to size and coated with epoxy on a barge; divers wrapping the laminate around a pile after the reinforcing bars have been secured in the spacers.

- a. **Size & Shape** – The small thickness of the laminates which is typically less than 0.05 inches makes them flexible enough to be wrapped around piles of any shape and size. Standard detail requires wrapping the laminate twice (i.e. 720 degrees), plus an 8-inch extension around the pile. Once the right length of laminate is cut from the roll in the field, the second half of the laminate is coated with an epoxy paste, and it is wrapped around the pile and bonded to the first layer, creating a two-ply structural shell around the pile (Fig. 1). This eliminates the need for custom ordering the jackets, saving significant time, and shipping and storage cost. The annular space between the jacket and the pile will be filled with grout, concrete or epoxy grout later.

- a. **Spacers** – These plastic parts are available in a variety of shapes and sizes and serve multiple purposes (Fig. 3). Divers can pass a zip tie through several spacers and fasten them around the pile. The longitudinal reinforcing bars (typically made of glass FRP) can be snapped into place (Fig. 1). This allows the engineer to know the precise location of each bar. The overall length of the spacers defines the annular space between the jacket and the pile that will be filled with grout or concrete. A variation of these spacers can be custom made to attach to the flanges of H-piles for placement of the longitudinal bars. In some cases, the repair portion of the pile extends into the mud line and the soil provides a seal at the bottom of the jacket for placement of the grout. However, there are many applications where the length of the repair is limited to the splash zone, requiring the creation of a seal at a point along the height of the pile where the bottom of the jacket will be positioned. The skirt pin shown in the foreground of Fig. 3 allows the creation of that seal.

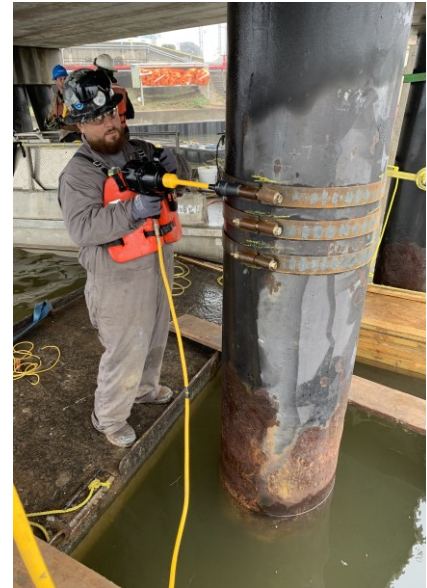
Fig. 4. ShearClamp™ used on H-piles and ShearWrap™ steel bands that are torqued around circular steel piles.

- b. **Shear Transfer** – In repaired piles, a load path must exist for the forces in the newly-formed reinforced concrete shell to bypass the damaged zone of the pile. When the pile is made of timber or concrete, the rough surface of the host pile usually provides sufficient load transfer through bond. However, when the host pile is made from steel, a mechanism such as welded shear studs can be used. Underwater welding is costly and difficult and as was the case on one of our recent projects, the flammable materials present on the site did not allow any welding. Two newly developed products assist with this shear transfer. One is called ShearWrap™ for use on circular steel piles. Each band

is about 3-4 inches wide, 0.2 inches thick and is comprised of two half circles. The divers place the band around the pile (usually above water) and loosely connect the bolts. The band is then free to slide along the height of the pile to its final position. At that point, the divers tighten the two bolts to the specified torque. In some cases, wings can be welded to the steel bands to increase the bearing capacity of the unit. Similarly, for steel H-piles, ShearClamp™ can be used. These individual clamps include a bolt that can be tightened against the flange of the pile. The capacity of each unit can be determined based on its resistance through friction and bearing.
