BULLETIN

MIAMI BUILDING
FIRST TO BENEFIT FROM
INNOVATIVE PILEMEDIC™ JACKET

BY MO EHSANI AND ABHI TIPNIS

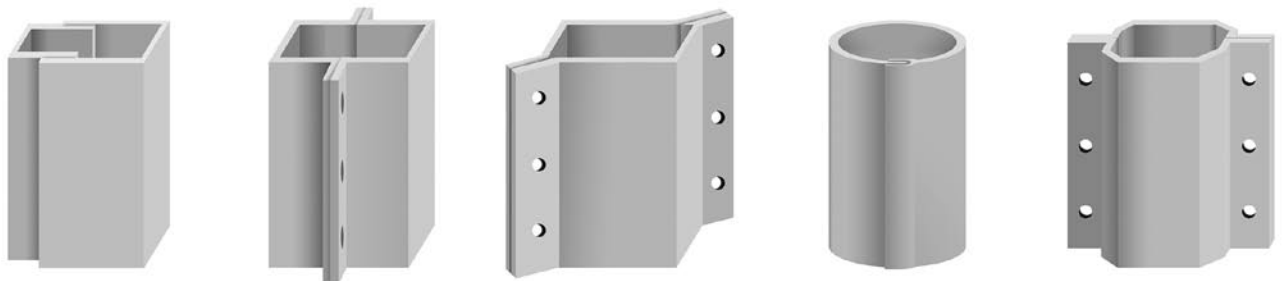
Fig. 1: Typical GFRP jackets used for repair of piles in North America

forms where the two half shells are supplied as U-shapes, where the sides are overlapped and bonded together in the field with epoxy or screws to create a solid rectangular or square shell. Some of the jackets commonly used to date are shown in Fig. 1. In some cases, these forms are used as stay-in-place forms.

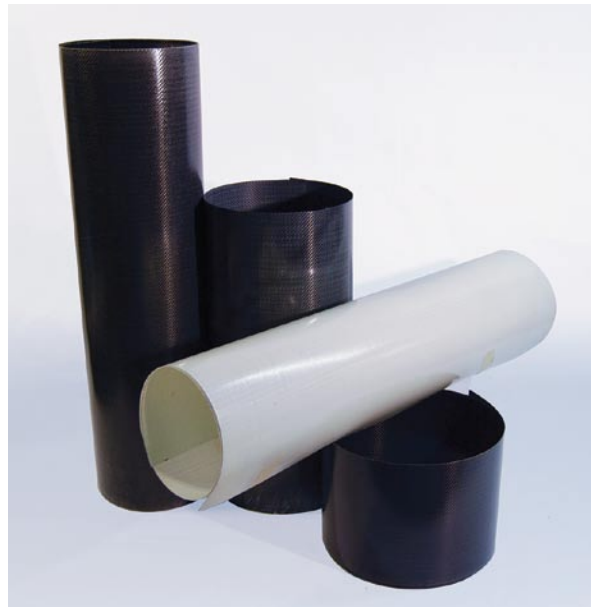
Fig. 2: Sample rolls of PileMedic™ carbon and glass laminates

ranging between 0.010 to 0.025 in. (0.25 to 0.64 mm). Depending on the design requirements, the laminate may include multiple layers of uniaxial or biaxial carbon and glass fabrics. Typical laminate rolls are less than 0.025 in. (0.64 mm) thick by 4 ft. (1.2 m) wide by 300 ft. (91.4 m) long (Fig. 2).

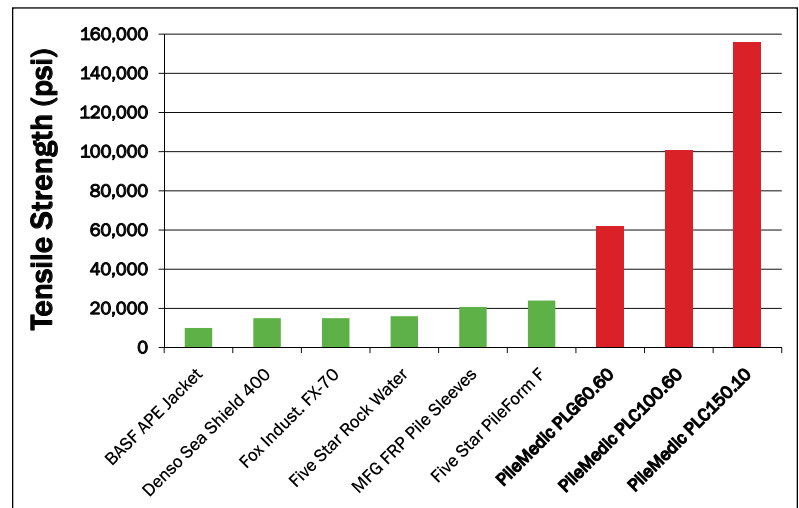
Fig. 3: Comparison of Tensile Strength of PileMedic™ with Conventional Jackets (Data compiled from information obtained from each company's website and literature.)

The manufacturing process allows for the production of laminates with a tensile strength higher than 150,000 psi (1035 MPa). By mixing and orienting the fibers in different directions, laminates with an infinite number of strength and stiffness characteristics can be produced. As shown in Fig. 3, the strength of PileMedic™ laminates is significantly higher than all other pile jackets in the market.

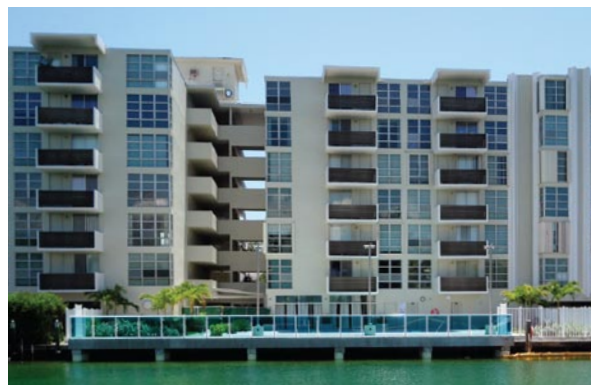
Fig. 4: Guilford House Condominiums, Bay Harbor Islands, FL

The first application of PileMedic™ laminates for the repair of underwater piles was recently completed at Guilford House Condominiums, Bay Harbor Islands, FL (Fig. 4). The project is located on the environmentally sensitive South Florida intra-coastal waterway. Approval from the Florida Department of Environmental Protection (DEP) was required prior to restoration.

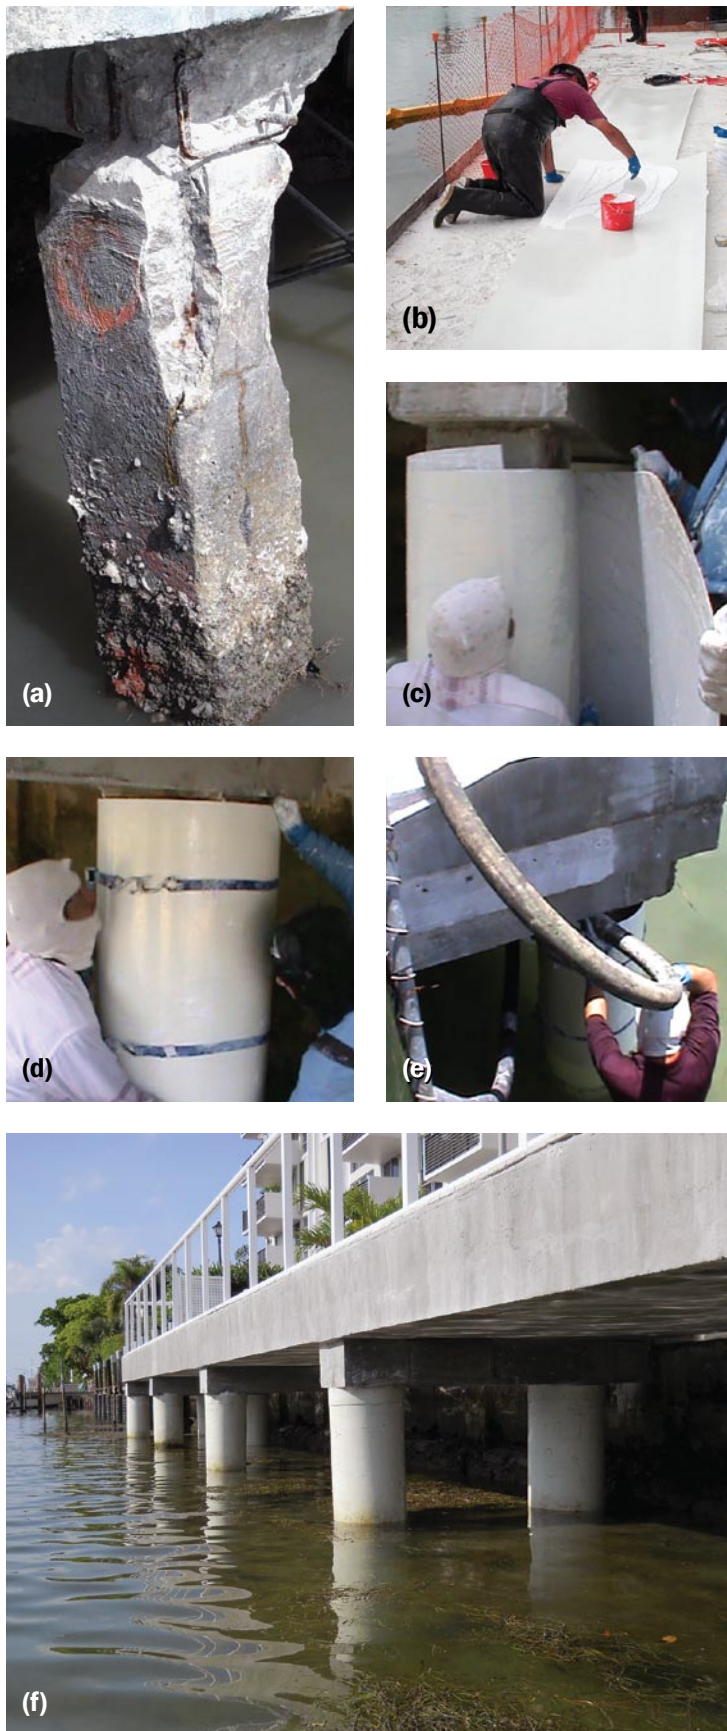
The 14 x 14 in. (356 x 356 mm) piles (Fig. 5(a)) had substantial steel corrosion and spalled concrete. While searching for a repair methodology, the contractor recommended using the new PileMedic™ laminates for the piles that supported an overlook on the pool deck, for ease of installation and the added structural enhancement.

Fig. 5: PileMedic™ repair steps: (a) deteriorated pile; (b) applying moisture-insensitive epoxy to laminate; (c) transporting laminate into water and wrapping it around pile; (d) final jacket size adjustment and temporary support by ratchet straps; (e) filling annular space; and (f) completed piles after removal of ratchet straps

insensitive and it cures underwater, eliminating the need for any coffer dams. The epoxy was mixed using a jiffy mixer and applied with a thickness of 40 mil (0.04 in. [1 mm]) to the 66+8 = 74 in. (1880 mm) length of the laminate; the first 66 in. (1680 mm) length of the laminate that will be placed next to the pile does not need to be coated with epoxy (Fig. 5(b)).

Because the water was relatively shallow, the workers could pick up the laminate and walk it in water. At this time, the laminate is wrapped around the pile to create the 21 in. (533 mm) diameter shell (Fig. 5(c)). At this stage, the uncured epoxy coating serves as a lubricant, allowing the laminate to slide easily as the crew makes final adjustments to the diameter of the shell. Ratchet straps were used to fix the diameter of the shell and prevent it from unraveling before the epoxy cures (Fig. 5(d)). The cylindrical shell can be moved vertically along the height of the pile to its final position. In this case, it was pushed down into the mud that created a seal at the base.

An underwater grout was mixed and pumped with a hose into the annular space between the jacket and the pile (Fig. 5(e)). As the tremie mixture was placed, it displaced the water in the annular space to the top until the entire annular space was filled with grout. At this stage, the hydrostatic pressure of the grout pushes the two layers of the FRP jacket tightly against one another while the ratchet straps prevent the jacket from opening up. At the same time, the heat generated from the hydration process of the grout helps with the curing of the epoxy. Depending on the ambient temperature, the epoxy will cure in several hours, at which time the ratchet straps can be removed. The repaired piles at the conclusion of the project are shown in Fig. 5(f).
